#### FINAL REPORT: SHASTA AND TEHAMA COUNTIES STREAM BARRIER ASSESSMENT AND EVALUATION

#### Pacific States Marine Fisheries Commission and California Department of Fish and Game

April 15, 2011

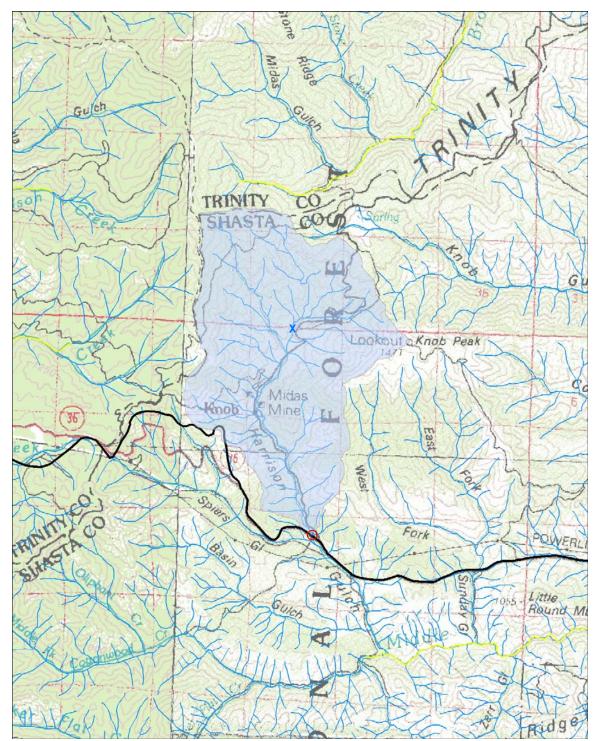
Site # 2: Harrison Gulch Bridge/Hwy 36 West; Middle Fork Cottonwood Creek; Sacramento River

**Comments:** Potential natural barrier <sup>1</sup>/<sub>4</sub> mile upstream of road crossing caused by log and rock jam.

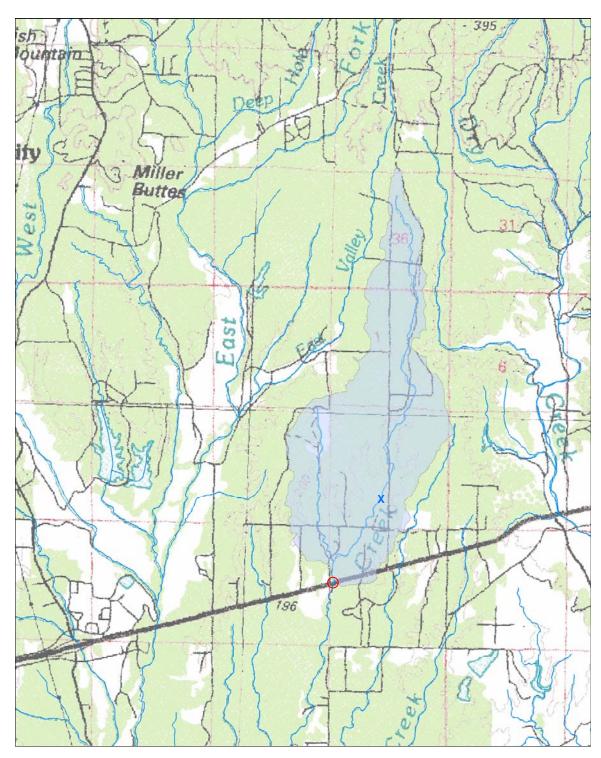
Site # 8: Salmon Creek/Hwy 299 East, Stillwater Creek; Sacramento River

**Habitat:** <u>Quality</u> = rated as "poor". This stream flows through residential area and has no in-stream habitat. There is a lack of riparian vegetation and mature tree cover. The main channel tapers off shortly upstream. <u>Quantity</u> = 5,280' of potential anadromous habitat upstream of crossing based on channel slope sustaining <8%.

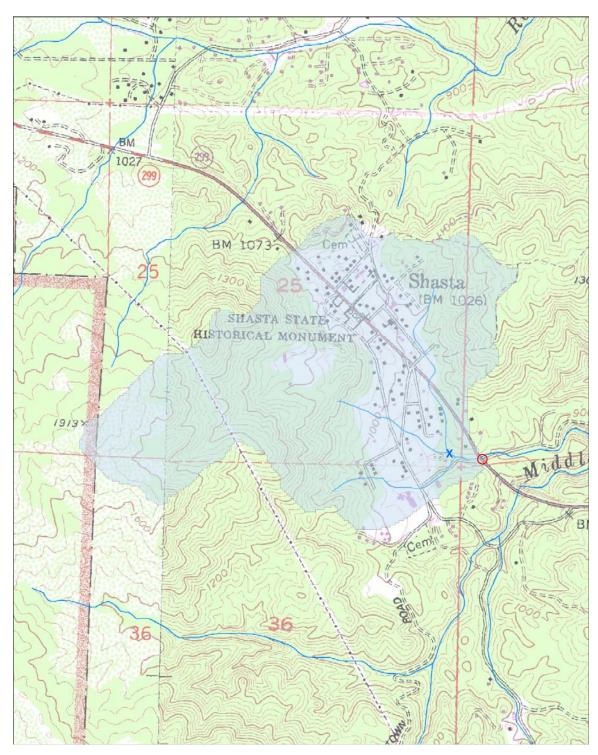
Site # 9: Unnamed Tributary to Middle Creek/Hwy 299 West ; Sacramento River

**Comments:** Natural barrier located downstream at confluence with main stem of Middle Creek. Located 0.4 miles downstream of Hwy 299 road crossing and consists of a 25' high bedrock cascade.

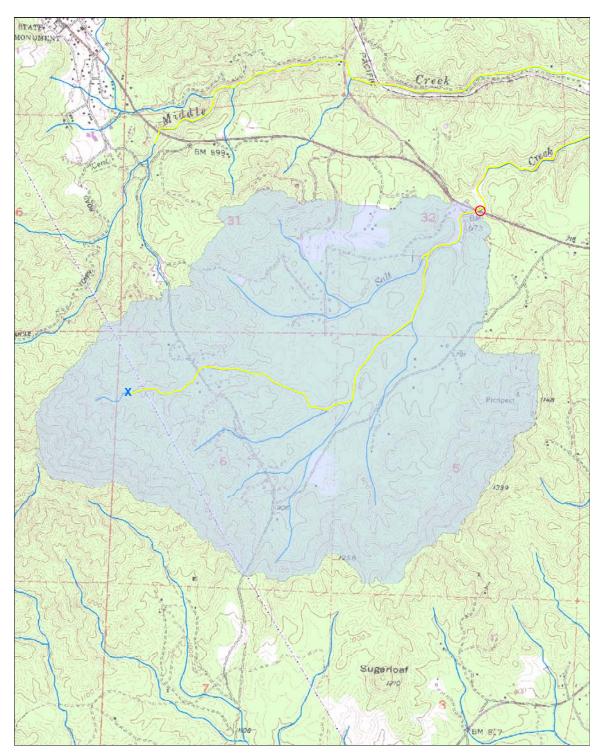
Site # 10: Salt Creek/Hwy 299 West; Sacramento River

**Comments:** This culvert has been retrofitted in the past with steel corner baffles and two concrete outlet weirs. FishXing software does not account for these corrections which would explain the depth and velocity barriers associated with this crossing. Adult and juvenile salmonids have been observed upstream of the stream crossing post retrofitting.

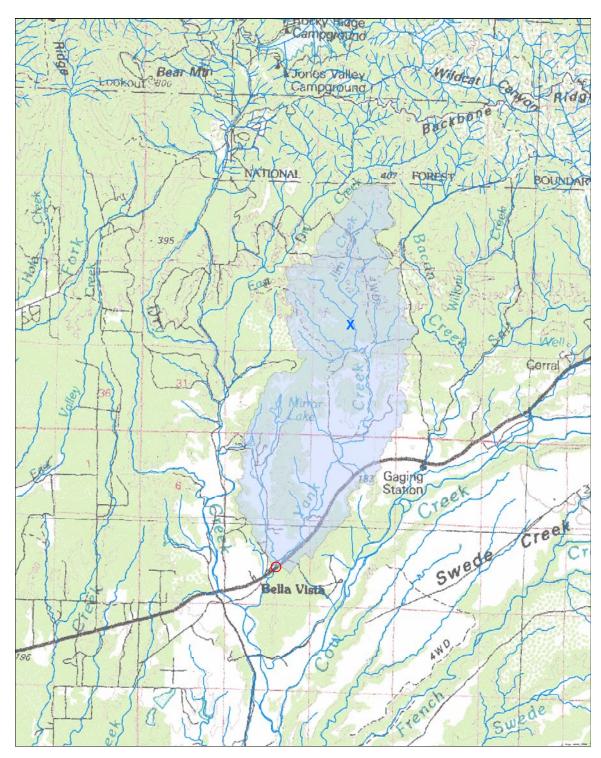
Site # 16: Yank Creek/Hwy 299 East; Dry Creek; Cow Creek; Sacramento River

**Comments:** Adjacent landowner claims culvert causes occasional flooding and large debris jams. Large woody debris jam present at time of survey.

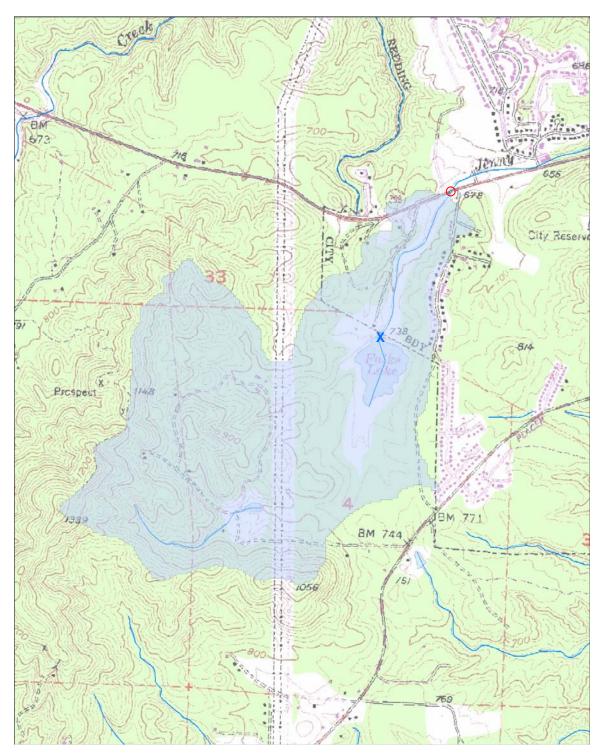
Site # 18: Jenny Creek/Hwy 299 West; Sacramento River

**Comments:** Two CMP culverts at the confluence with the Sacramento River are likely a partial barrier to upstream migration, especially when the river is at lower flow. Another road crossing is located downstream of the Hwy. 299 crossing in a residential area.
