Site Name: Lower Mission Ck Concrete Channel (Caltrans Concrete Channel) PAD ID: 707374

Stream Name: Mission Creek

Structure Owner: Santa Barbara County Flood Control District

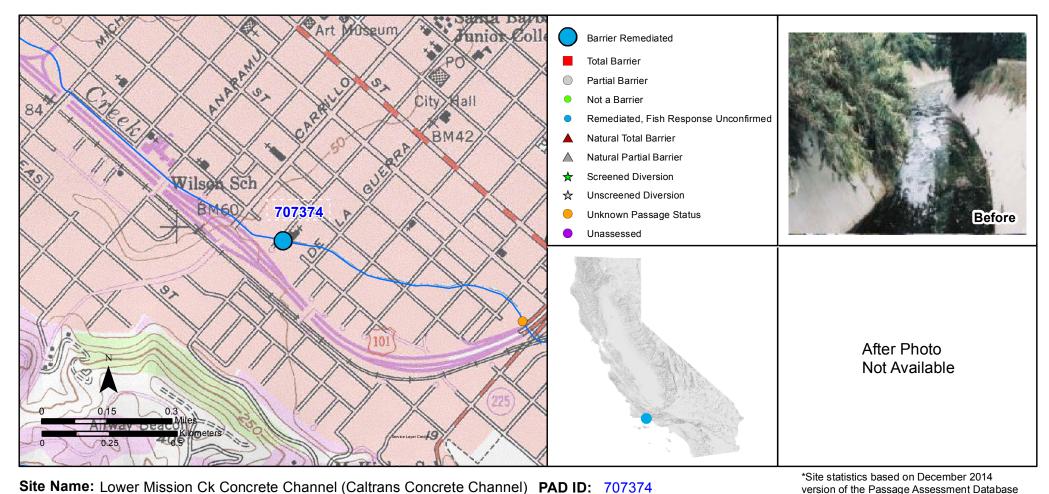
Notes: In late 2013, the construction of a fish way (low flow channel) was completed with resting areas (side pockets) at 40 foot intervals to allow fish to swim upstream during and/or following rain events. Observations during rains following completion of the upper channel have shown that the modified channel is performing as designed, with flow rates and depths that are acceptable for steelhead passage. Prior to remediation (February 2008), a 27" and a 30" steelhead was observed downstream of the lower concrete channel (see photos). Approximately 0.75 miles long channel (between Arrellaga Street and Canon Perdido Street) prevented fish from migrating upstream because as the water spread out across the flat concrete channel, water flow was too fast and too shallow for fish to swim upstream, and there were no resting areas. In 1961, the channel was constructed by CalTrans to improve flood control along Highway 101.Before: Total barrier per professional judgment by Stoecker Environmental Consulting. Another concrete lined trapezoidal channel 0.25 miles in length is directly upstream separated by
