Site Name: Culvert Hwy 197 Stream Name: Peacock Creek Structure Owner: California Department of Transportation Year Remediated: 2013 Site Type: Road crossing Site Status After Remediation: Remediated, fish response unconfirmed Species Benefited After Remediation: Multiple Andromous Salmonids

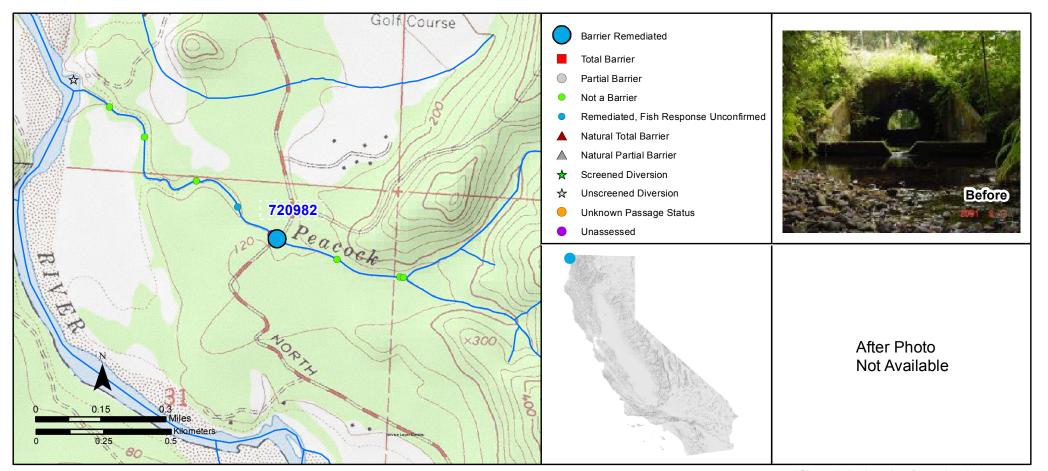
Notes: In April 2013, the jump at outlet was notched and redwood baffles were replaced with steel baffles. Before: Partial barrier per FishXing Software per CDFW. Listed as partial barrier to adult coho, total barrier to upstream juveniles. The Peacock Creek culvert provides good passage for adult anadromous salmonids and the culvert barrel is predicted to provide some passage for resident trout and juvenile salmonids. However, the outlet weir is perched almost 0.5 ft above the natural tailwater control creating a leap that impedes upstream migration of resident trout and juvenile salmonids. The leap at the outlet weir should be addressed to enhance passage for resident trout and juvenile salmonids. The wood-block weir performance and condition should be monitored as the blocks are in fair-to-poor condition. Metal arch culvert under North Bank Road, 15' wide at base x 7' high x 75' long with railroad tie baffles and a stilling pool at the outfall of the culvert. Main concern is excessive summer water extraction.
