Site Name: Diversion Dam (Removed)

Stream Name: Tajiguas Creek

PAD ID: 706364

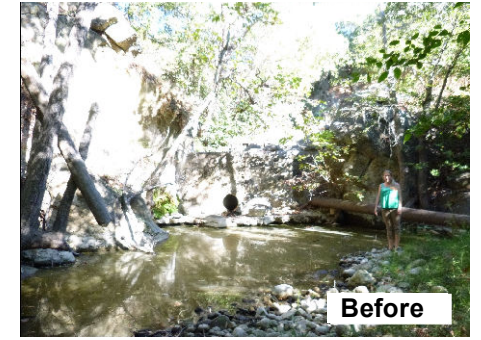
Before

Barrier Description Prior to Remediation: Total
