Site Name: culvert (removed)

Stream Name: Big Bend Creek

Structure Owner: U.S. Forest Service

PAD ID: 707636

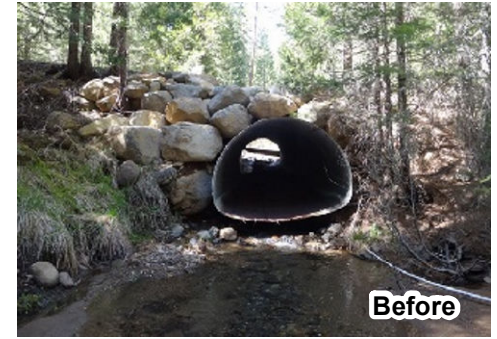
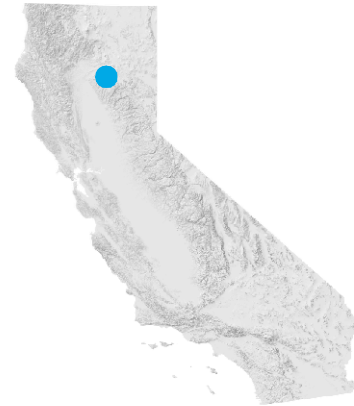
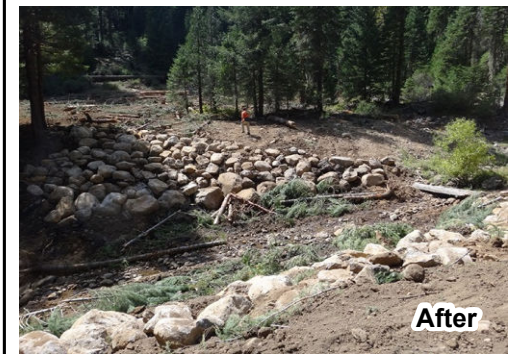
Barrier Description Prior to Remediation:Total

Notes: In 2014, an 8-foot diameter squash pipe was removed from the perennial Big Bend Creek. This pipe was a 100% barrier to upstream fish passage. Road approaches were pulled back and armored with boulders and slash. Following equipment work, native grass seed and willow stakes were placed along both banks of the creek at the road-stream crossing site. In early 2015, USFS checked upstream for steelhead redds, but they did not find any. It looked like the lack of snowmelt left the creeks are too low for the fish to access this year, as there were redds in the mainstem of Mill Creek but not in the tributaries. Before: Total barrier per professional judgement by USFS.
