Site Name: Glen Oaks Dam
Stream Name: Stuart Creek
Structure Owner:
Year Remediated: 2014
Site Type: Road crossing
Site Status After Remediation: Remediated, fish response unconfirmed
Species Benefited After Remediation:
Immediate Downstream barrier PAD ID: [712577](#)

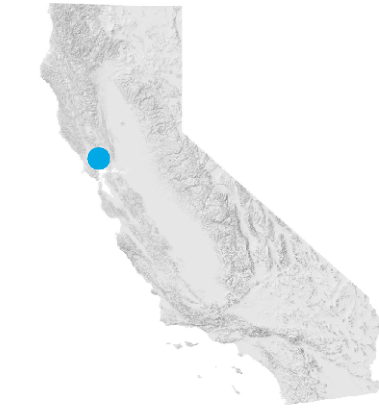
Notes: In 2014, the spillway was lowered and the notch was widened to provide upstream adult passage and improve passage for juveniles. This project opened up 1 mile of high quality steelhead habitat upstream. There is a 12-foot waterfall 1 mile upstream that blocks anadromy. Before: RED filter result. Total barrier per DFG Restoration Manual per Sonoma Ecology Center.
