Site Name: Glenndale Road Bridge

Stream Name: Lindsay Creek

PAD ID: 736797

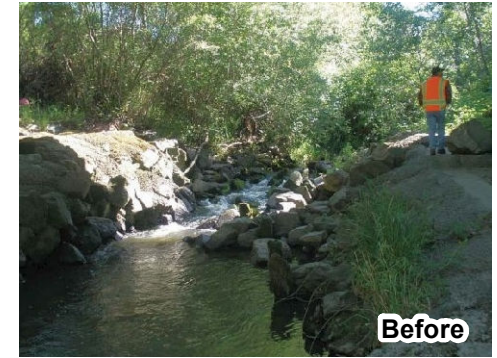
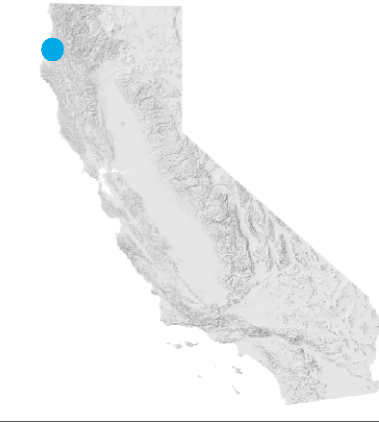
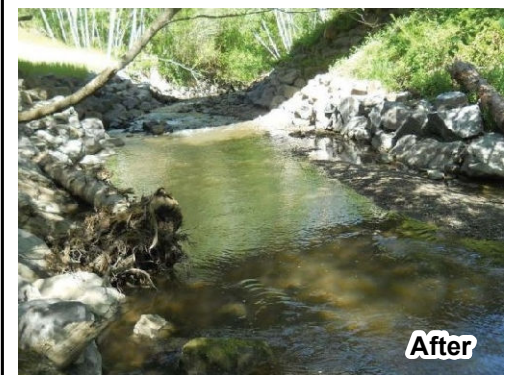
Barrier Description Prior to Remediation: Temporal & Partial

Notes: On October 2013, the County removed the gunite false work, widening the stream channel underneath the bridge and removal of RSP within the channel. Added larger RSP along the stream bank to help project the bridge from future scour. This was funded in part by FRGP. Before: Temporal & Partial barrier per professional judgement by Humboldt County Public Works Department. Confinement of the channel, gunite scour along the banks, sedimentation aggradation creates partial and seasonal barrier to upstream and possibly downstream migration of all salmonid life stages. Accumulated rock caused a high-gradient cascade riffle within the stream segment underneath the bridge, which was determined by fisheries professionals to act as a low- and high-flow partial barrier to salmonids.
