Site Name: Parks Creek #5 culvert (removed)
Stream Name: Parks Creek
Structure Owner:
Year Remediated: 2014
Site Type: Road crossing
Site Status After Remediation: Remediated, fish response unconfirmed
Species Benefited After Remediation:
Immediate Downstream barrier PAD ID: 737360

PAD ID: 758585
Tributary To: Shasta River
Barrier Remediation By:
Barrier Description Prior to Remediation: Temporal & Partial
Count of Barriers Downstream: 3
Count of Barriers Upstream: 0
Distance Upstream to Next Barrier or Limit of Anadromy : 45.81923 Miles

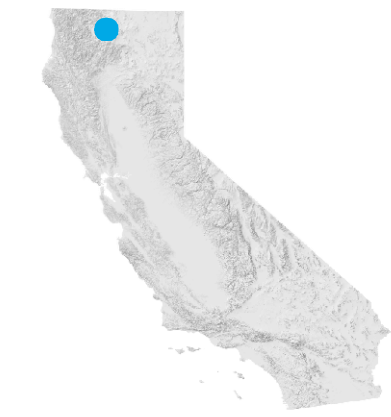
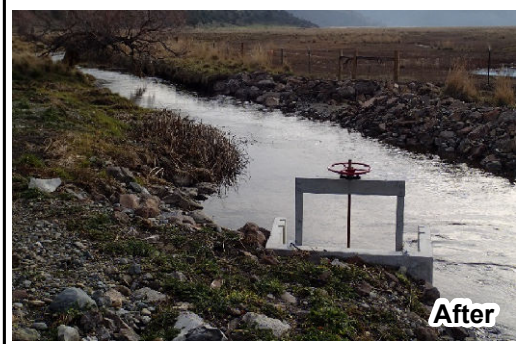
Notes: In September 2014, the entire structure (culvert) was removed from the creek, and a headgate and pipe were installed in its place. This was a Coho Help Act project. Before: Temporal & Partial barrier per professional judgement by CDFW. Twin culvert (36 in (diameter)) road crossing/point of diversion for agriculture irrigation. The upstream side of the culverts have board slots, fitted with boards to create head to direct flow into headgate. The structure creates a temporal and partial barrier due to stream flow combined and/or with how the diversion is being operated. The barrier may be due to velocities, or from blockage. Previously updated on 5/10/2013. On 5/22/2015, updated the passage status to not a barrier per a ppx by Catelin Bean at Coho TRT and per CDFW coho help webpage.
