Site Name: Rock and mortar dam with spillway

Stream Name: Arroyo Trabuco

PAD ID: 758694

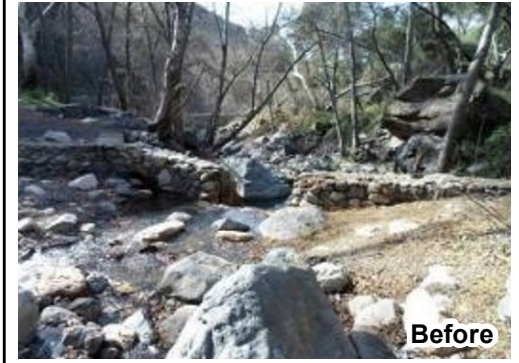
Notes: In December 2014, the Cleveland National Forest in conjunction with the Tahoe Mine Reclamation Creek removed this dam. Before: Total barrier per field survey conducted by USFS. 2013 USFS survey comments: Rock and mortar 6' H x 5.5' W x 31' L dam with spillway, condition: Good. Dam caused cascade over boulders with shallow outlet pool Has head gate that is obstructed by boulders, wing walls tie into road prism Dams are planned for removal. Removal of dams will likely be completed between 2017- 2019.
