Site Name: Rock and mortar fill between bedrock and boulder (removed)

PAD ID: [758697](#)

Stream Name: Arroyo Trabuco

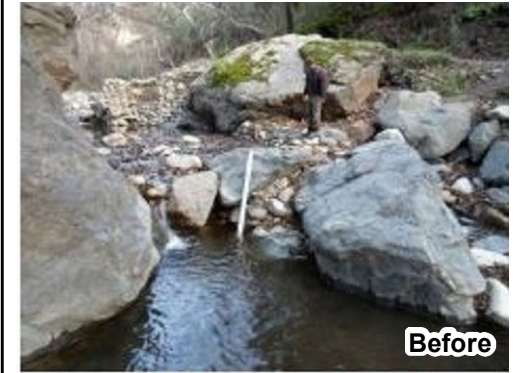
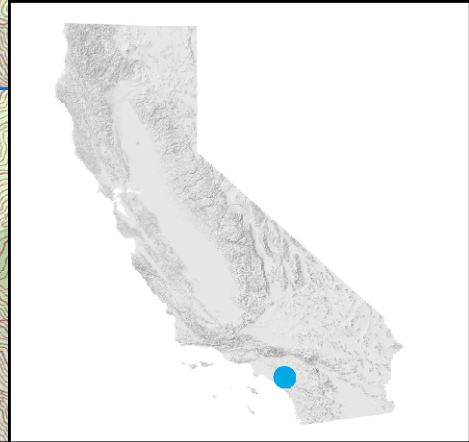
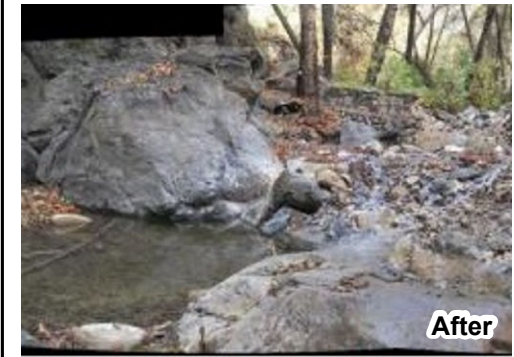
Notes: In December 2014, the Cleveland National Forest in conjunction with the Tahoe Mine Reclamation Crew removed this dam. Before: Total barrier per field survey conducted by U.S. Forest Service. 2013 USFS survey comments: Rock and mortar fill (2.5' h x 2.5' w) between bedrock and boulder , condition: Fair. Juvenile barrier Built between bedrock and Large boulders Dams are planned for removal. Removal of dams will likely be completed between 2017- 2019.
