**Site Name:** Tenaja Falls Trail low flow concrete crossing (removed)

**Stream Name:** San Mateo Creek

**Year Remediated:** 2012

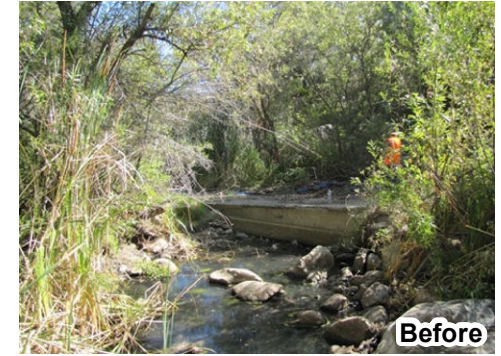
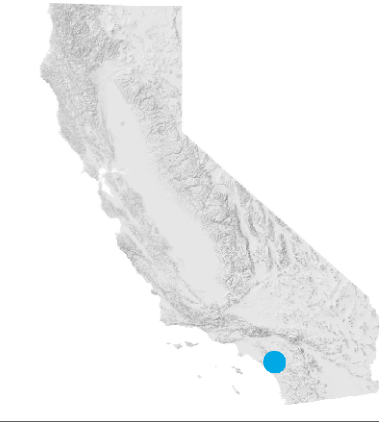
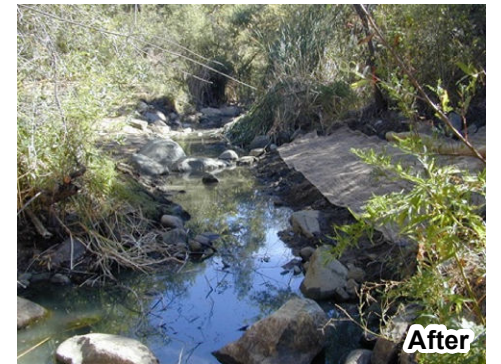
**Barrier Description Prior to Remediation:**Unknown

**Notes:** Concrete crossing was removed in October 2012 restoring 3.5 miles of stream and habitat for endangered southern steelhead and other sensitive aquatic organisms. San Mateo Creek is a historical fishery for steelhead trout. Before: Hardened crossing on the Tenaja Falls Trail in the Cleveland National Forest that crosses San Mateo Creek and impedes passage of aquatic organisms.
