CATALOG OF SONOMA COUNTY STREAM CROSSINGS WITH CULVERTS LOCATED ON FISH-BEARING STREAM REACHES WITHIN THE RUSSIAN RIVER BASIN

By
Ross Taylor and Associates

Site ID# S-001: Unnamed Tributary/Willow Creek Road; Willow Creek; Russian River **Road Ownership** County

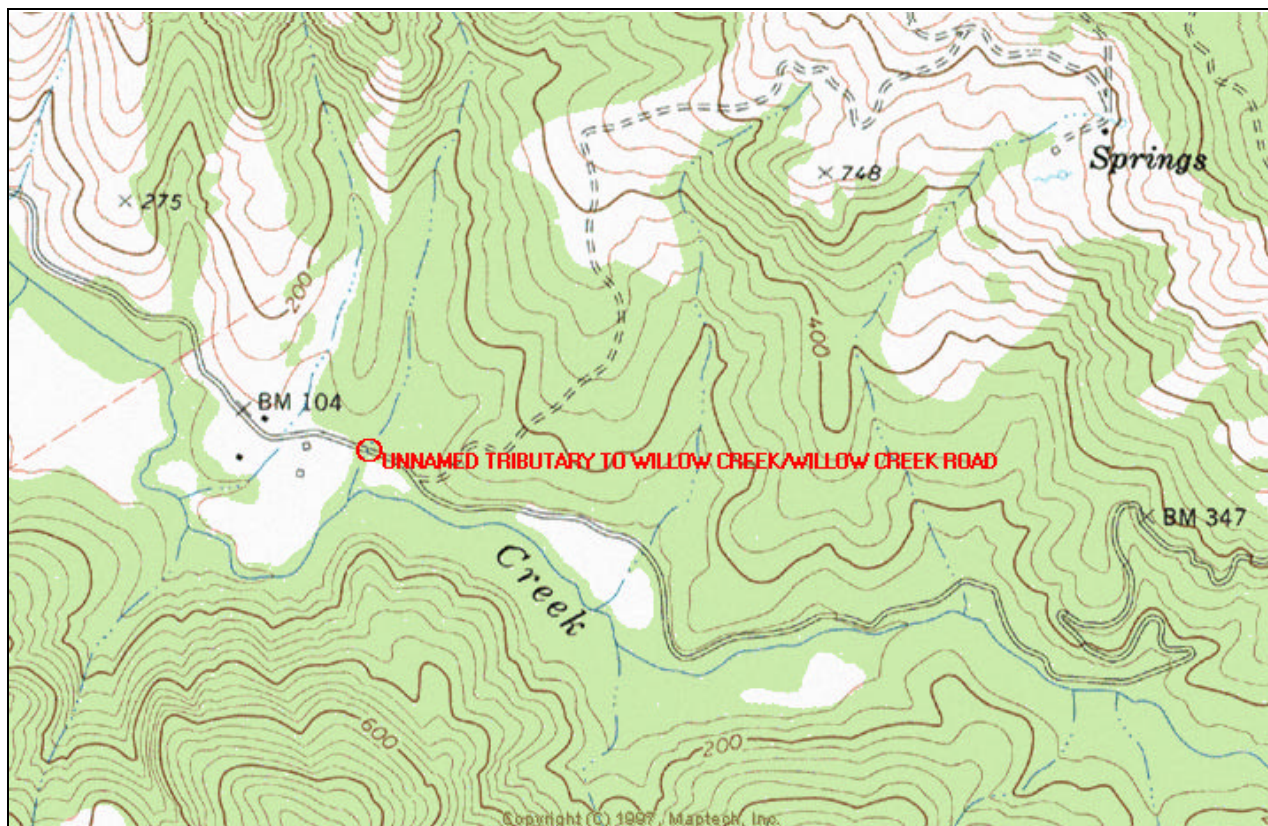
Fill Estimate: 253 cubic yards. **Overall Condition:** Good.

Sizing: Adequately sized; HW/D = 1 on a storm flow with approximately an 84-year recurrence interval. Willow Creek Road is overtopped on more than a 250-year storm flow.

Barrier Status: **GRAY:** FishXing estimated this crossing meets the 8-16-16 passage criteria for adult steelhead on 35% of the range of migration flows and fails to meet criteria for all age classes of juveniles. There is a lack-of-depth for adults on lower migration flows and also excessive velocities on most flows for juveniles.

Preferred Treatment: When needed, replace with a properly-sized open-bottom arch or a bridge.

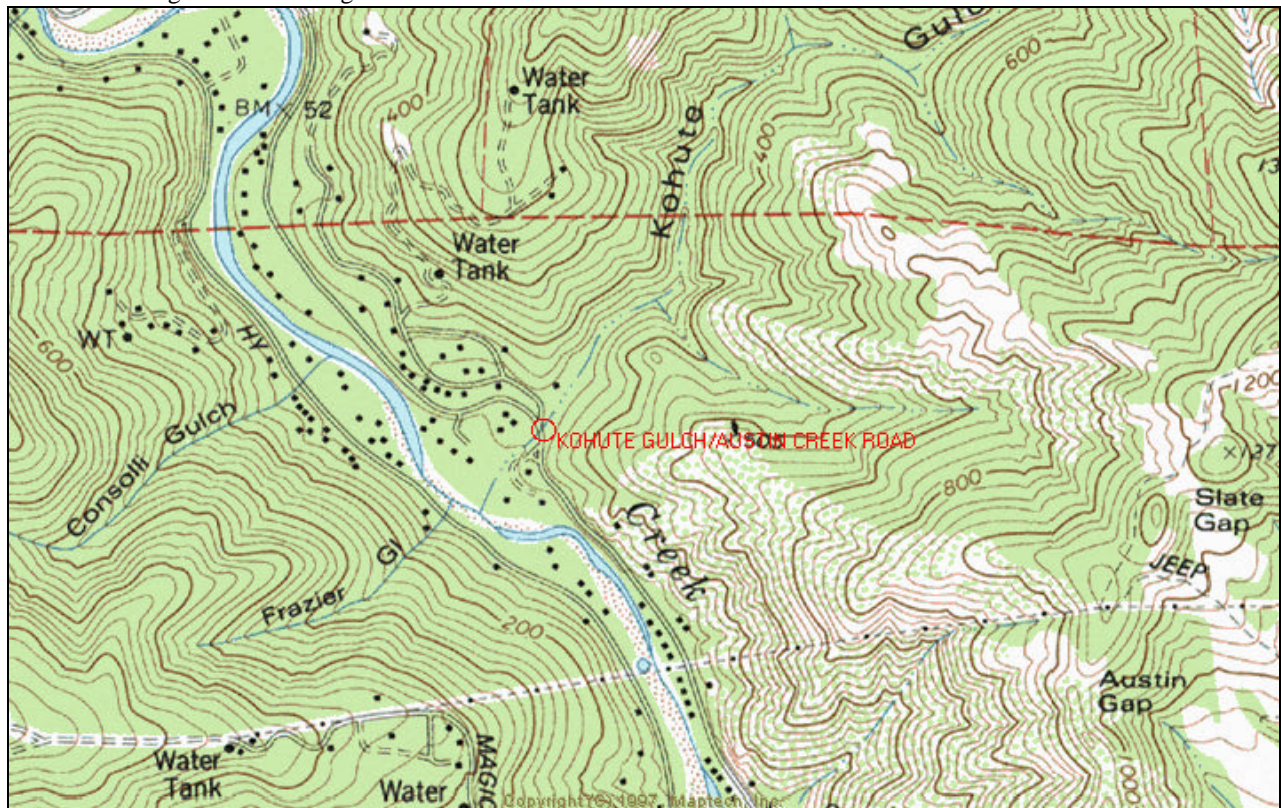
Fill Estimate: 221 cubic yards. **Overall Condition:** Good.

Barrier Status: **GRAY:** FishXing determined this crossing meets the 8-16-16 ft/sec passage criteria for adult steelhead on 18% of the range of migration flows and fails to meet criteria for all age classes of juveniles. There is a lack-of-depth for adults on lower migration flows and also excessive velocities on most flows for juveniles.

Preferred Treatment: Because the current culvert is extremely undersized a full replacement is the only option to improve fish passage and increase storm flow conveyance. Replace with a properly sized open-bottom arch on concrete footings or with a bridge.

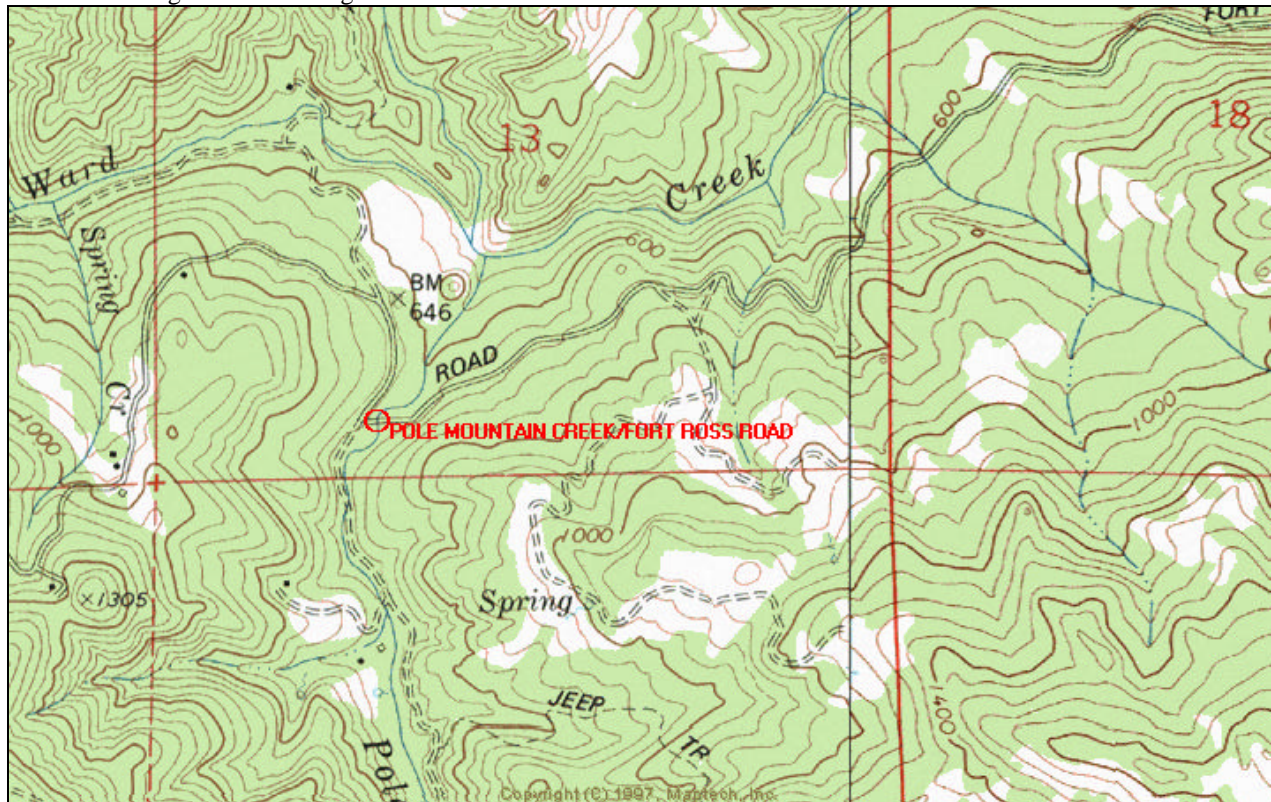
Culvert Type: Two Circular Pipes, SSP. **Corrugations:** 6" x 2" **Dimensions:** diameters = 9.0' **Lengths:** 76.6'
Slopes: LB pipe = 0.05%; RB pipe = 0.38% **Modifications:** None. **Rustline Height:** LB = 2.2'; RB = 2.0'
Average Active Channel Width: 12.4' **Fill Estimate:** 1,037 cubic yards. **Overall Condition:** Rusted through.
Sizing: Undersized; HW/D = 1 on a storm flow with approximately a 32-year recurrence interval. Fort Ross Road is overtopped on more than a 250-year storm flow.

Barrier Status: Both pipes =**GRAY**: FishXing determined this crossing meets the 8-16-16 ft/sec passage criteria for adult steelhead on 50% of the range of estimated migration flows and fails to meet passage criteria all age classes of juveniles. For adults, the perched outlets are leap barriers until stream discharge is greater than 50 c.f.s.

Preferred Treatment: Because both culverts are in poor condition with completed rusted-through inverts, a full replacement is the best long-term option to improve fish passage. Replace with a properly sized open-bottom arch on concrete footings or with a bridge.

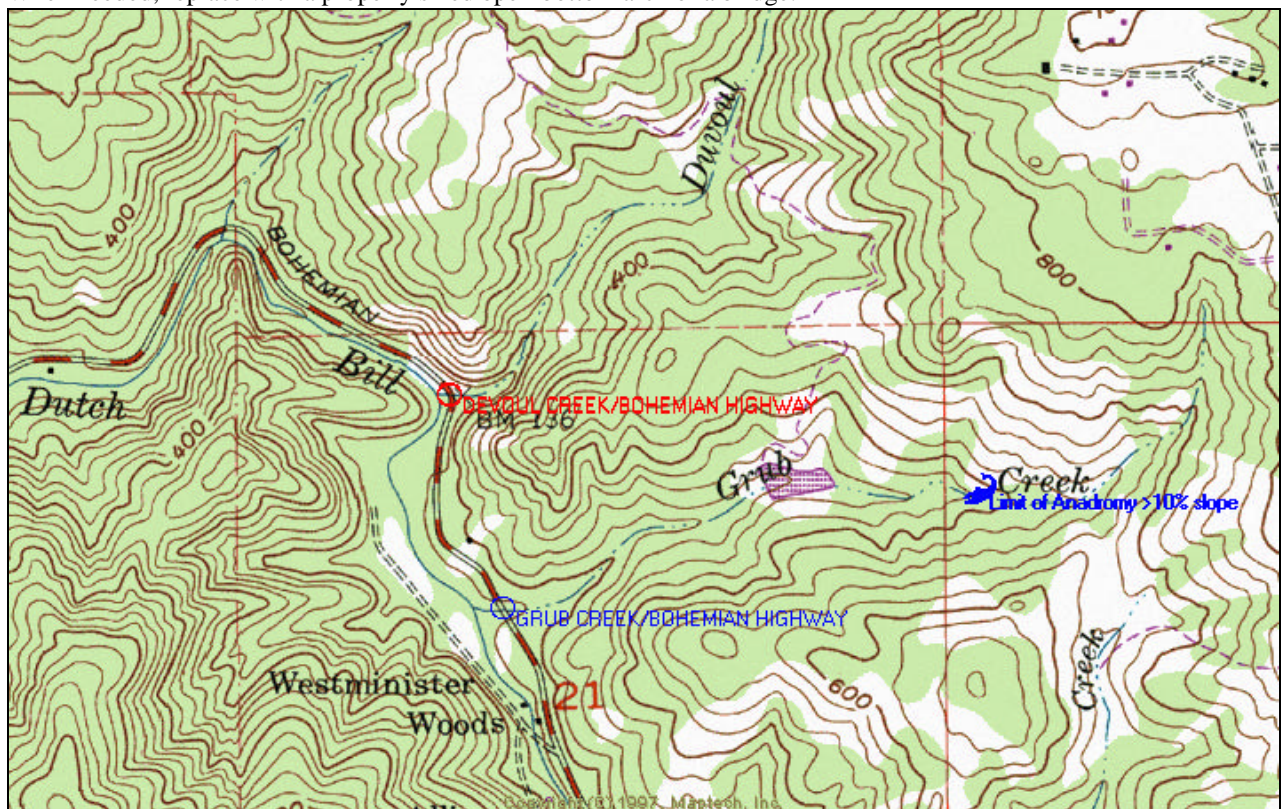
Barrier Status: **GRAY:** FishXing determined this crossing meets the 8-16-16 ft/sec passage criteria for adult steelhead on 80% of the range of estimated migration flows, meets passage criteria for resident/2+ juveniles on 20% of the range of estimated migration flows, and fails to meet passage criteria for 1+/young-of-year juveniles. Actual passage of adults and older juveniles may be higher than predicted because the main violation was lack-of-depth.

Preferred Treatment: None recommended because the current box culvert provides adequate passage. However, the crossing is sized to overtop on less than a 10-year storm flow. Periodically inspect for condition and maintenance. When needed, replace with a properly sized open-bottom arch or a bridge.

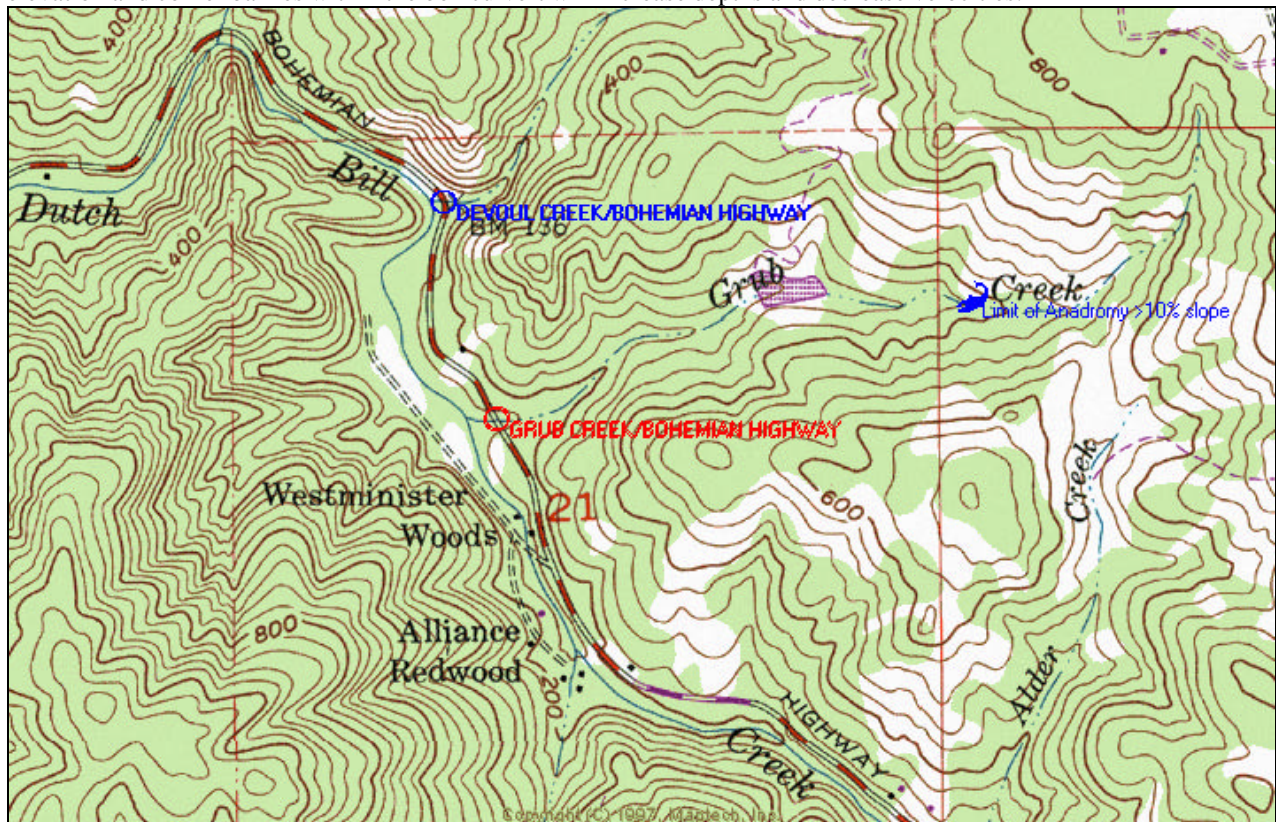
Barrier Status: **GRAY:** FishXing determined this crossing meets the 8-16-16 ft/sec passage criteria for adult steelhead on 43% of the range of estimated migration flows and fails to meet passage criteria for all age classes of juveniles. Actual passage of adults and older juveniles may be higher than predicted because the main violation was lack-of-depth.

Preferred Treatment: Because the current box culvert is sized to pass more than a 100-year storm flow, a retrofit is recommended to improve fish passage. Two or three boulder weirs downstream of the crossing will raise tail-water elevation and corner baffles within the box culvert will increase depths and decrease velocities.

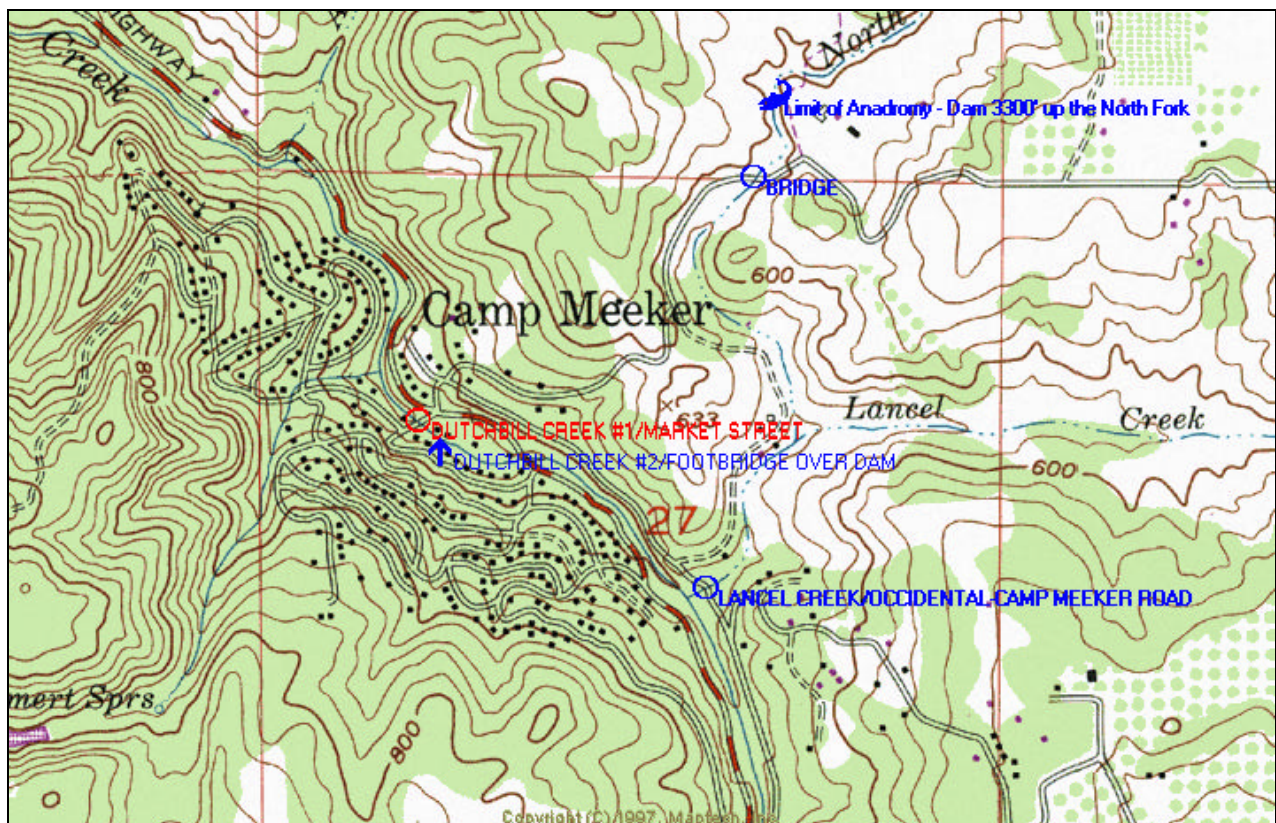
Barrier Status: **RED:** the Green-Gray-Red filter determined this crossing fails to meet passage criteria for all species of adult salmonids and all age classes of juveniles due to the extremely perched outlet (~ 5 feet).

Preferred Treatment: Because the current box culvert is sized to pass more than a 250-year storm flow, a retrofit is recommended to improve fish passage. Consider the feasibility of constructing a series of eight to ten concrete weirs attached to the culvert's outlet, designed to function as a fishway. It may be appropriate to divert lower flows into one of the bays with a weir across the inlet of one of the bays. Concrete weirs (sloped with v-notch) within the box culvert will increase depths and decrease velocities. Due to the complexity of the project, the County should consult with CDFG and NMFS hydraulic engineers with assistance in the retrofit's design.

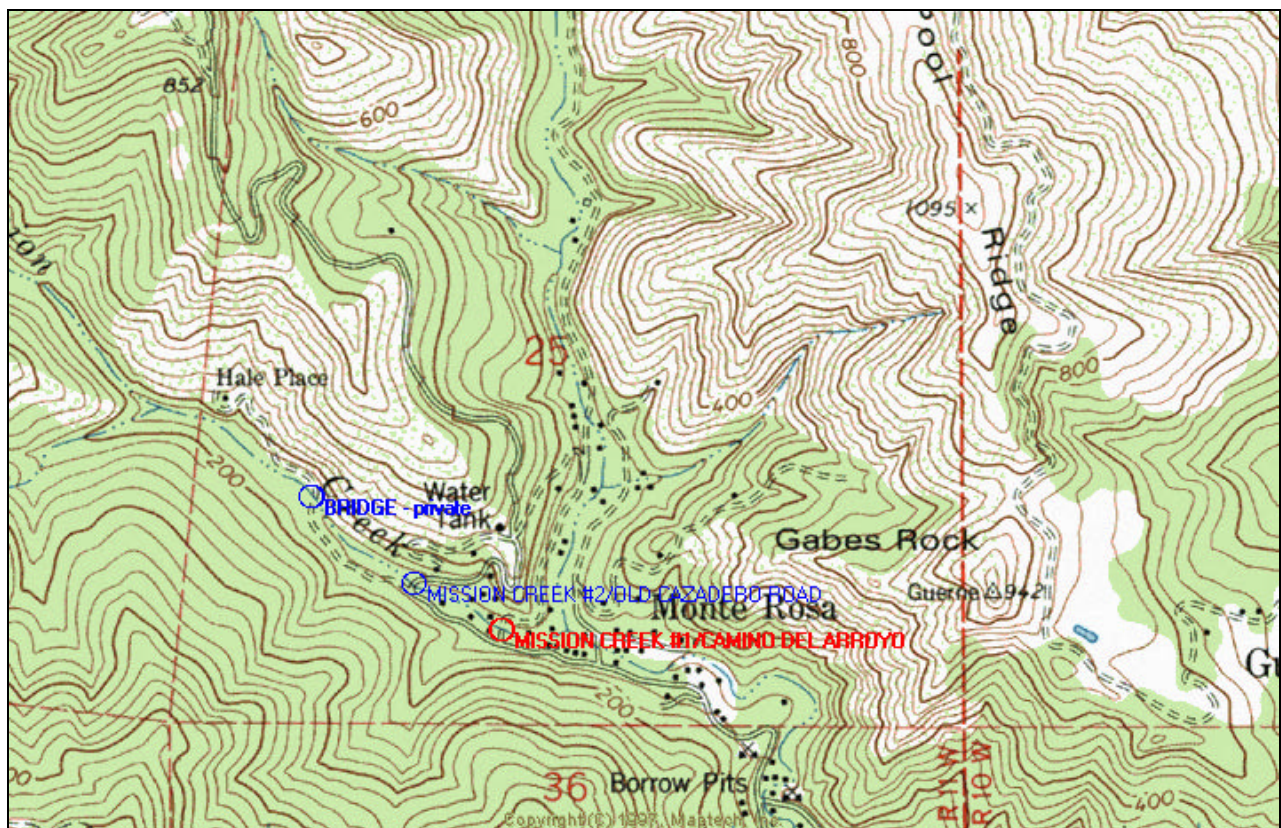
Culvert Type: Circular, Concrete. **Corrugations:** None. **Dimensions:** diameter = 5.4' **Length:** 48.1' **Slope:** 1.60% **Modifications:** None. **Rustline Height:** N/A **Average Active Channel Width:** 11.0' **Fill Estimate:** 384 cubic yards. **Overall Condition:** Abraded.

Barrier Status: **GRAY:** FishXing determined this crossing meets the 8-16-16 ft/sec passage criteria for all species of adult salmonids on 42% of the range of estimated migration flows and fails to meet passage criteria for all age classes of juveniles. The main violation in passage criteria for all age classes of salmonids is excessive velocities.

Preferred Treatment: A full replacement with an open-bottom arch or a bridge is the only feasible option for improving fish passage at this site because the current crossing is extremely undersized. Due to the potential effects of headwall cutting when the new crossing is installed, the County should consider the use of grade control weirs to minimize the impacts of potentially rapid and severe downcutting of the upstream channel.
