MEMORANDUM

Date: June 12, 2007
To: Matt Carpenter and Corey Harpole
Organization: Newhall Land and Farming Company
From: Andrew Collison
PWA Project #: 1820.02
PWA Project Name: Newhall Ranch
Subject: Channel geomorphic assessment of Lion Canyon
Copy(ies) To: Lisa Austin, File

Geomorphic Reconnaissance

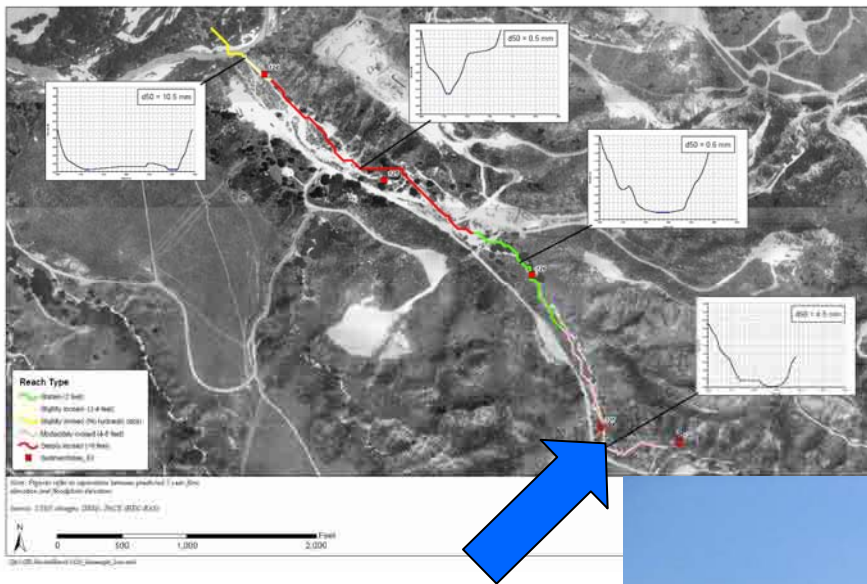
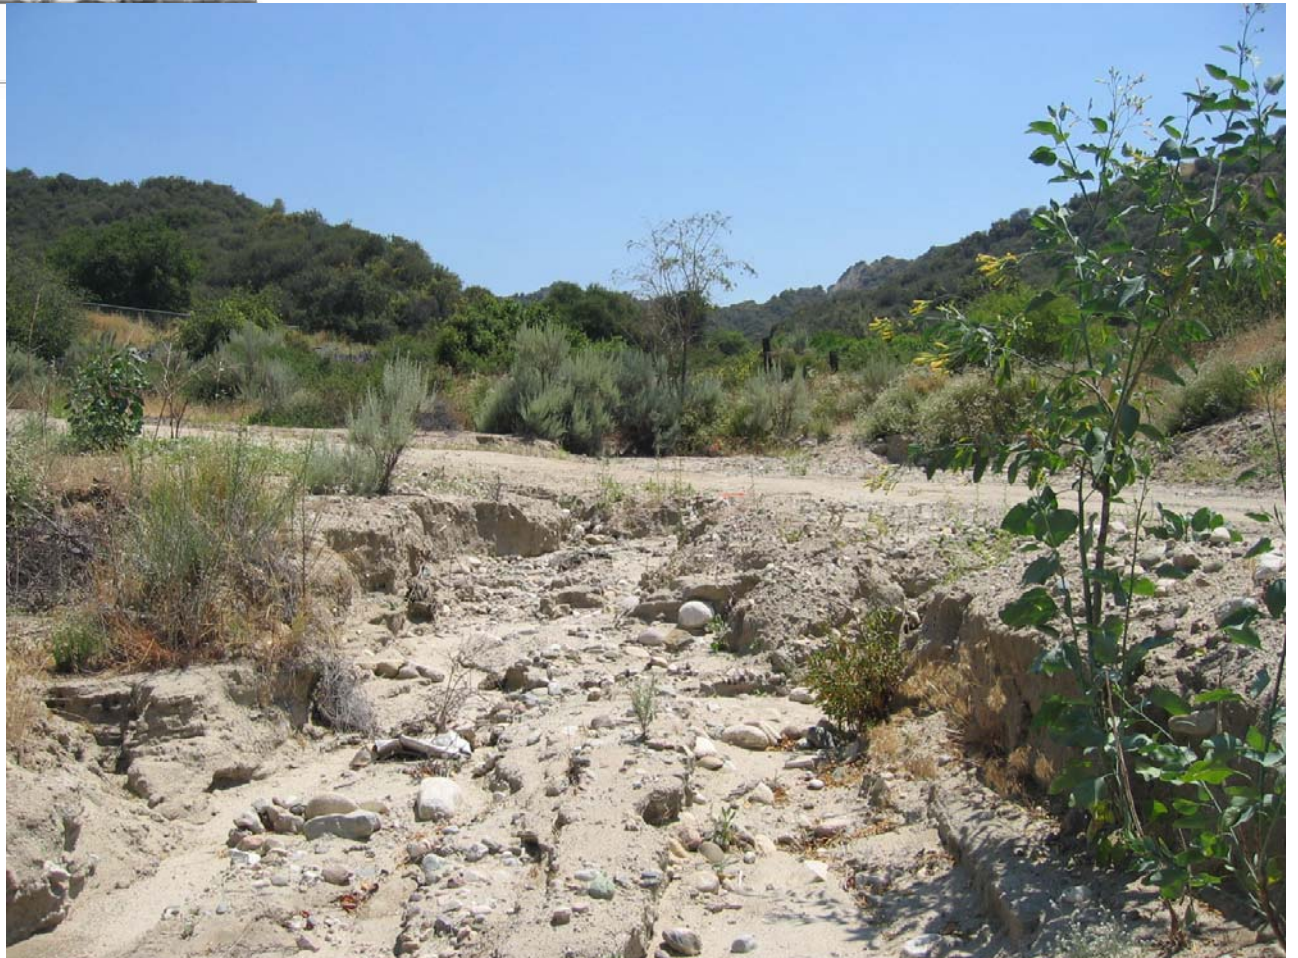
Lion #1

Slightly eroded

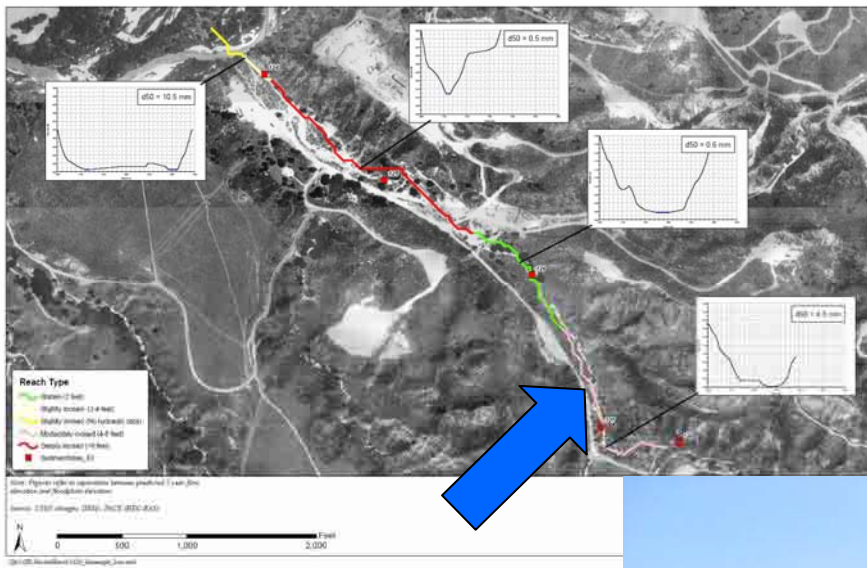
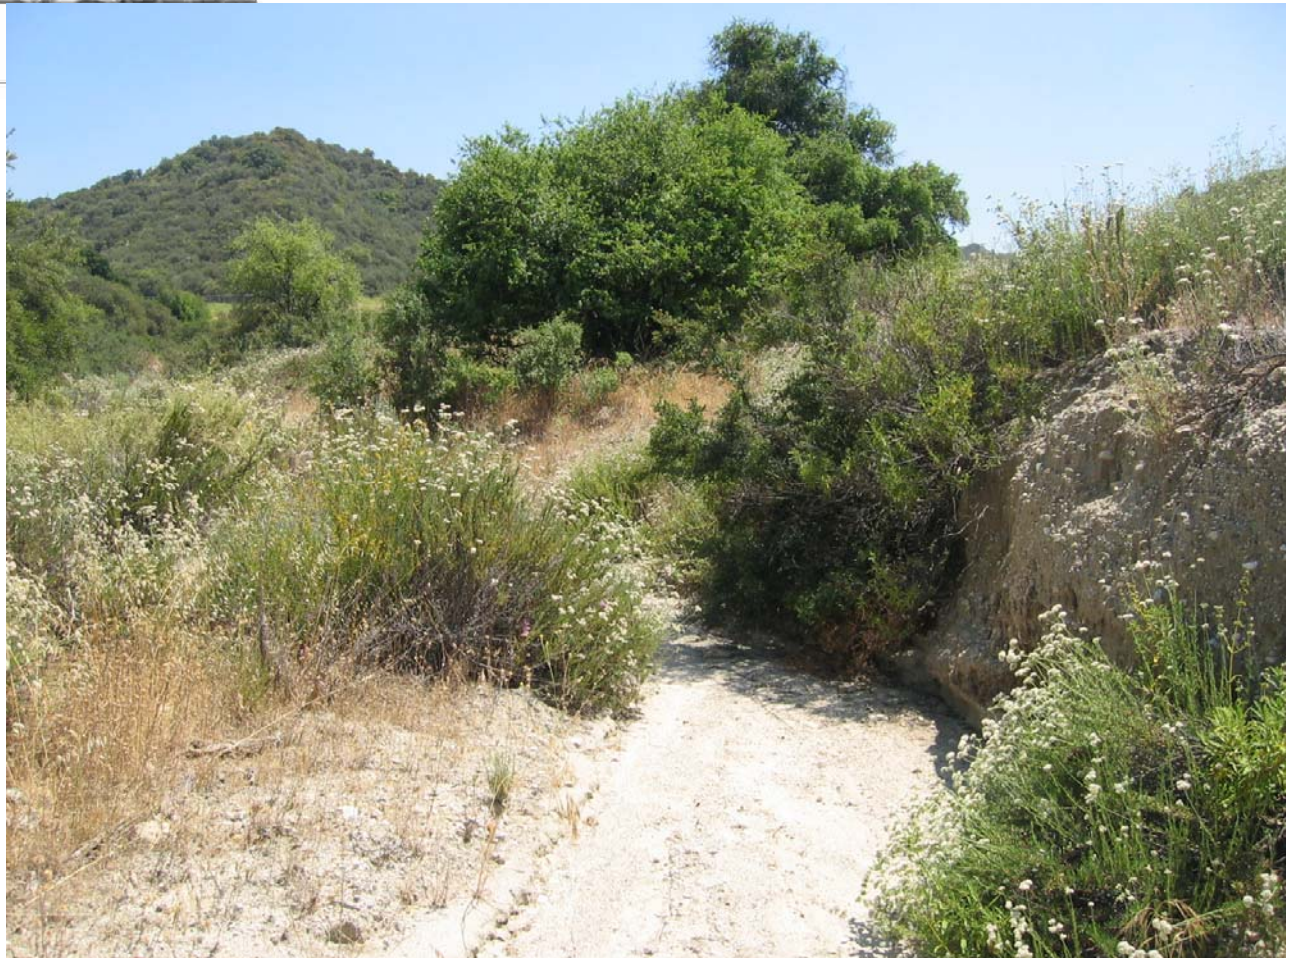
Lion #4

Slightly eroding
outside bends, inner
floodplain

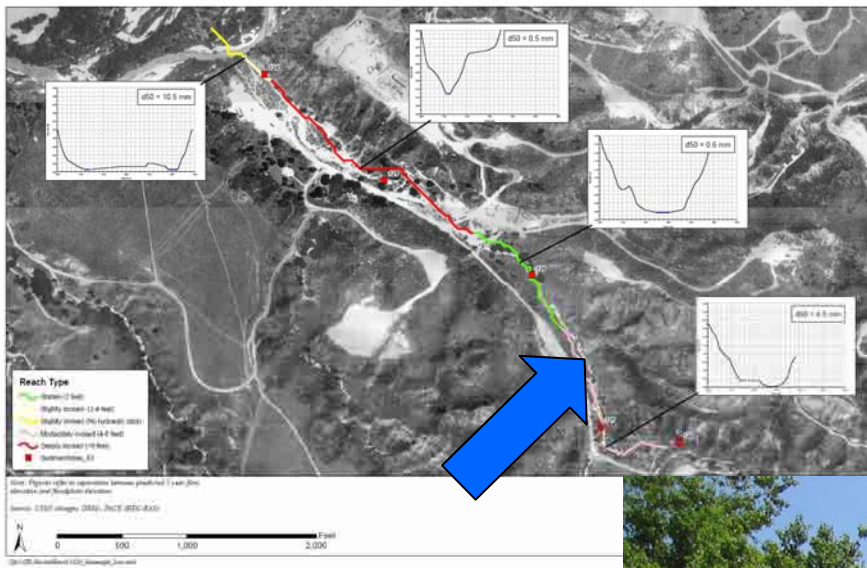
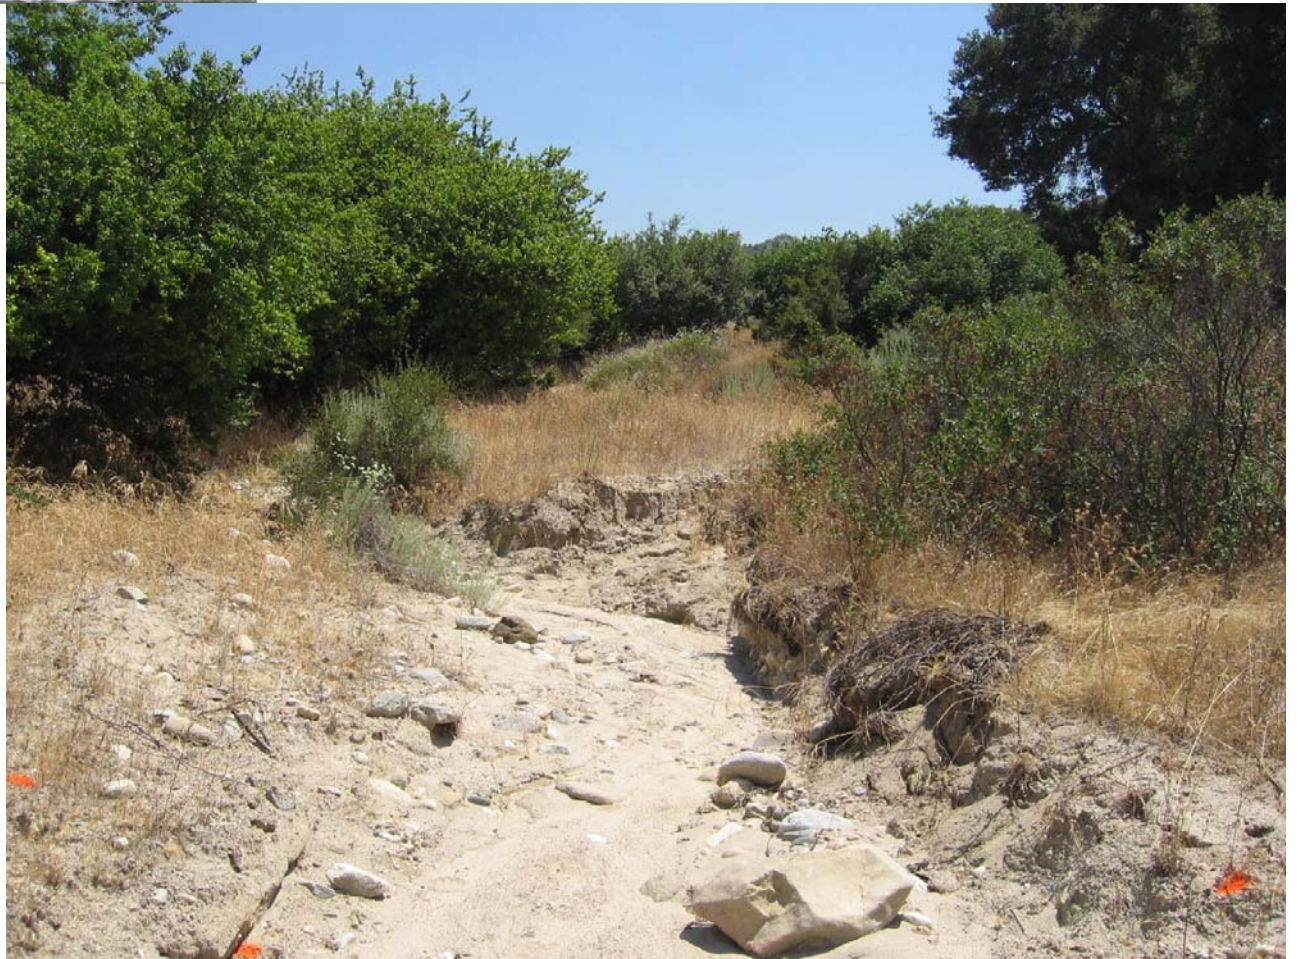
Lion #5

Stable - slightly eroded

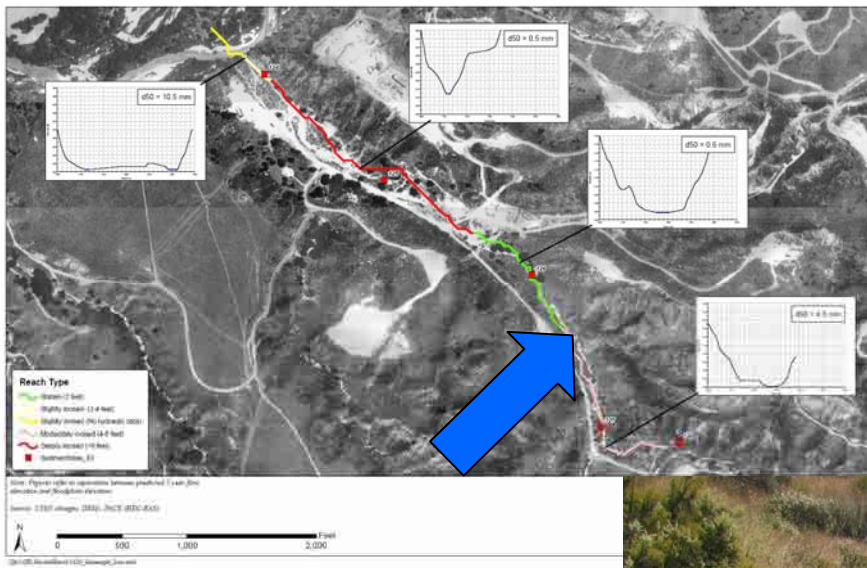
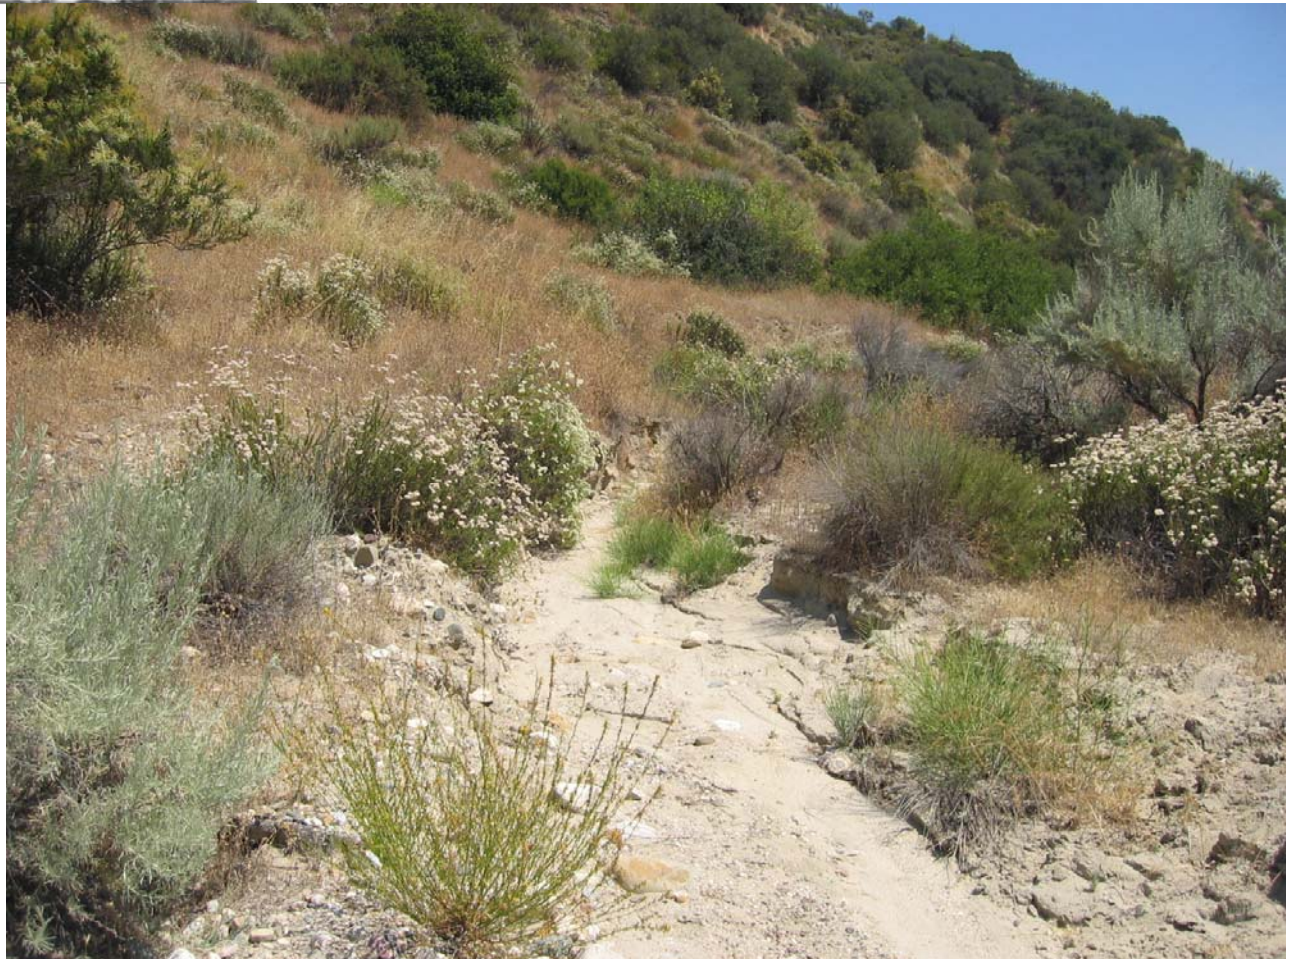
Lion #6

Stable - slightly eroded

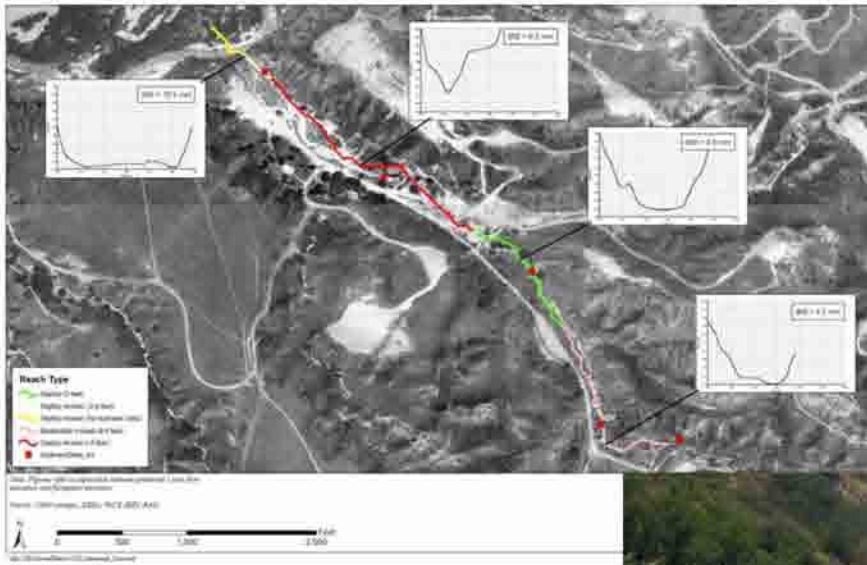
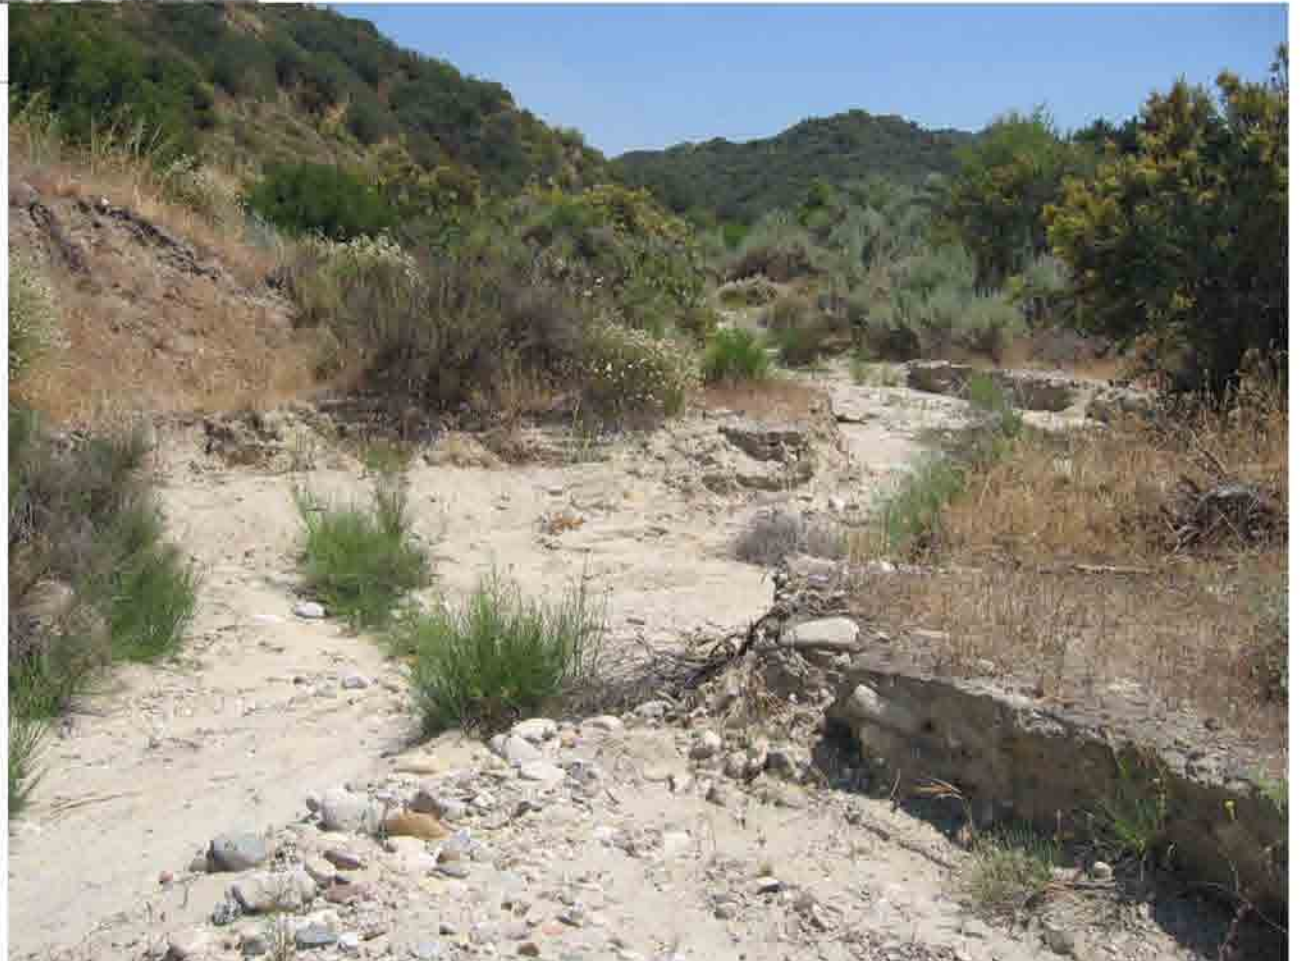
Lion #7

Stable

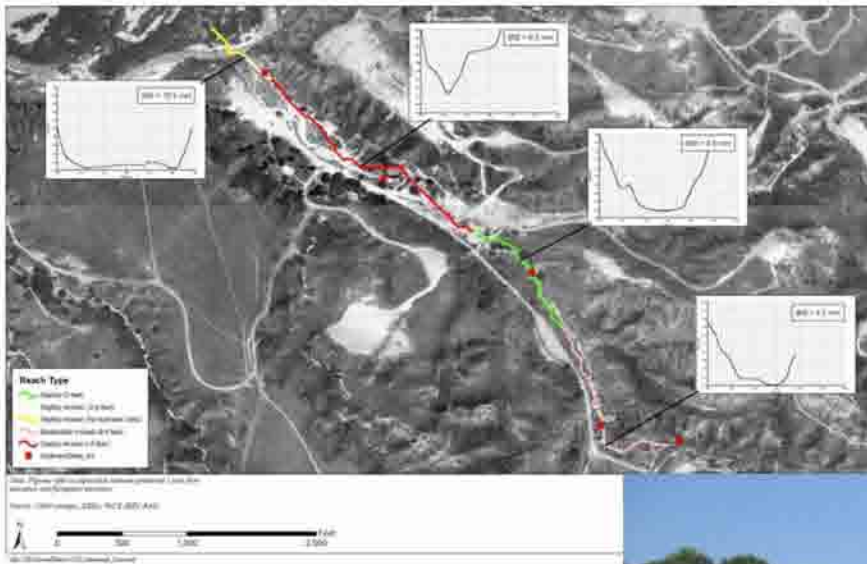
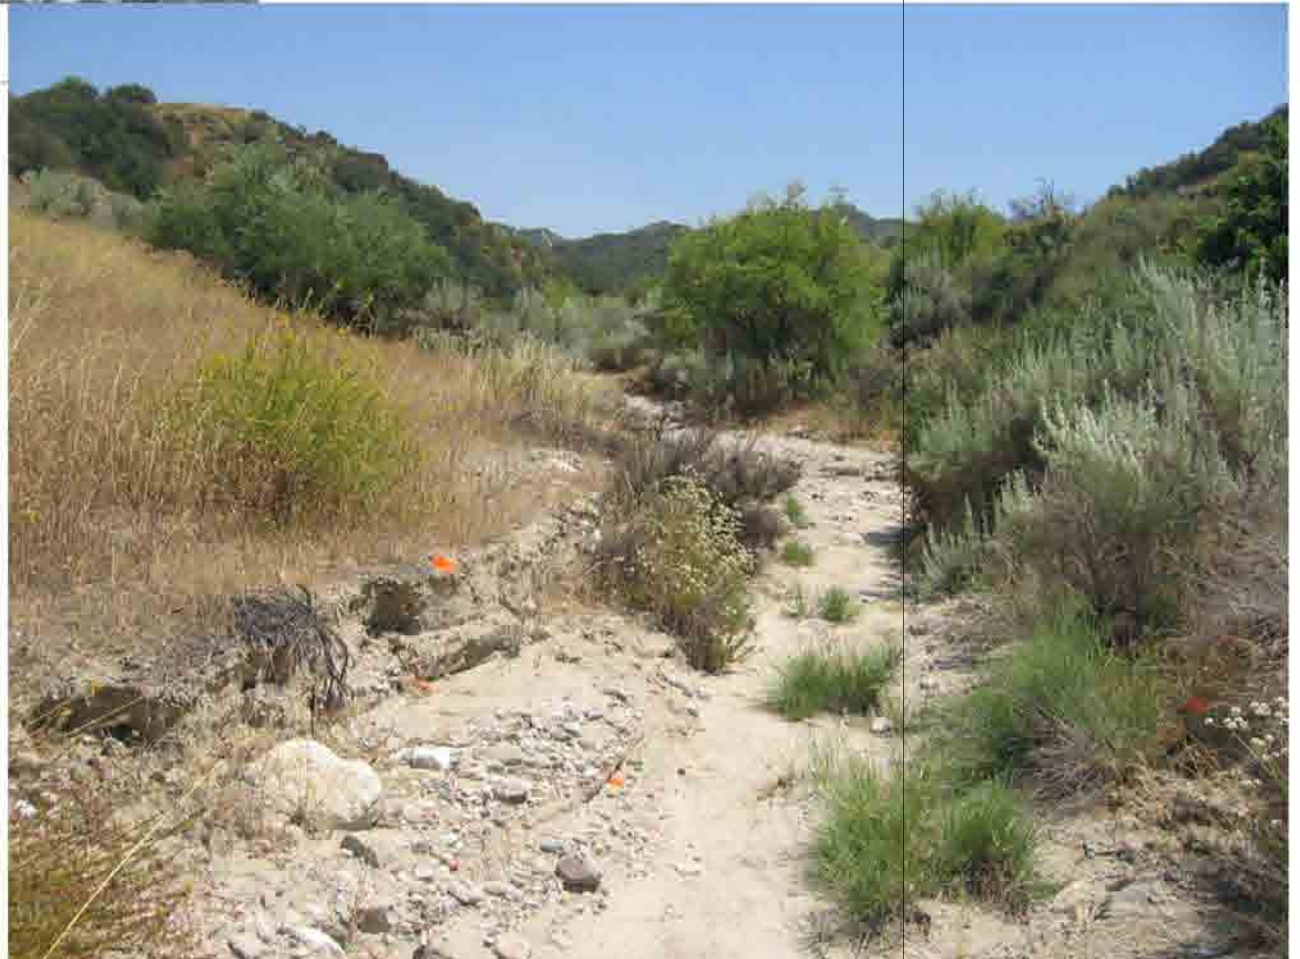
Lion #8

Stable

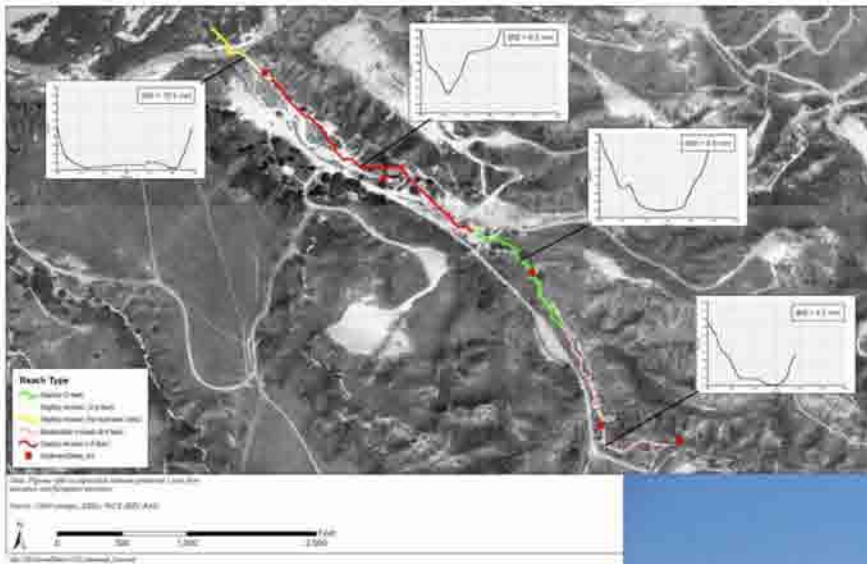
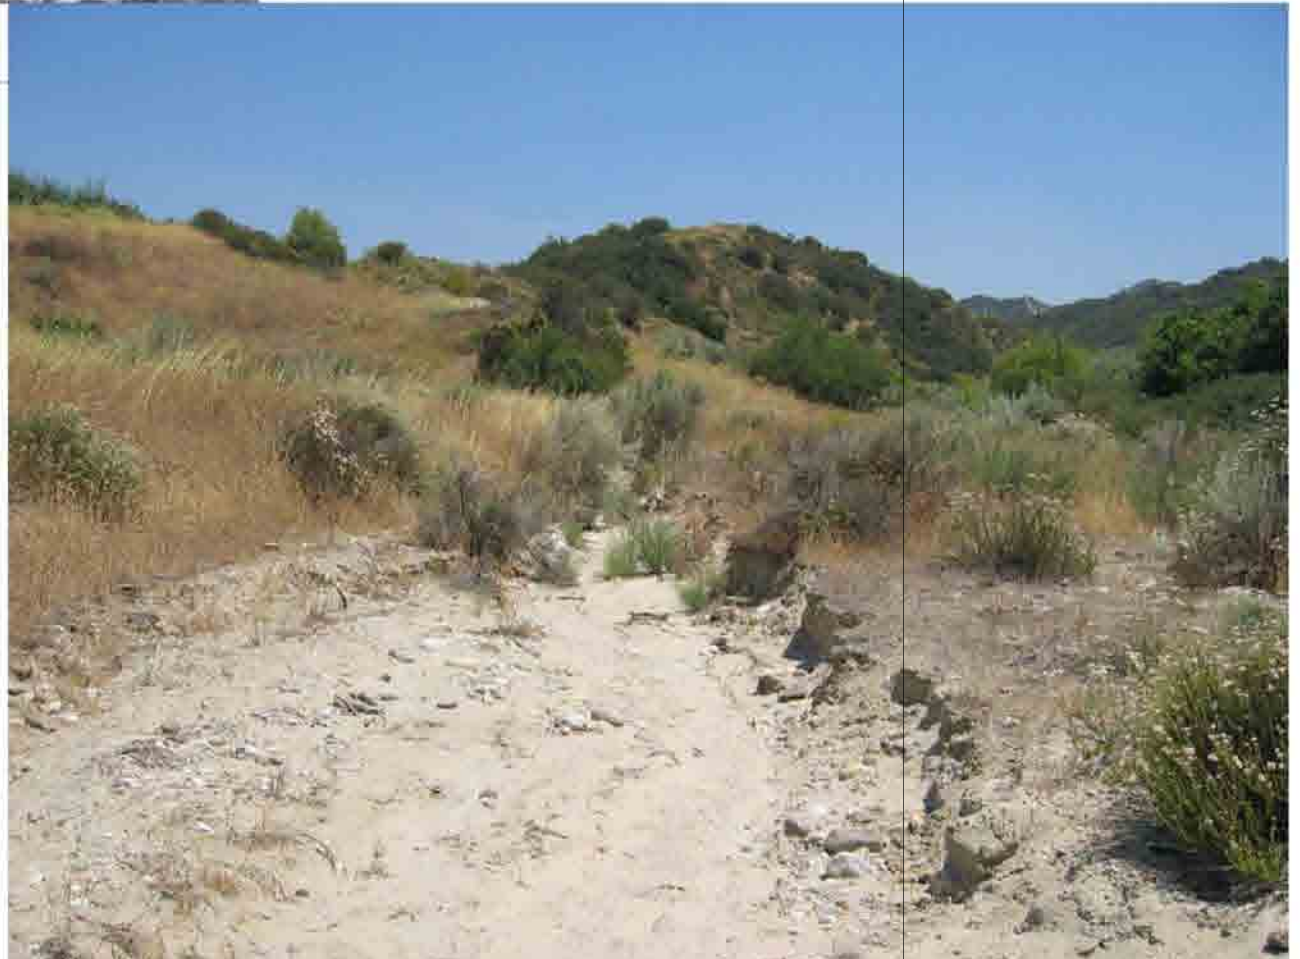
Lion #9

Stable

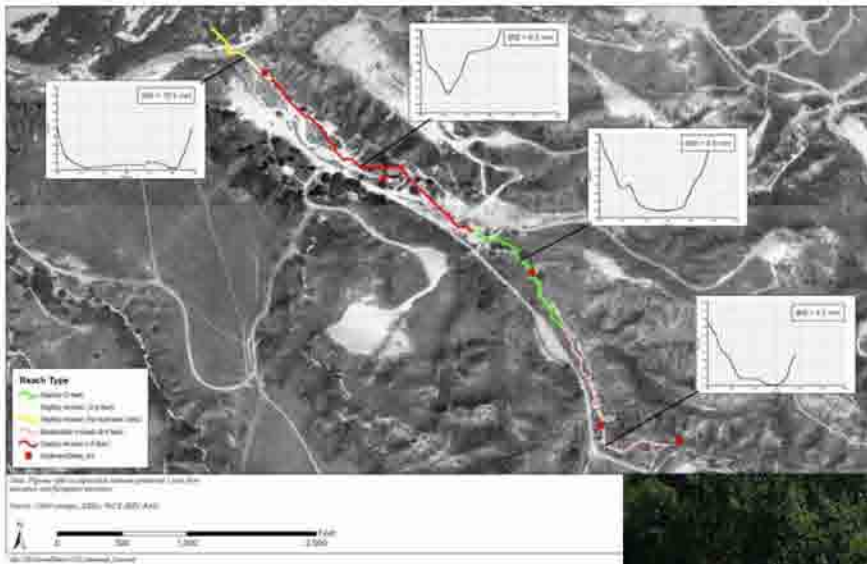
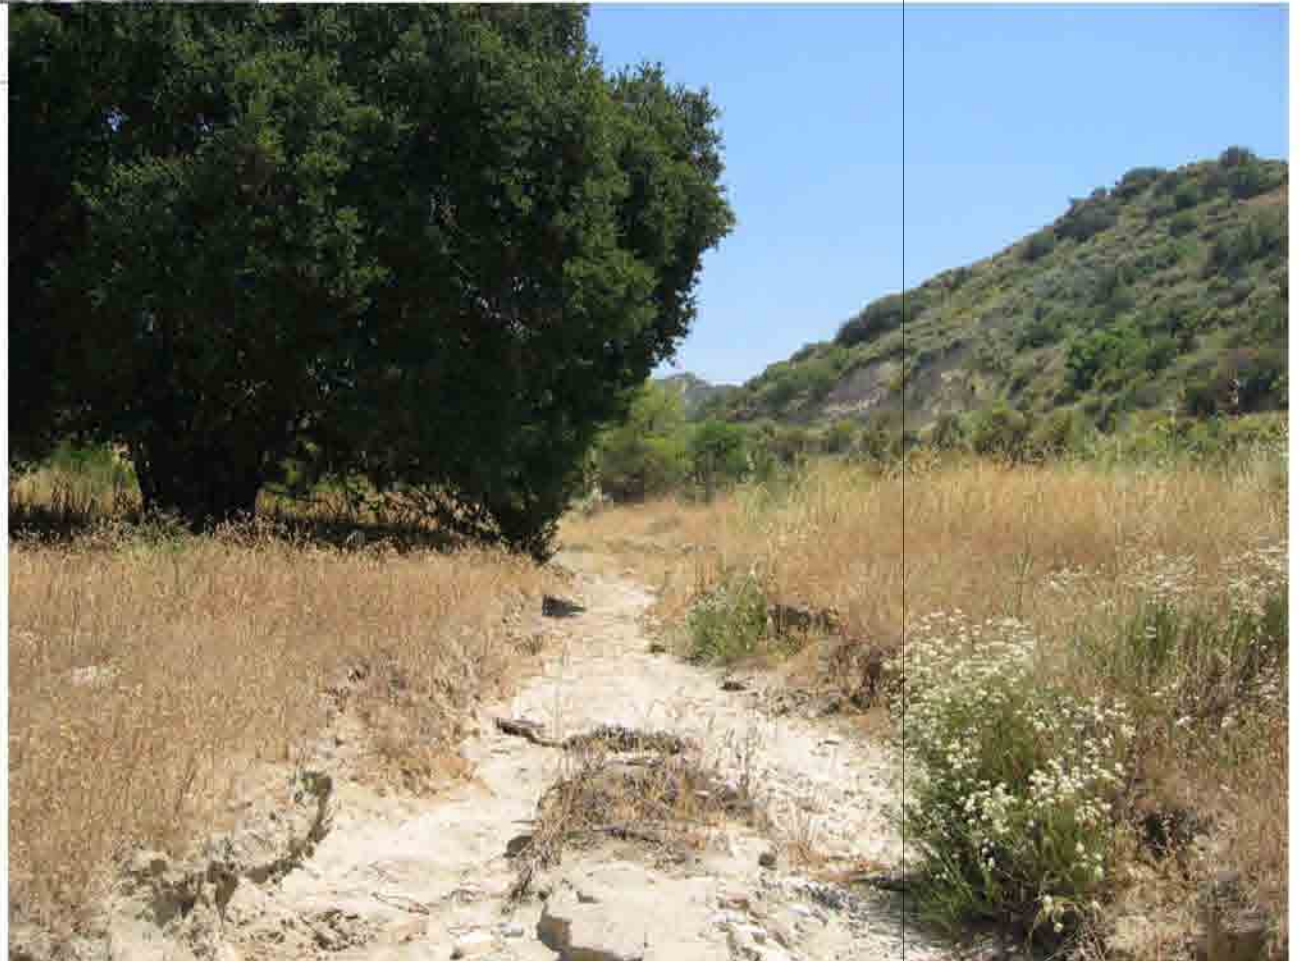
Lion #10

Stable

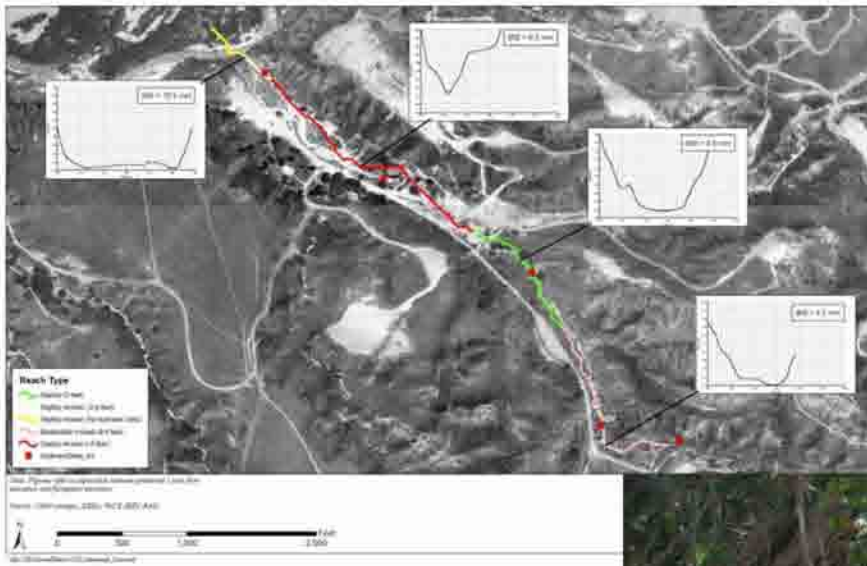
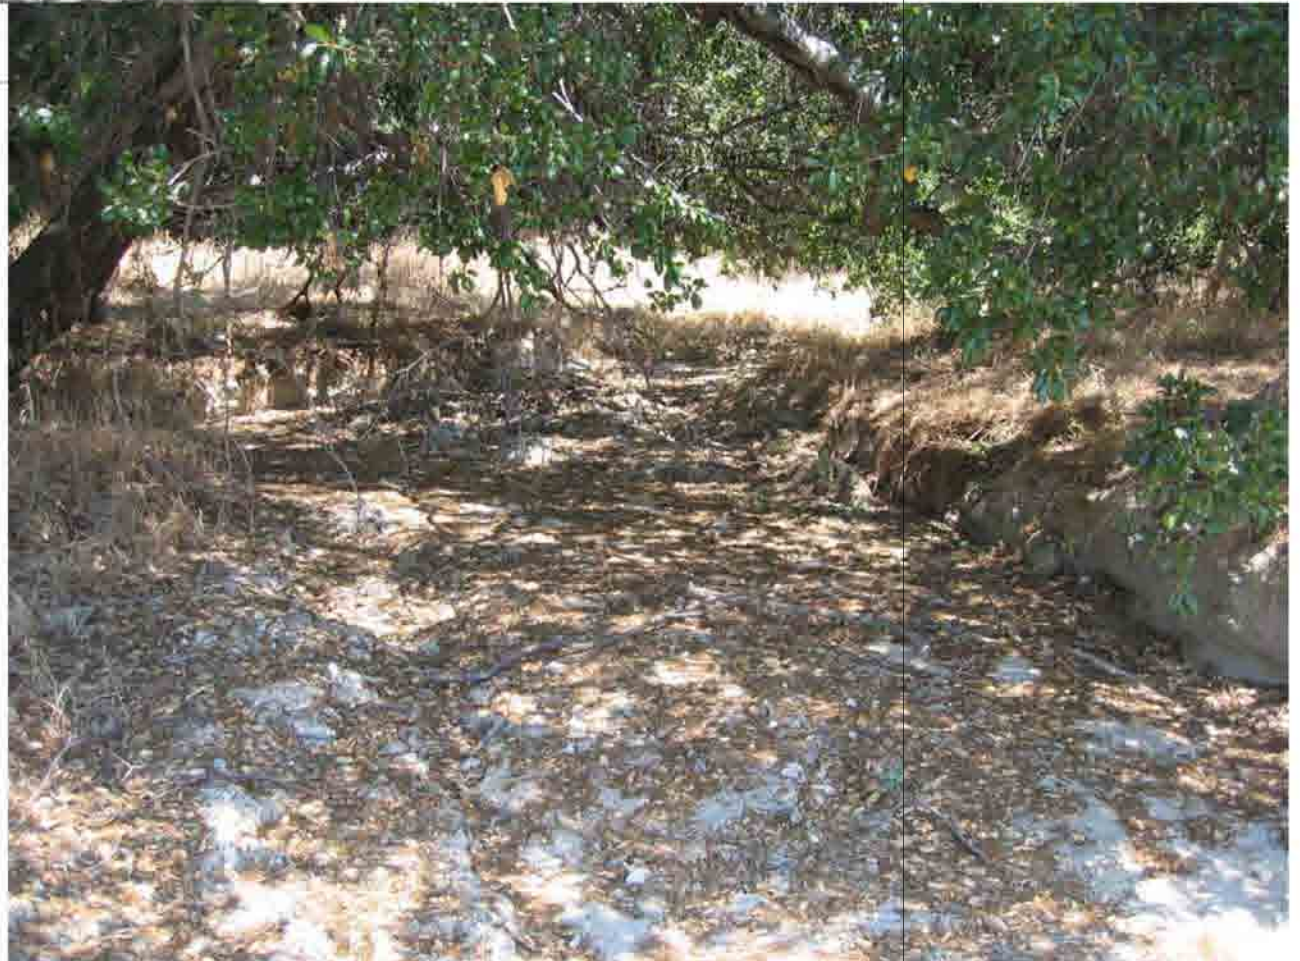
Lion #11

Stable

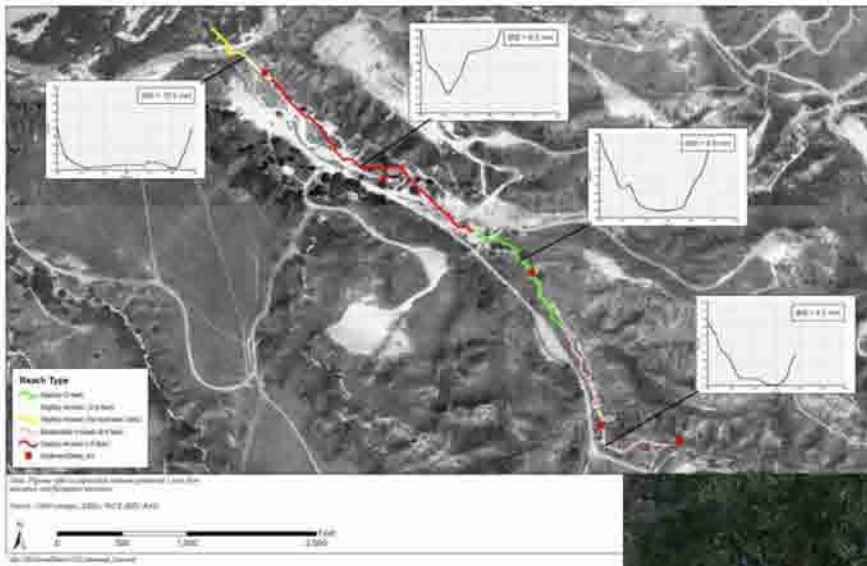
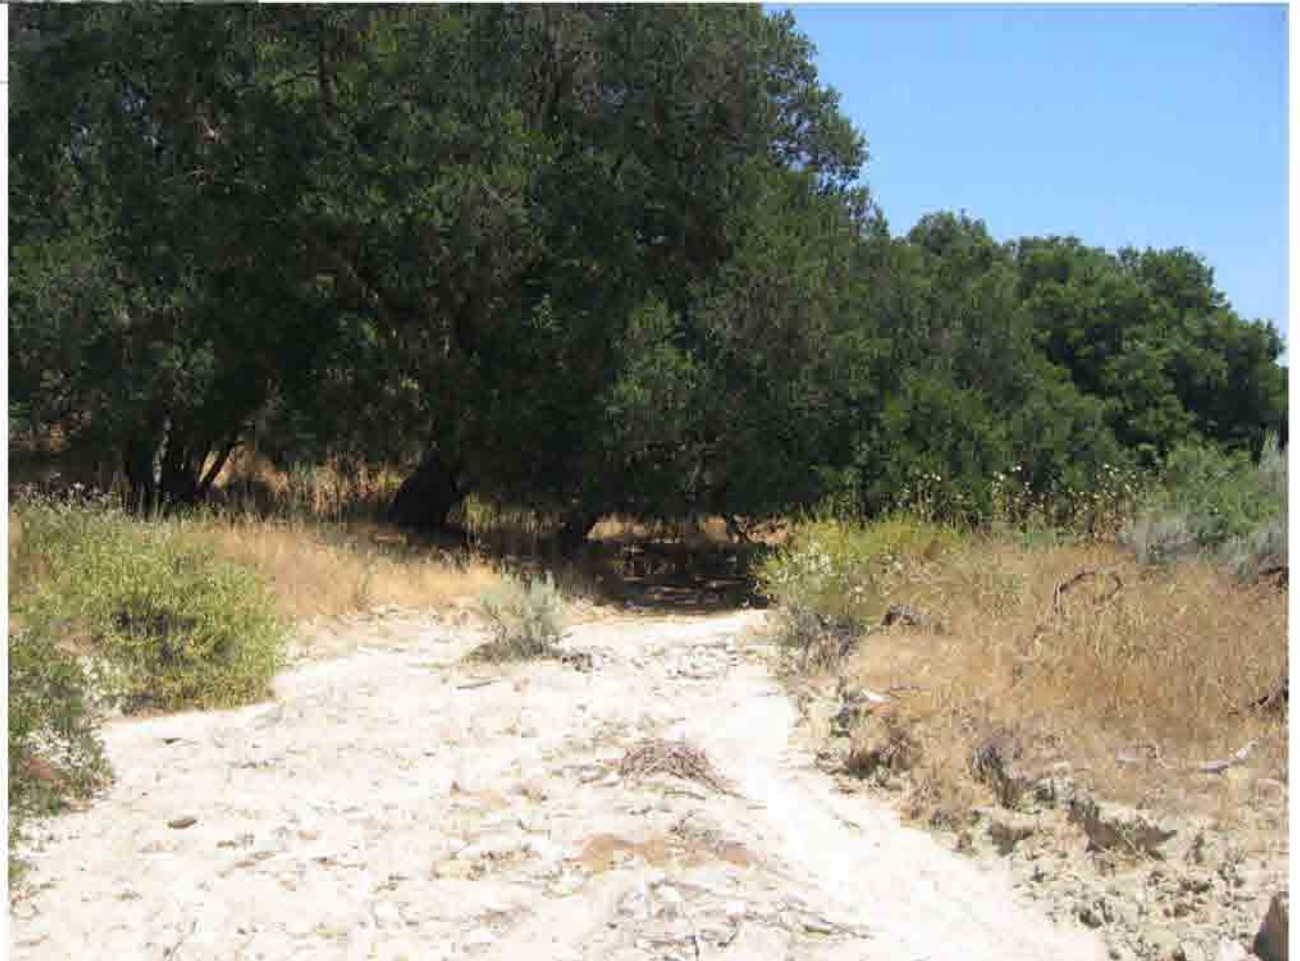
Lion #12

Stable

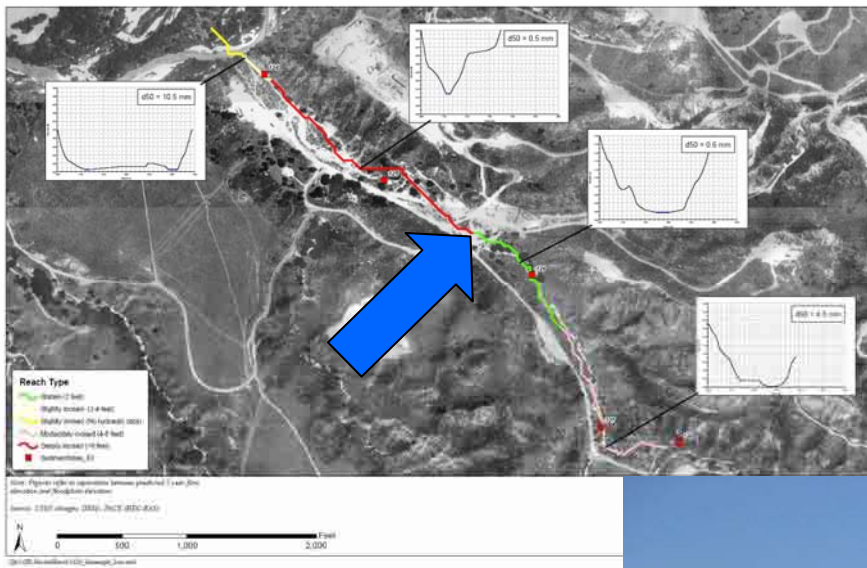
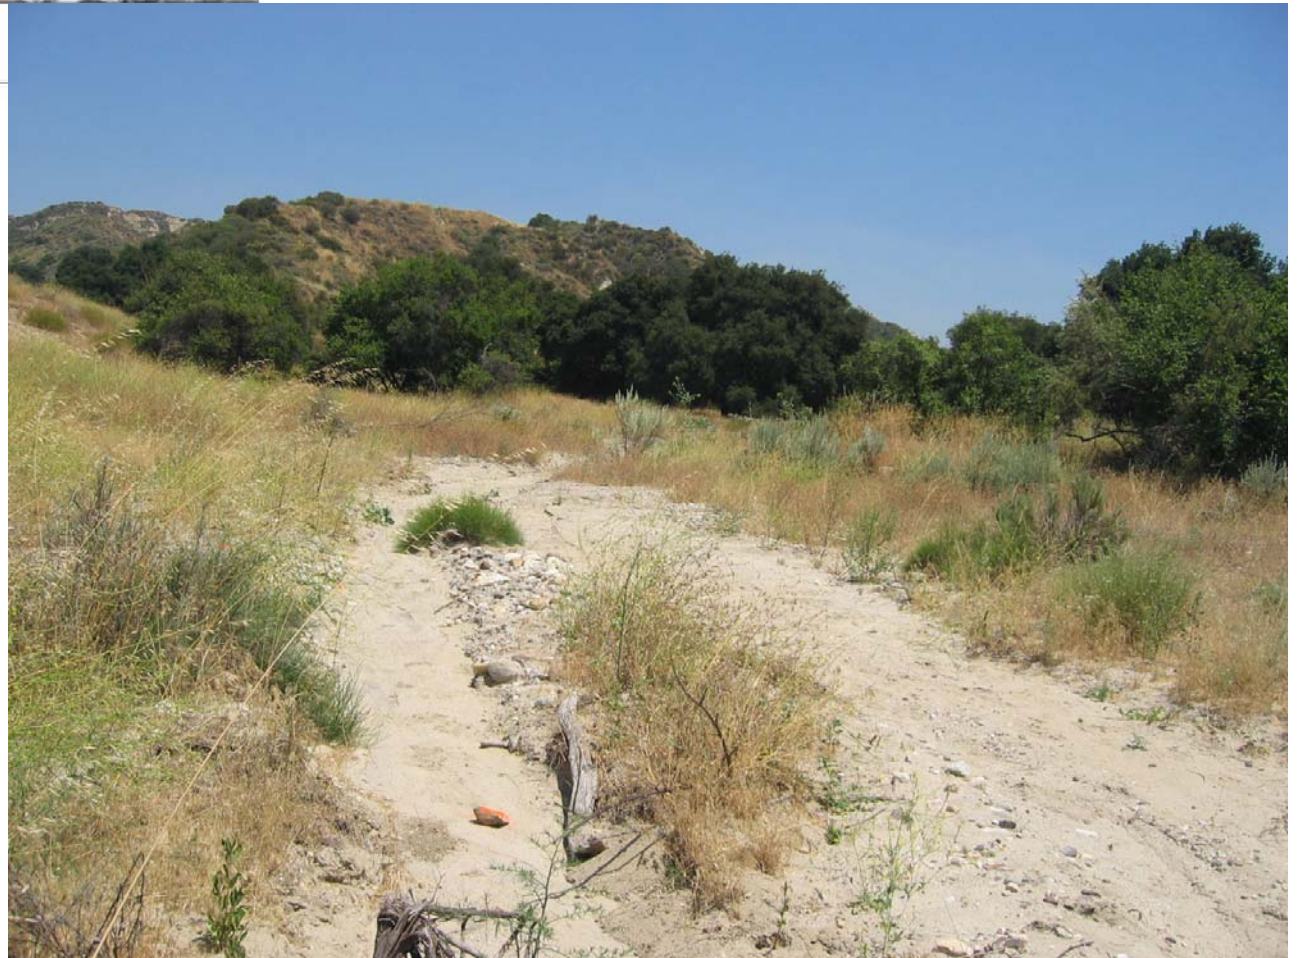
Lion #13

Stable – slightly
aggradational

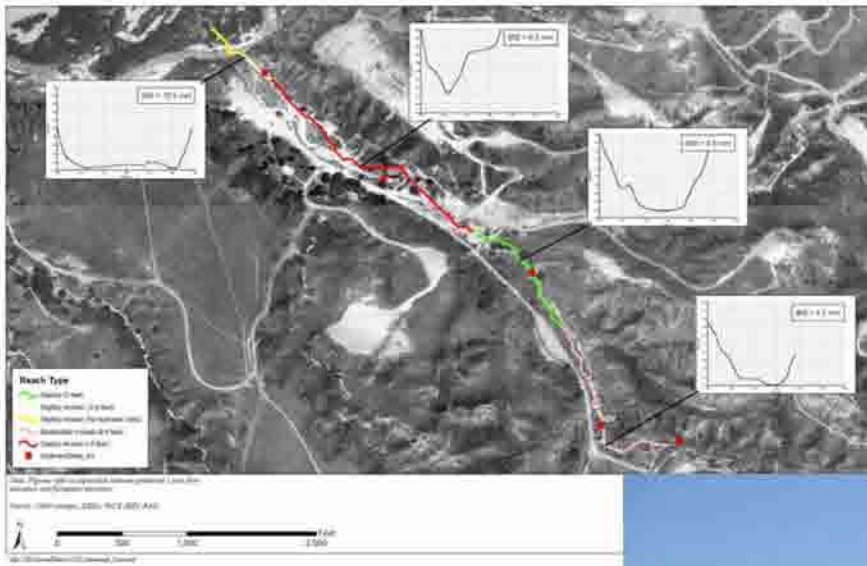
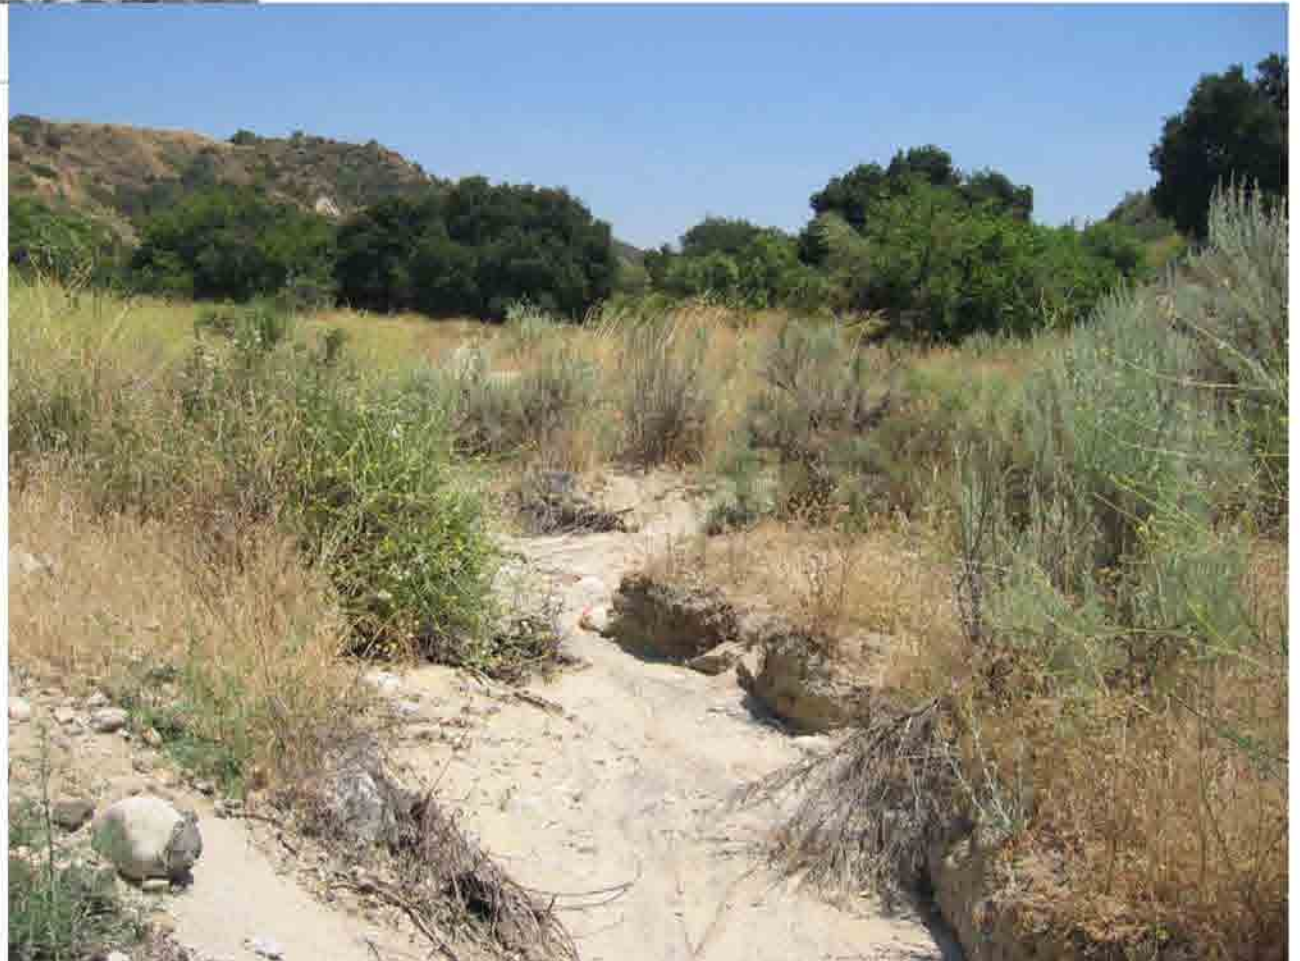
Lion #14

Stable

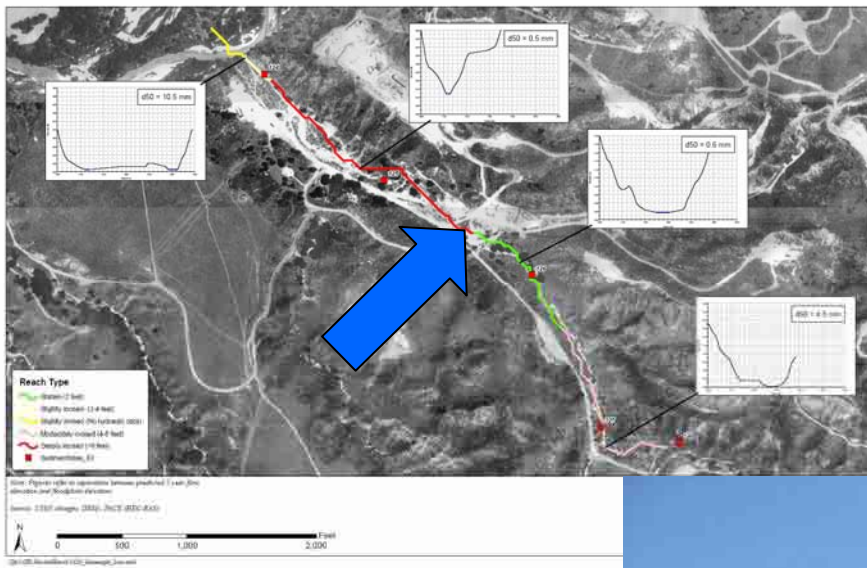
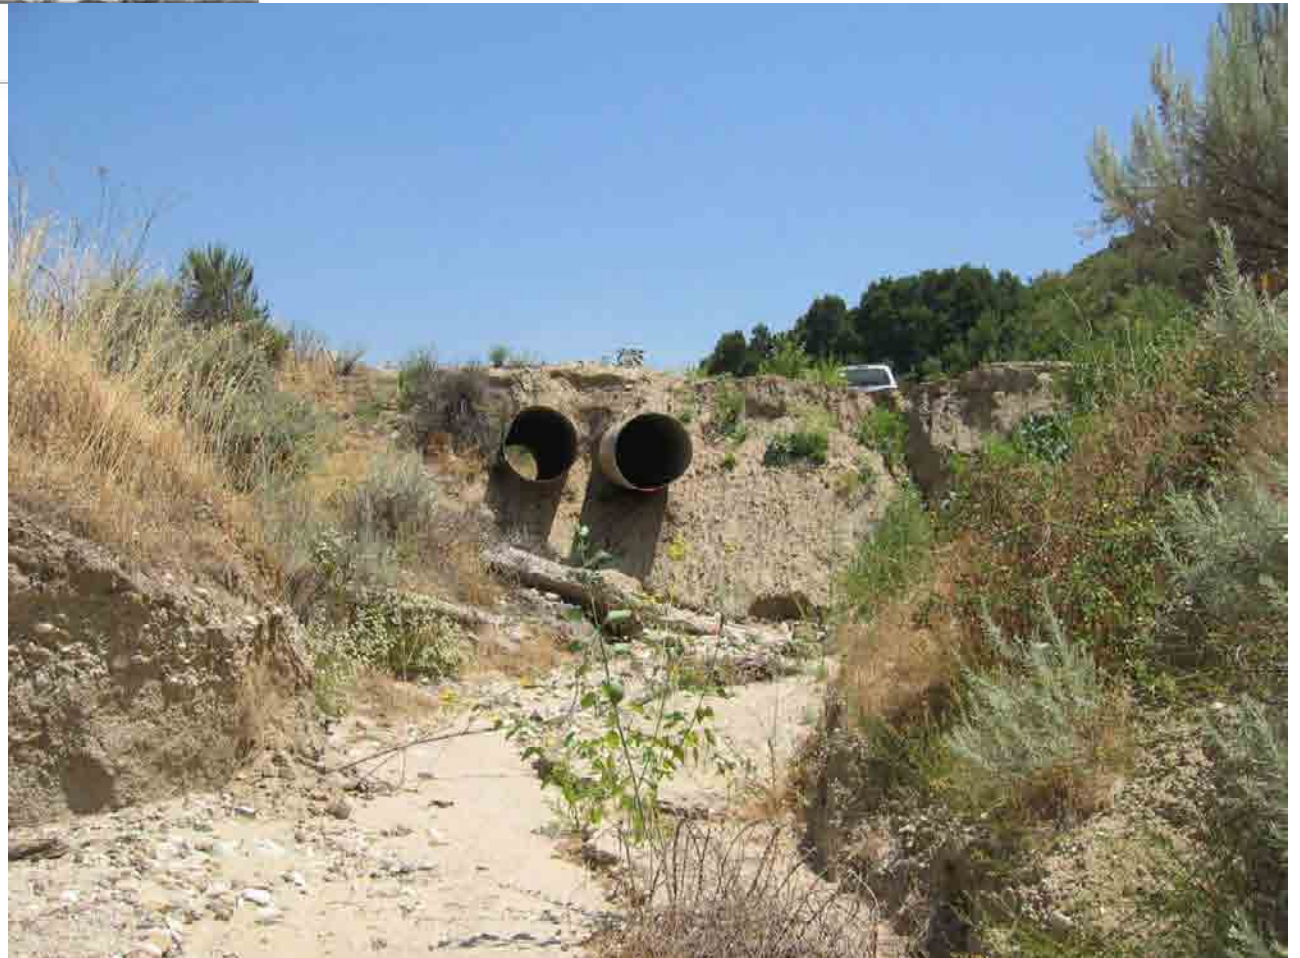
Lion #15

Deeply incised
