MEMORANDUM

Date: June 12, 2007
To: Matt Carpenter and Corey Harpole
Organization: Newhall Land and Farming Company
From: Andrew Collison
PWA Project #: 1820.02
PWA Project Name: Newhall Ranch
Subject: Channel geomorphic assessment of Lion Canyon
Copy(ies) To: Lisa Austin, File

Geomorphic Reconnaissance

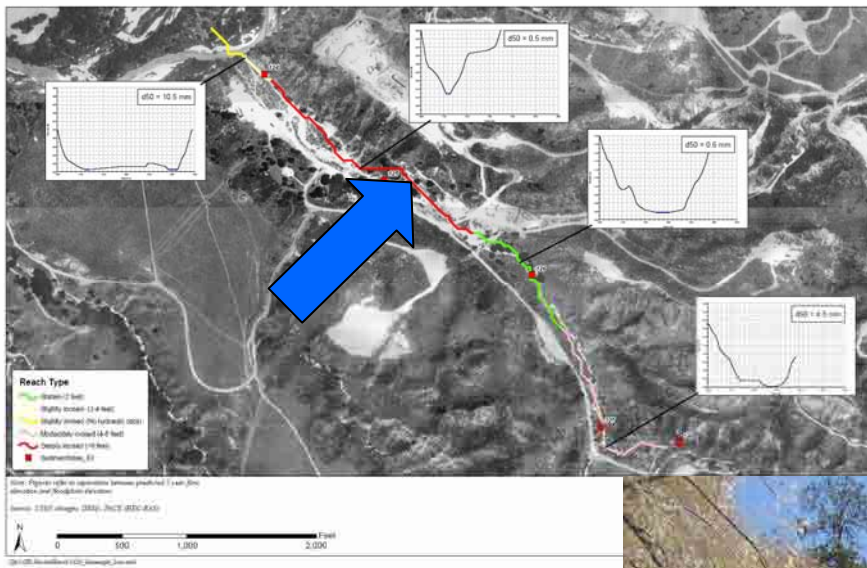
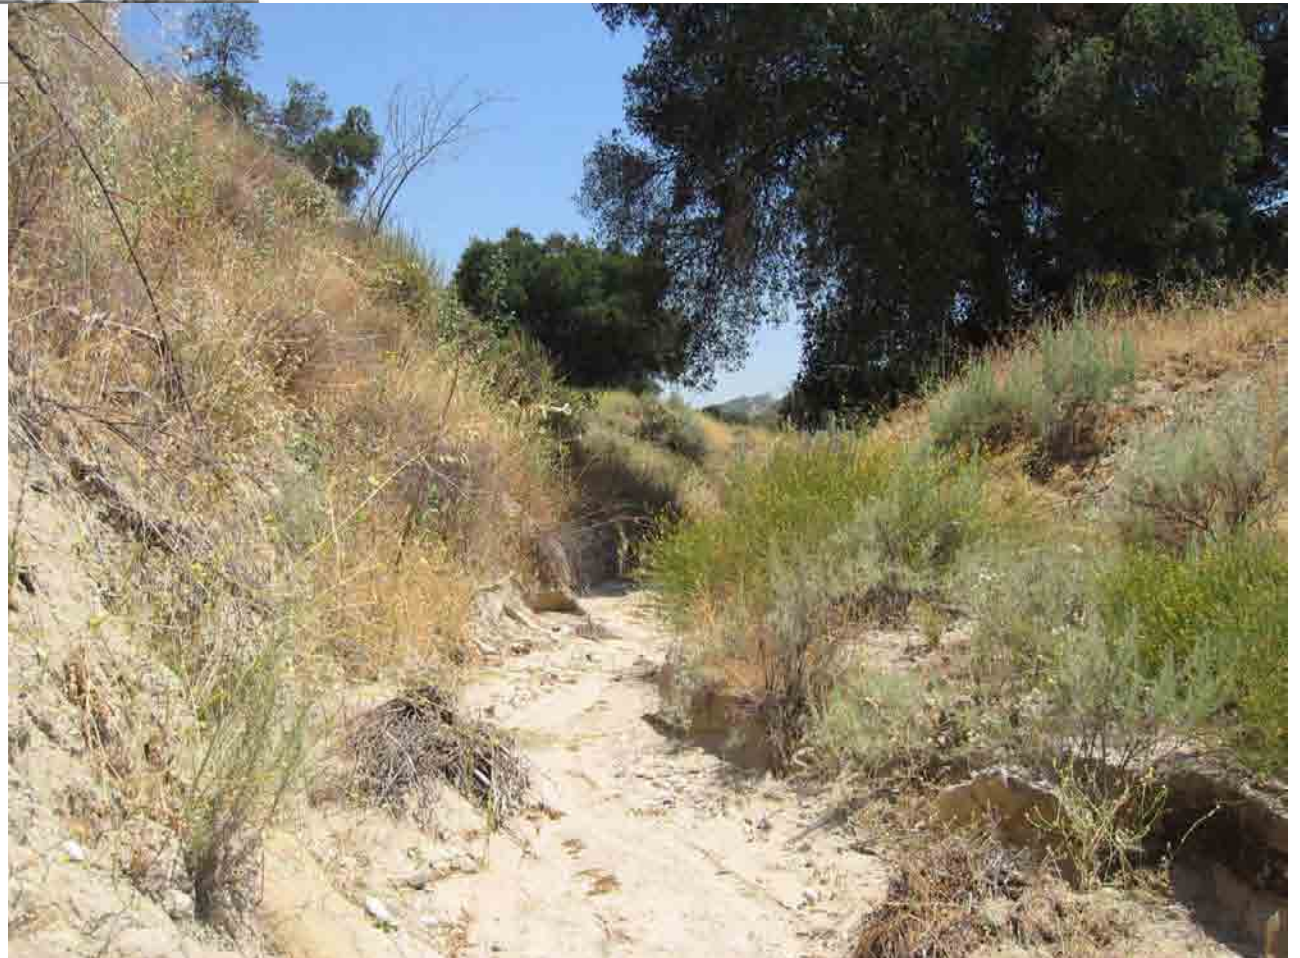
Lion #17

Deeply incised

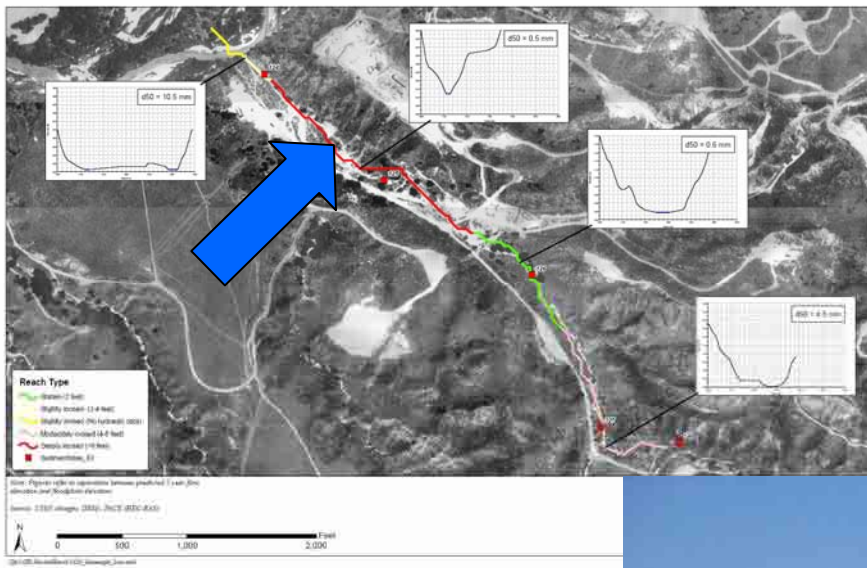
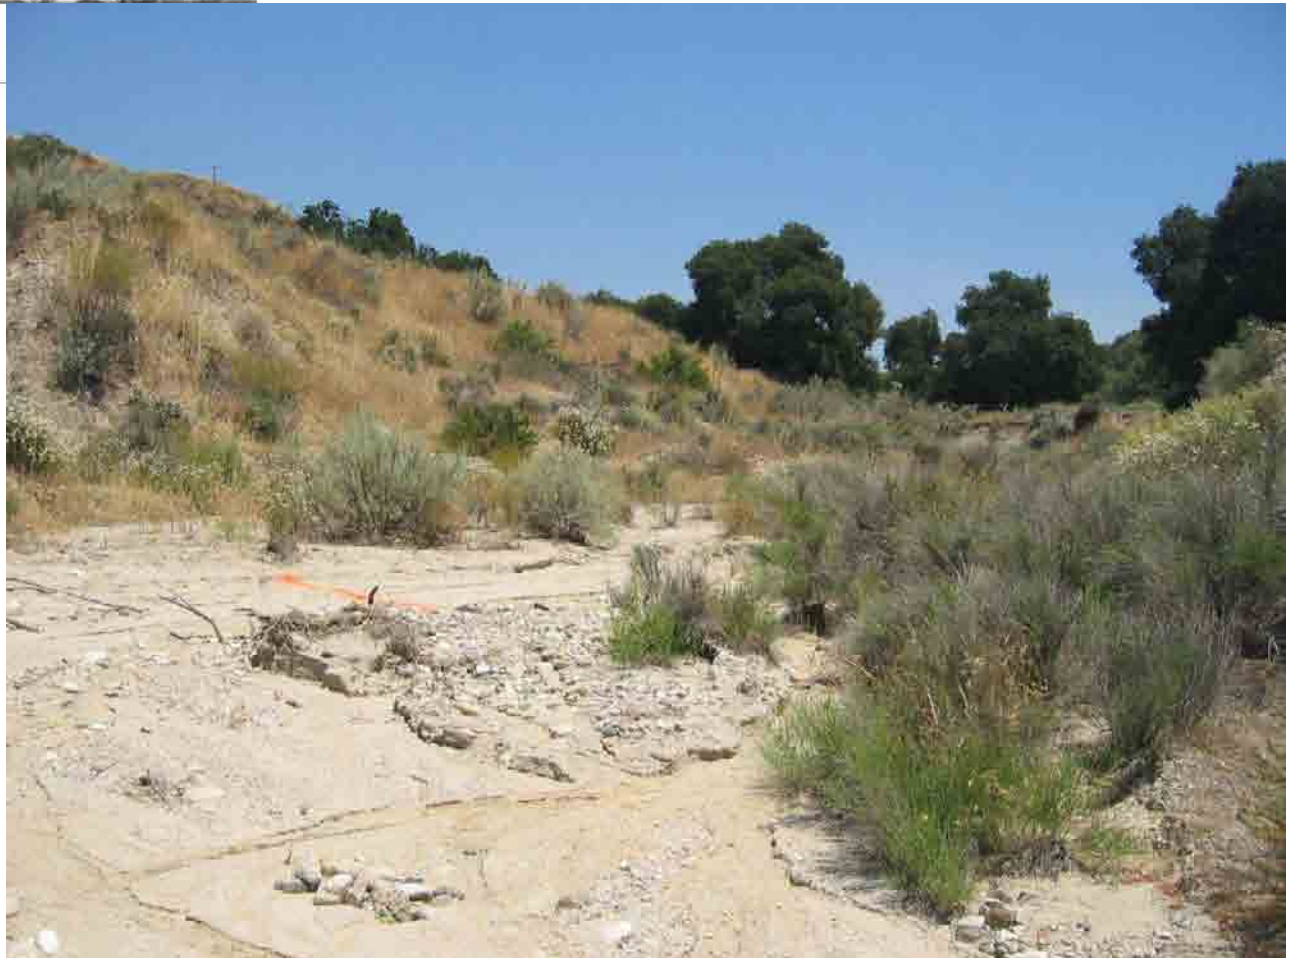
Lion #18

Slightly incised – relict
terraces eroding on
outside bends

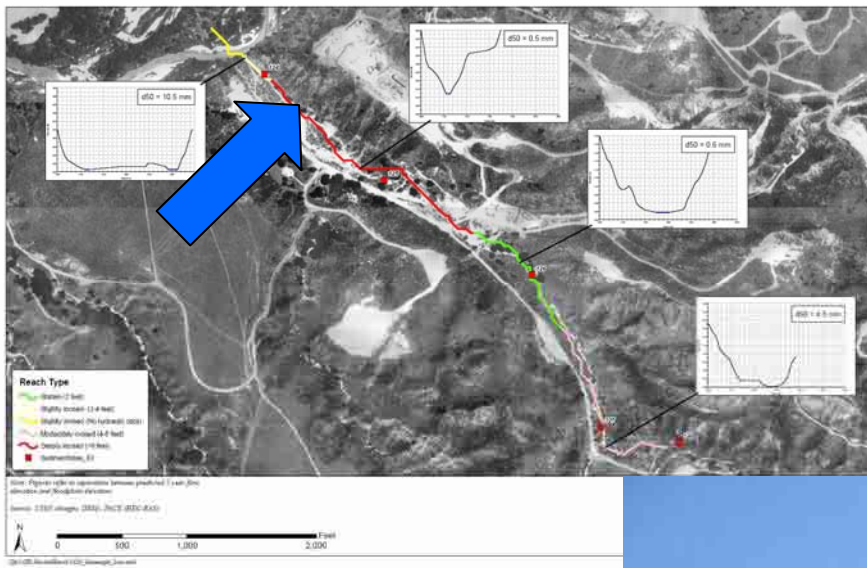
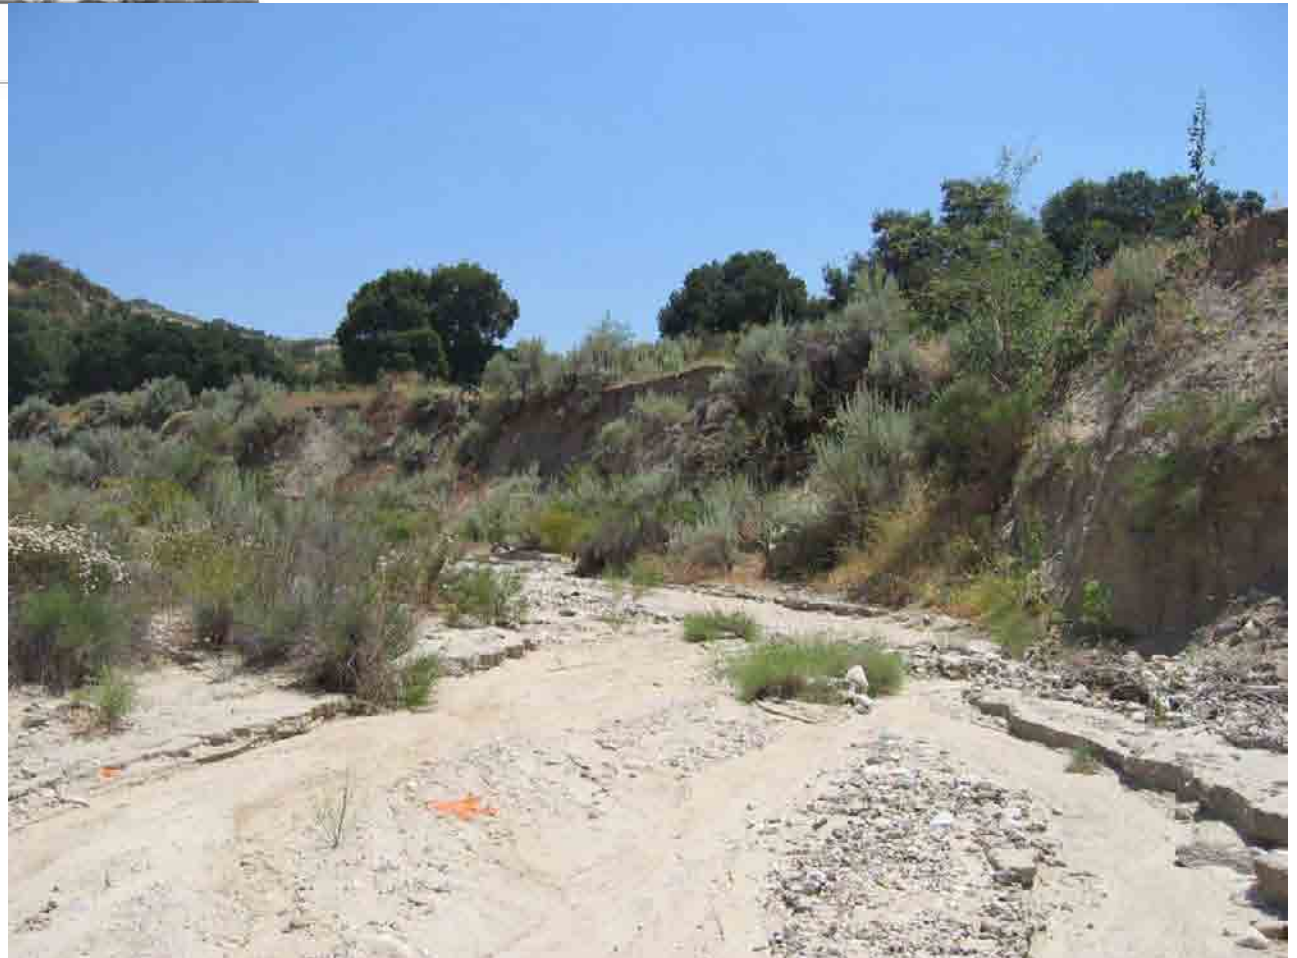
Lion #19

Slightly incised – relict
terraces eroding on
outside bends

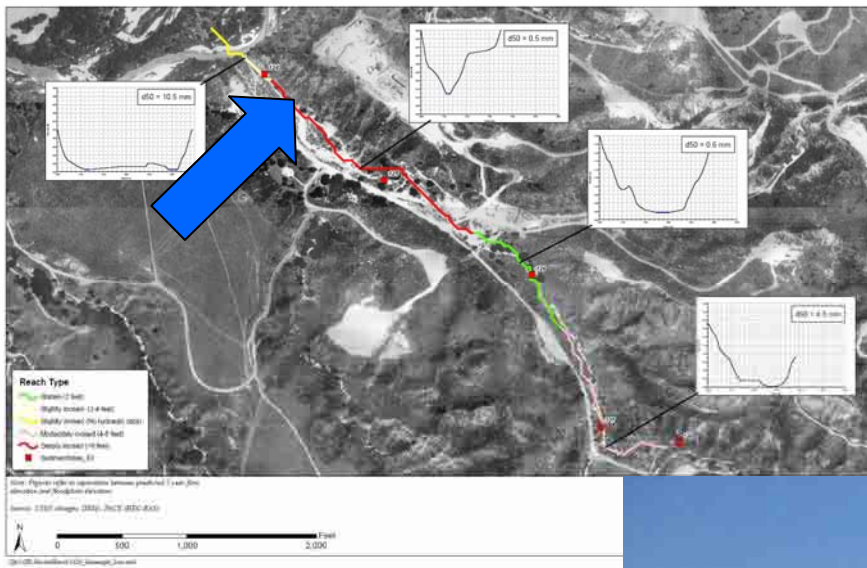
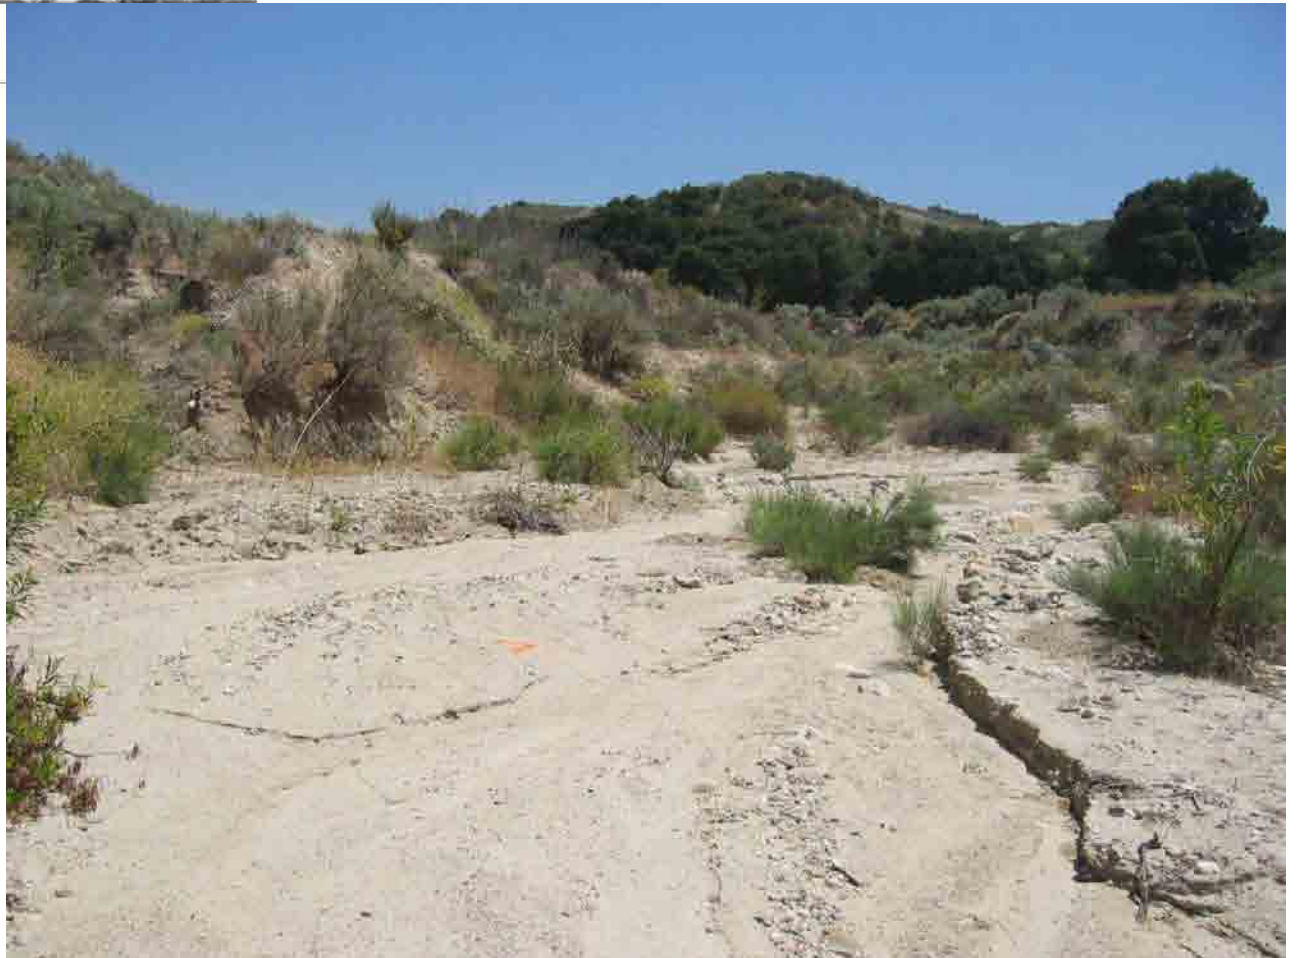
Lion #20

Slightly incised – relict terraces eroding on outside bends

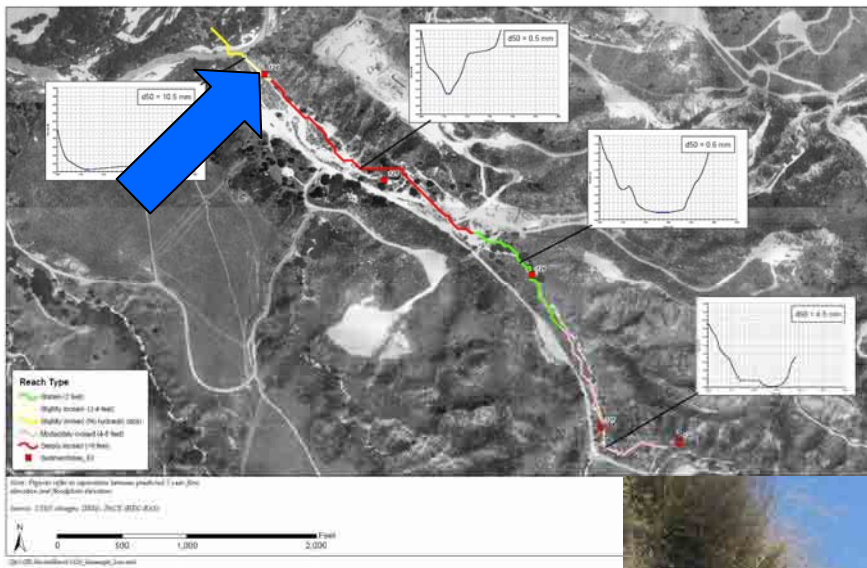
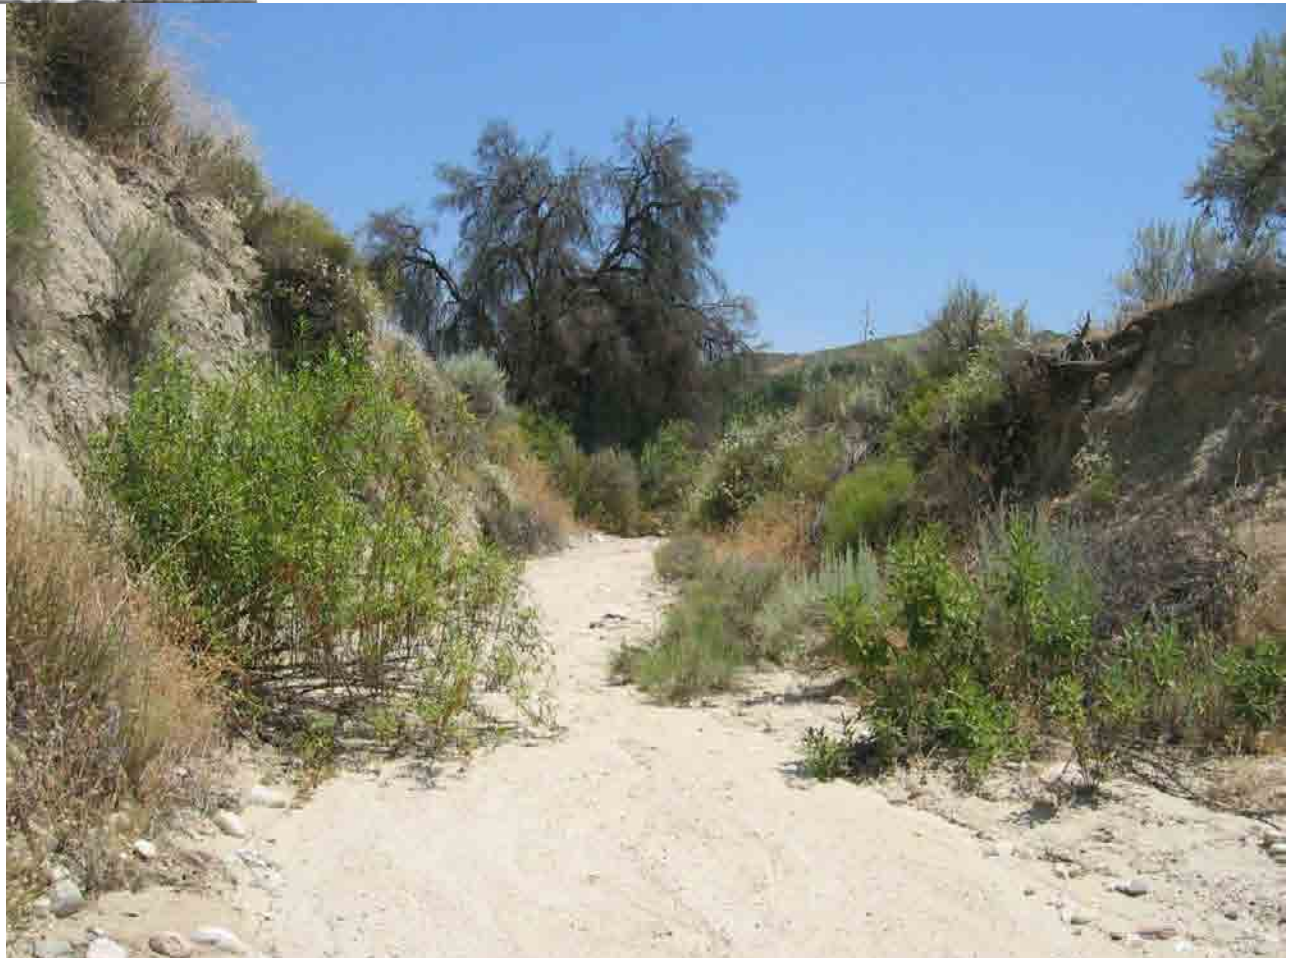
Lion #21

Slightly incised – relict terraces eroding on outside bends

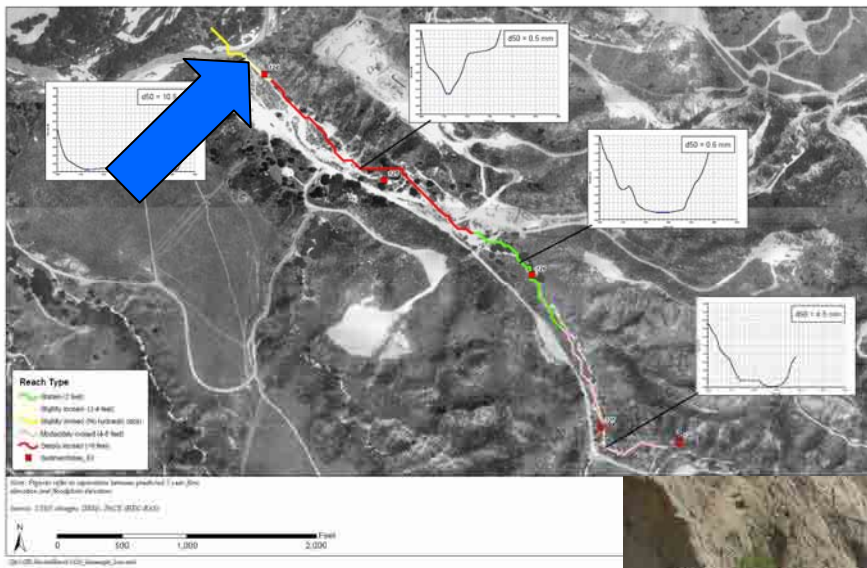
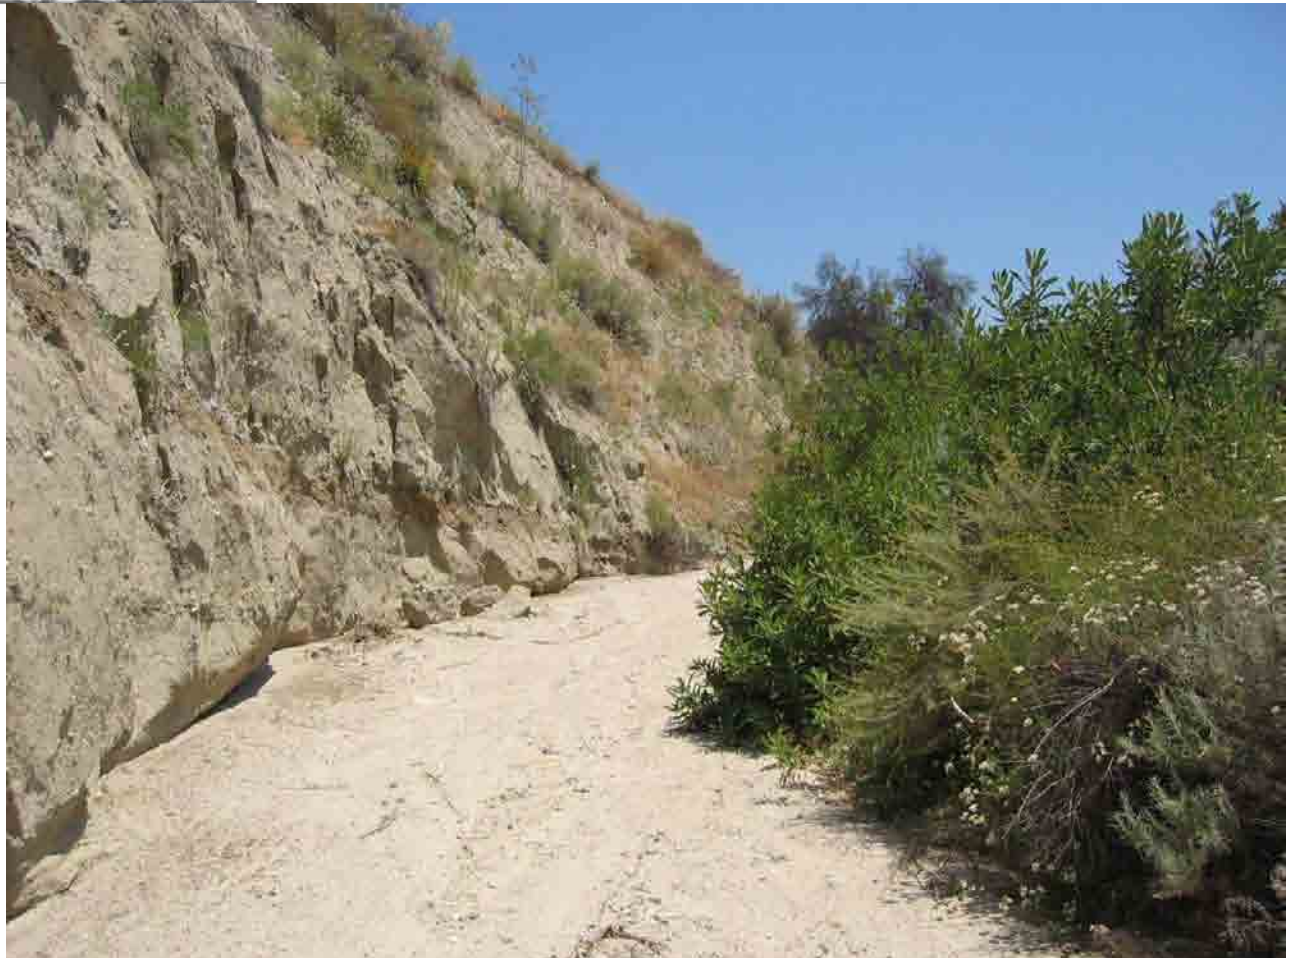
Lion #22

Slightly incised – relict terraces eroding on outside bends and large undercut valley side

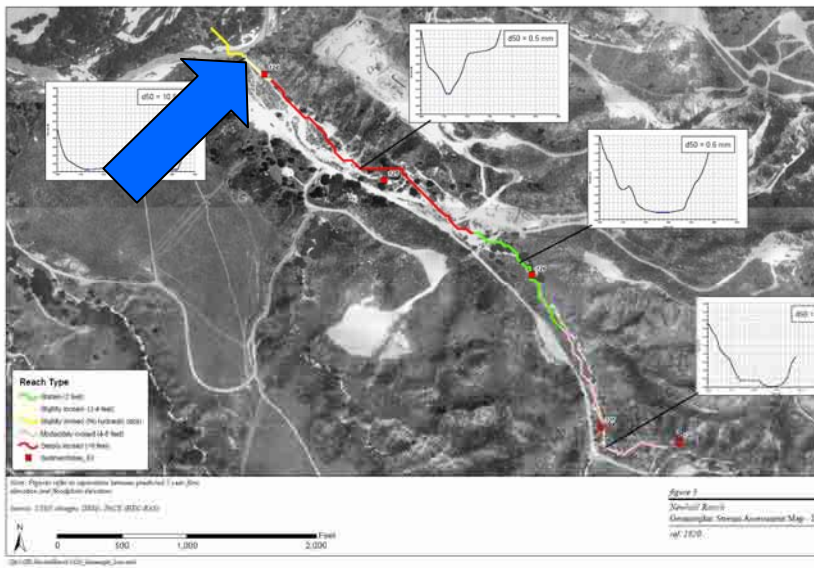
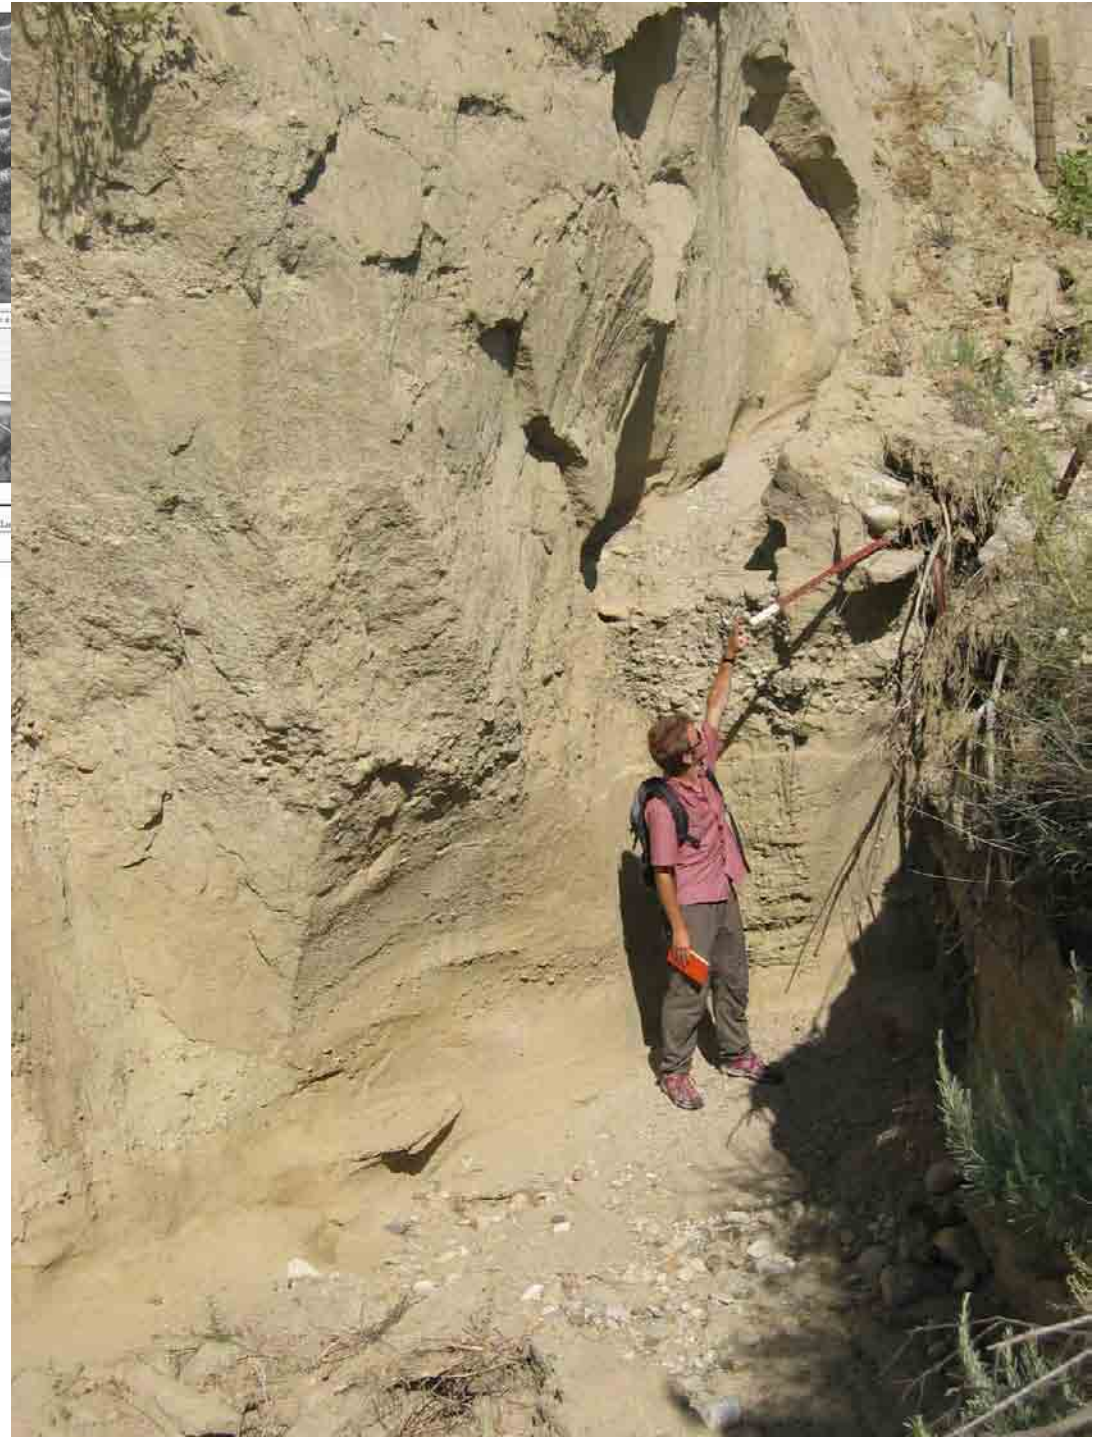
Lion #23

Lion Canyon has steep headwaters (above the project boundary) that feed into a slightly eroded upper channel reach (Images #1 – 6) transitioning gradually to a more stable reach with a well connected and vegetated floodplain (Images 7-9). This incorporates a reach with mature oaks (Images 10-13) before transitioning back to additional stable floodplain (Image 14). There is a very sharp transition from stable to unstable conditions at the road crossing, which acts as a grade control protecting the upper reaches from incision. The source of the incision is likely uncontrolled drainage from the unimproved road surface. Downstream of the grade control is a 12 foot high knickpoint (Image 15) and a reach of deeply incised channel with some failing banks (Images 16 and 17 near to more mature oaks. This reach opens up into a wider section (Images 18-20) where the channel is eroding into relict terraces, triggering extensive bank collapses. Downstream the channel become slightly more stable but still remains incised with erosion on the outside bends and the formation of a small new floodplain on the inner bends (Images 21-22). The right valley side looking downstream is undercut by the creek, creating a high unstable slope. This reach culminates in a 8 foot high knickpoint (further evidence of incision) leading to the Santa Clara River.

Deeply incised with
knickpoint and large
undercut valley side
