2014–2015 Detailed Fish Passage Assessment Evaluations

District 4 – Marin and San Mateo Counties | Highway 1

April 2015
Revised May 2016

Prepared For:
California Department of Transportation
Division of Environmental Analysis
Office of Biology and Technical Assistance
Sacramento, CA USA

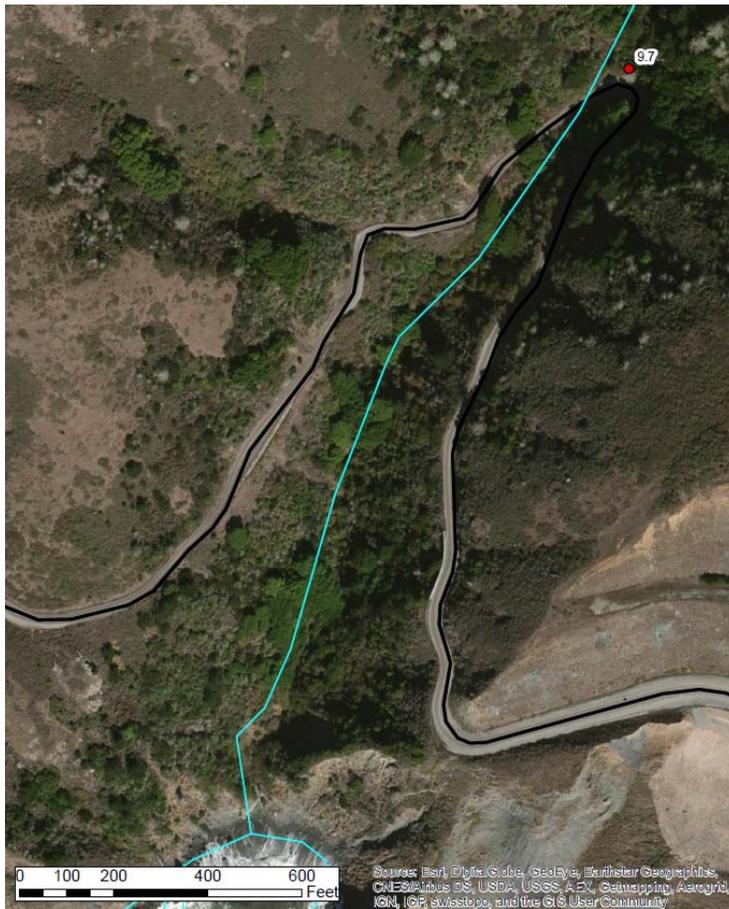
Examination of aerial imagery downstream of the MRN 1 9.70 crossing to the Pacific Ocean (see **Figure 3**) indicated a very steep natural gradient. GIS analysis estimated gradient of up to 25-30% downstream of the crossing, indicating that this drainage did not historically support anadromous salmonids. A literature review also did not indicate historical use of this watershed by anadromous fish. Therefore, this site was not carried forward for further fish passage evaluation.

Figure 3. Aerial view of MRN 1 9.70 downstream to the Pacific Ocean.

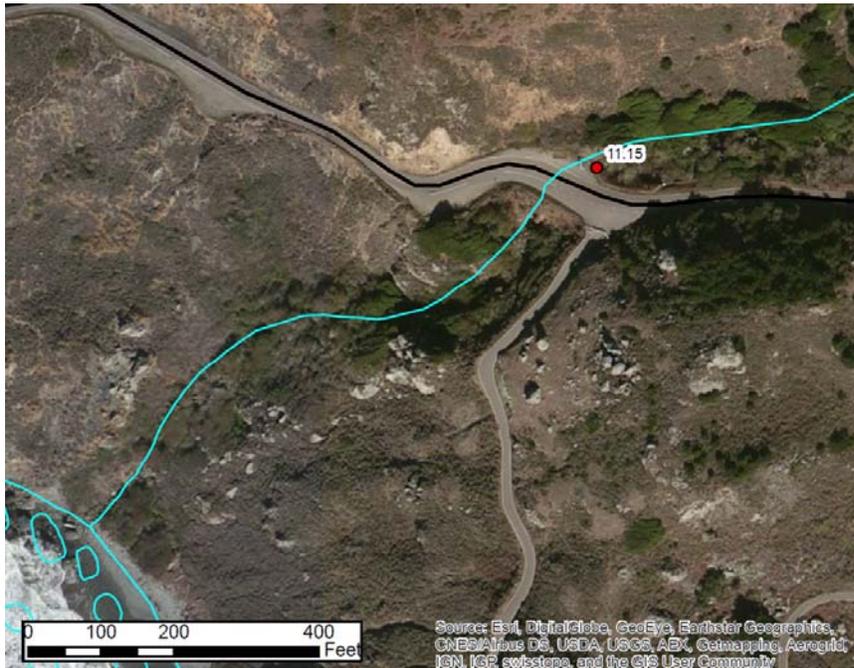
Examination of aerial imagery downstream of the MRN 1 11.15 (Webb Creek) crossing to the Pacific Ocean (see **Figure 4**) indicated a very steep natural gradient. GIS analysis estimated gradient of up to 25-30% downstream of the crossing, indicating that this drainage did not historically support anadromous salmonids. A literature review also did not indicate historical use of this watershed by anadromous fish. Therefore, this site was not carried forward for further fish passage evaluation.

Figure 4. Aerial view of MRN 1 11.15 downstream to the Pacific Ocean.

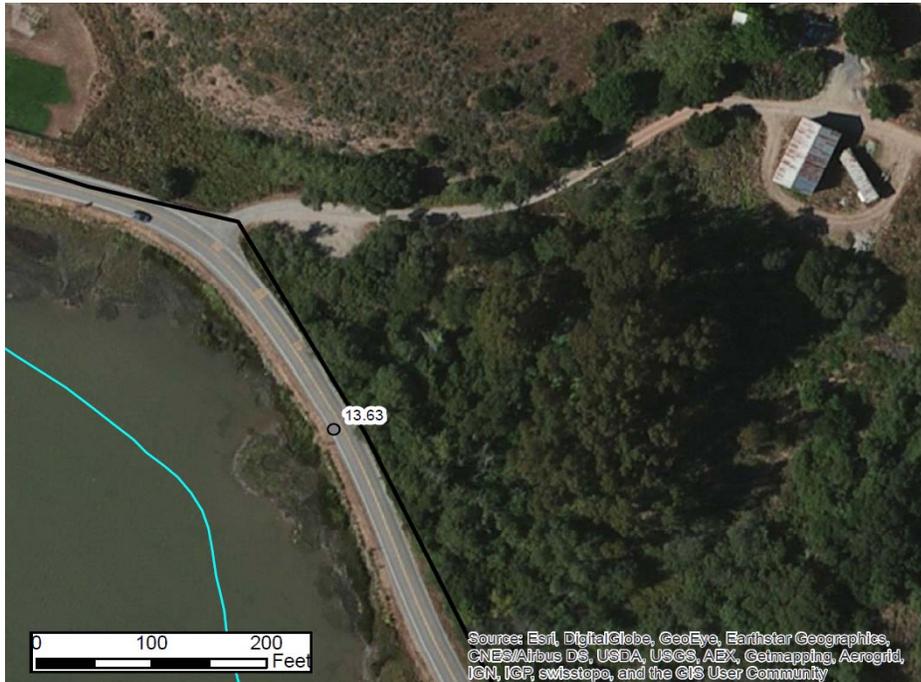
Hydrologic GIS analyses indicate that this drainage may have historically crossed through the location of an existing school property, and may have been moved just to the south of the property (**Figure 6** – purple highlighting indicates the natural stream pathway based on elevation). Site photos indicate grass growing in the vicinity of the inlet and the outlet, and downstream of the outlet, with a lack of a definable channel

downstream of the outlet. It is also difficult to determine whether there is a definable channel upstream of the crossing. The NPS (Fong 2002) conducted a fisheries assessment of tributaries to east Bolinas Bay on NPS-managed land, but did not identify this drainage as a steelhead-bearing stream. Based on aerial imagery and site photos, the crossing appears to drain a swale and not an anadromous fish-bearing stream. Therefore, this crossing was not further evaluated for fish passage.

Figure 5. Aerial view of MRN 1 13.63 and its upstream drainage.

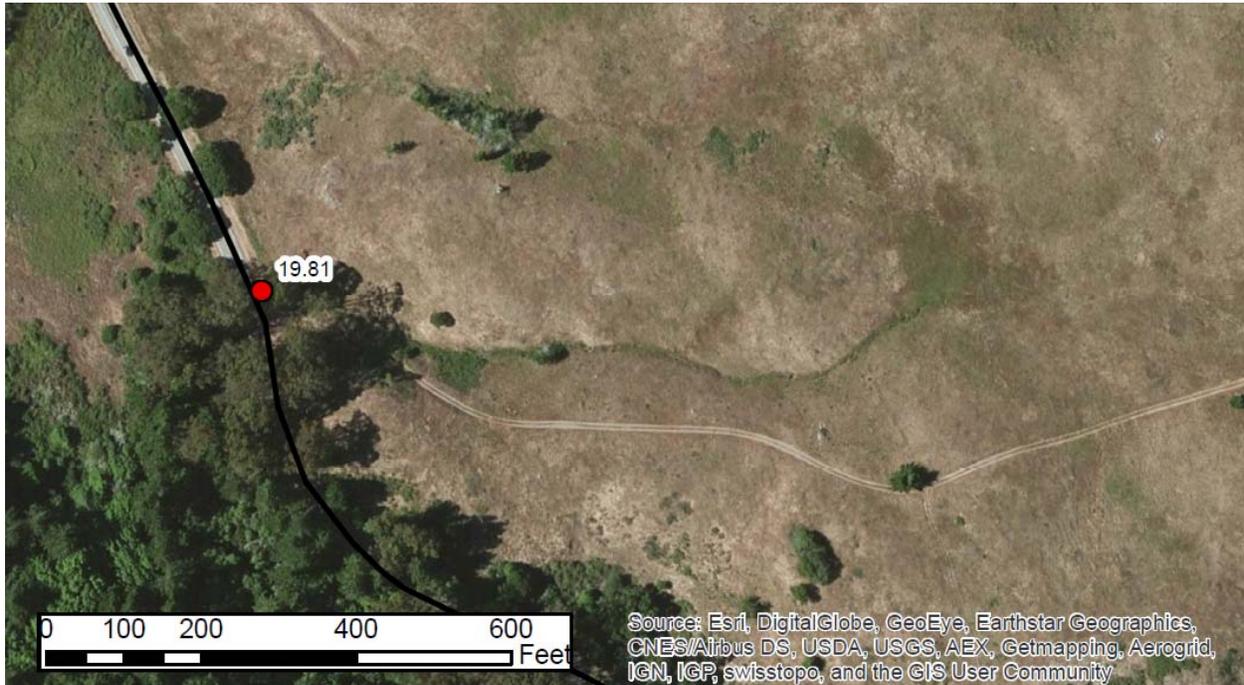
Review of aerial imagery, site photos and hydrologic GIS analysis indicates that very little flow generally passes through this crossing, and the site lacks suitable fisheries habitat. Therefore, this site was not further evaluated for fish passage. An aerial view of the crossing and its upstream drainage is provided in **Figure 7**.

Figure 7. Aerial view of MRN 1 19.81 and its upstream drainage.

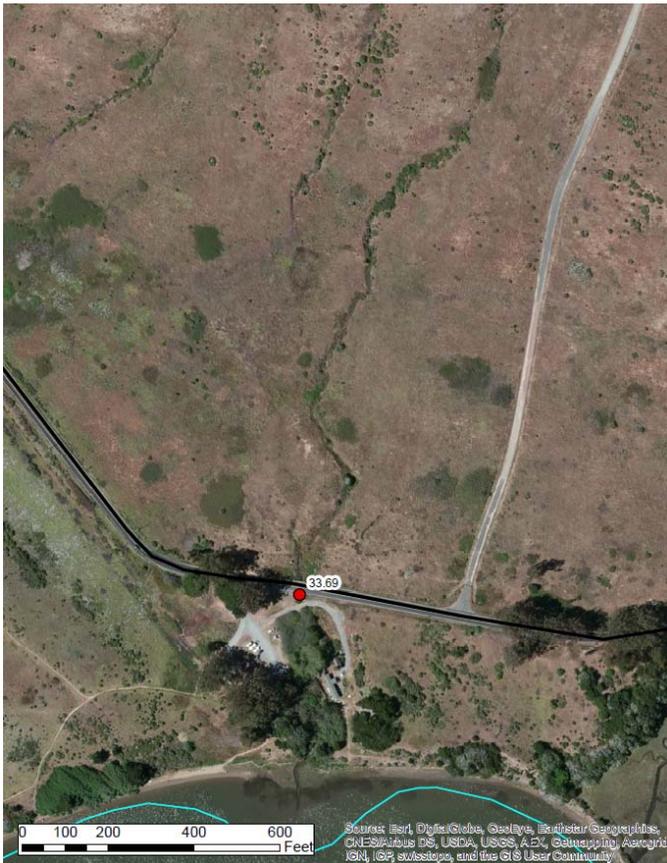
Review of aerial imagery, site photos and hydrologic GIS analysis indicates that very little flow generally passes through this crossing, and the site lacks suitable fisheries habitat. Therefore, this site was not further evaluated for fish passage. An aerial view of the crossing and its upstream drainage is provided in **Figure 9**.

Figure 9. Aerial view of MRN 1 33.69 and its upstream drainage.

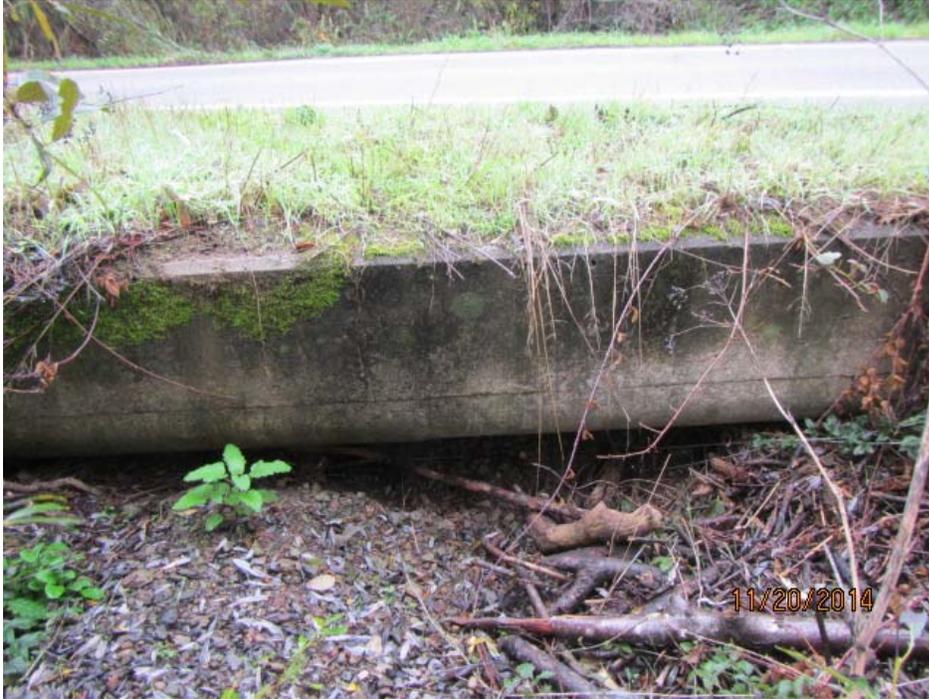
MRN 1 14.86 – Although this site ranked as “green”, unimpeded fish passage is not provided due to the concrete box culvert being nearly full with sediment (**Figure 10**). Sediment excavation is recommended prior to re-surveying the site and making a fish passage determination.

Figure 10. Sediment accumulation in culvert at MRN 1 14.86. Upstream looking downstream. November 2014.

This crossing was identified as “green” by the CDFW Passage Evaluation Filter, however, this classification was discarded because the culvert was nearly full with sediment. It is recommended that this site be re-surveyed after the excess sediment is removed from the site. The estimated potential habitat upstream of the crossing was approximately 0.4 miles before the stream gradient increased above 12% over more than 100 m in stream length (Figure 21). Due to discrepancies between the stream channel and the stream network representation, initial high gradient segments just upstream of the crossing were ignored. Fong (2002) estimated the length of potential habitat in Wilkins Gulch as approximately 1 km (.6 miles), with the upstream extent an 8 m tall waterfall.

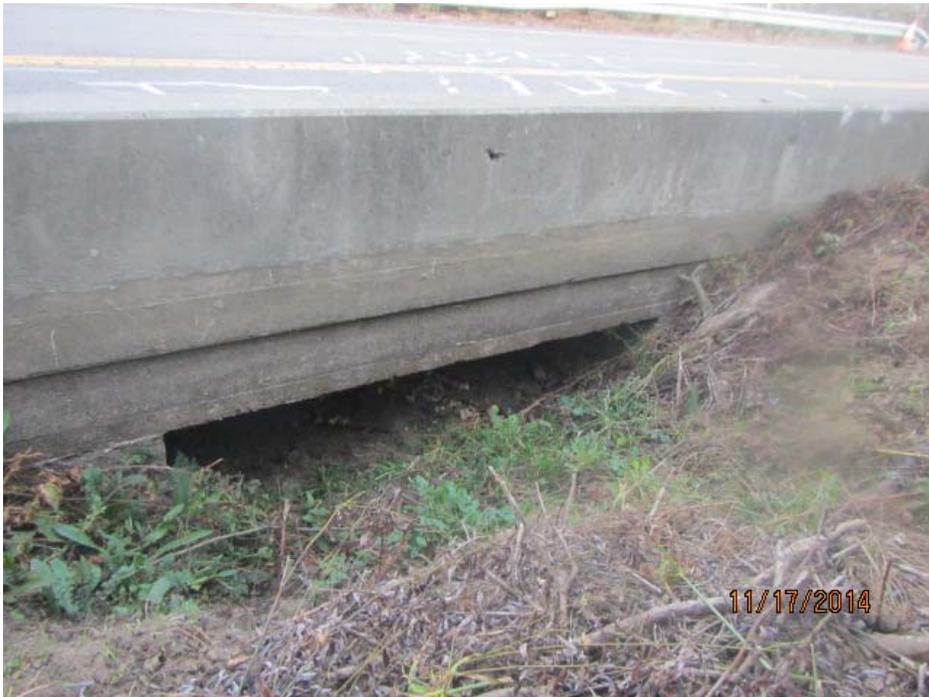
MRN 1 27.92 – Although this site ranked as “green”, unimpeded fish passage is not provided due to the concrete box culvert outlet being nearly full with sediment (**Figure 11**). Sediment excavation is recommended prior to re-surveying the site. In addition, the channel enters the culvert at a 90 degree angle.

Figure 11. Sediment accumulation in culvert at MRN 1 27.92. Downstream looking upstream. November 2014.

As previously described, this site was initially identified as “green” according to the CDFW Passage Evaluation Filter, but this determination was ignored due to the culvert being nearly filled with sediment at the downstream end. It is recommended that this site be re-surveyed after the excess sediment is removed from the site. Potential upstream habitat available was estimated at approximately 0.6 miles based on stream gradient (Figure 15).

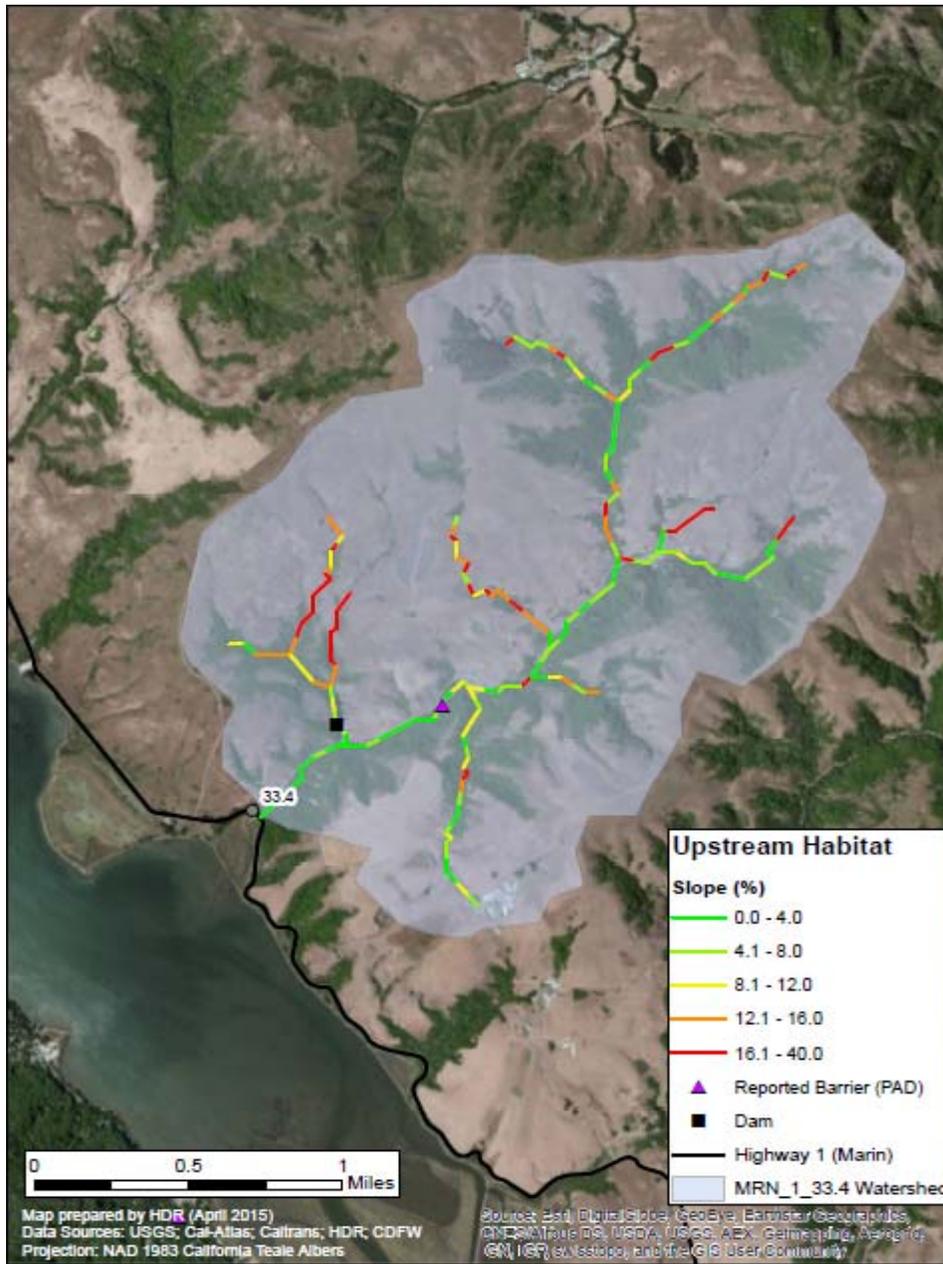
Potential upstream habitat available in Millerton Gulch and its tributaries was estimated to be approximately 1.4 miles, based on the 12% gradient criterion (**Figure 14**). Potential upstream habitat was reduced in part due to a dam and reservoir present near the mouth of one of the stream's tributaries. According to the PAD, a waterfall acts as a barrier on the mainstem of Millerton Gulch. It could not be determined if this barrier is still present based on aerial imagery, and therefore, was not assumed to limit upstream habitat availability.

Figure 14. Stream gradient and fish passage barriers upstream of MRN 1 33.4 (Millerton Gulch).

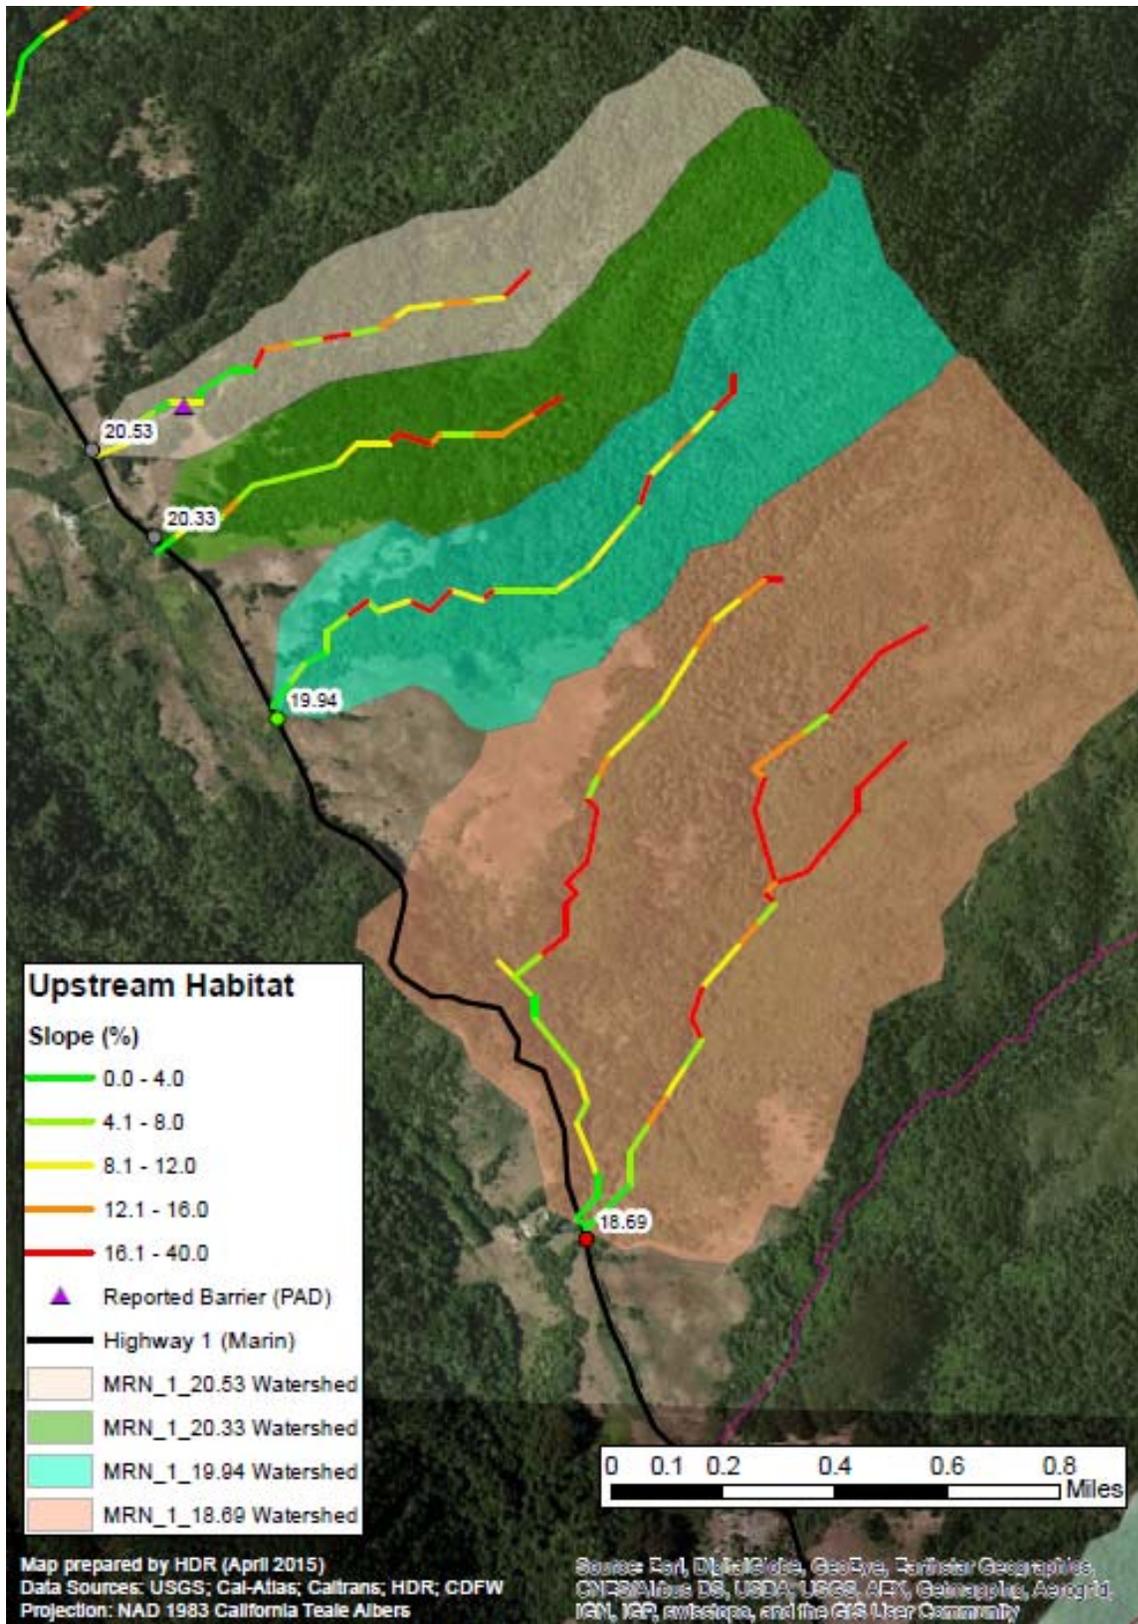
This crossing was identified as “gray” by the CDFW Passage Evaluation Filter. Estimated potential habitat upstream of the crossing approximately was 0.2 miles prior to reaching South Hagamier Dam, reported as a total fish passage barrier by the PAD (Figure 19).

Figure 19. Stream gradient upstream of MRN 1 20.53, 20.33, 19.94 and 18.69.

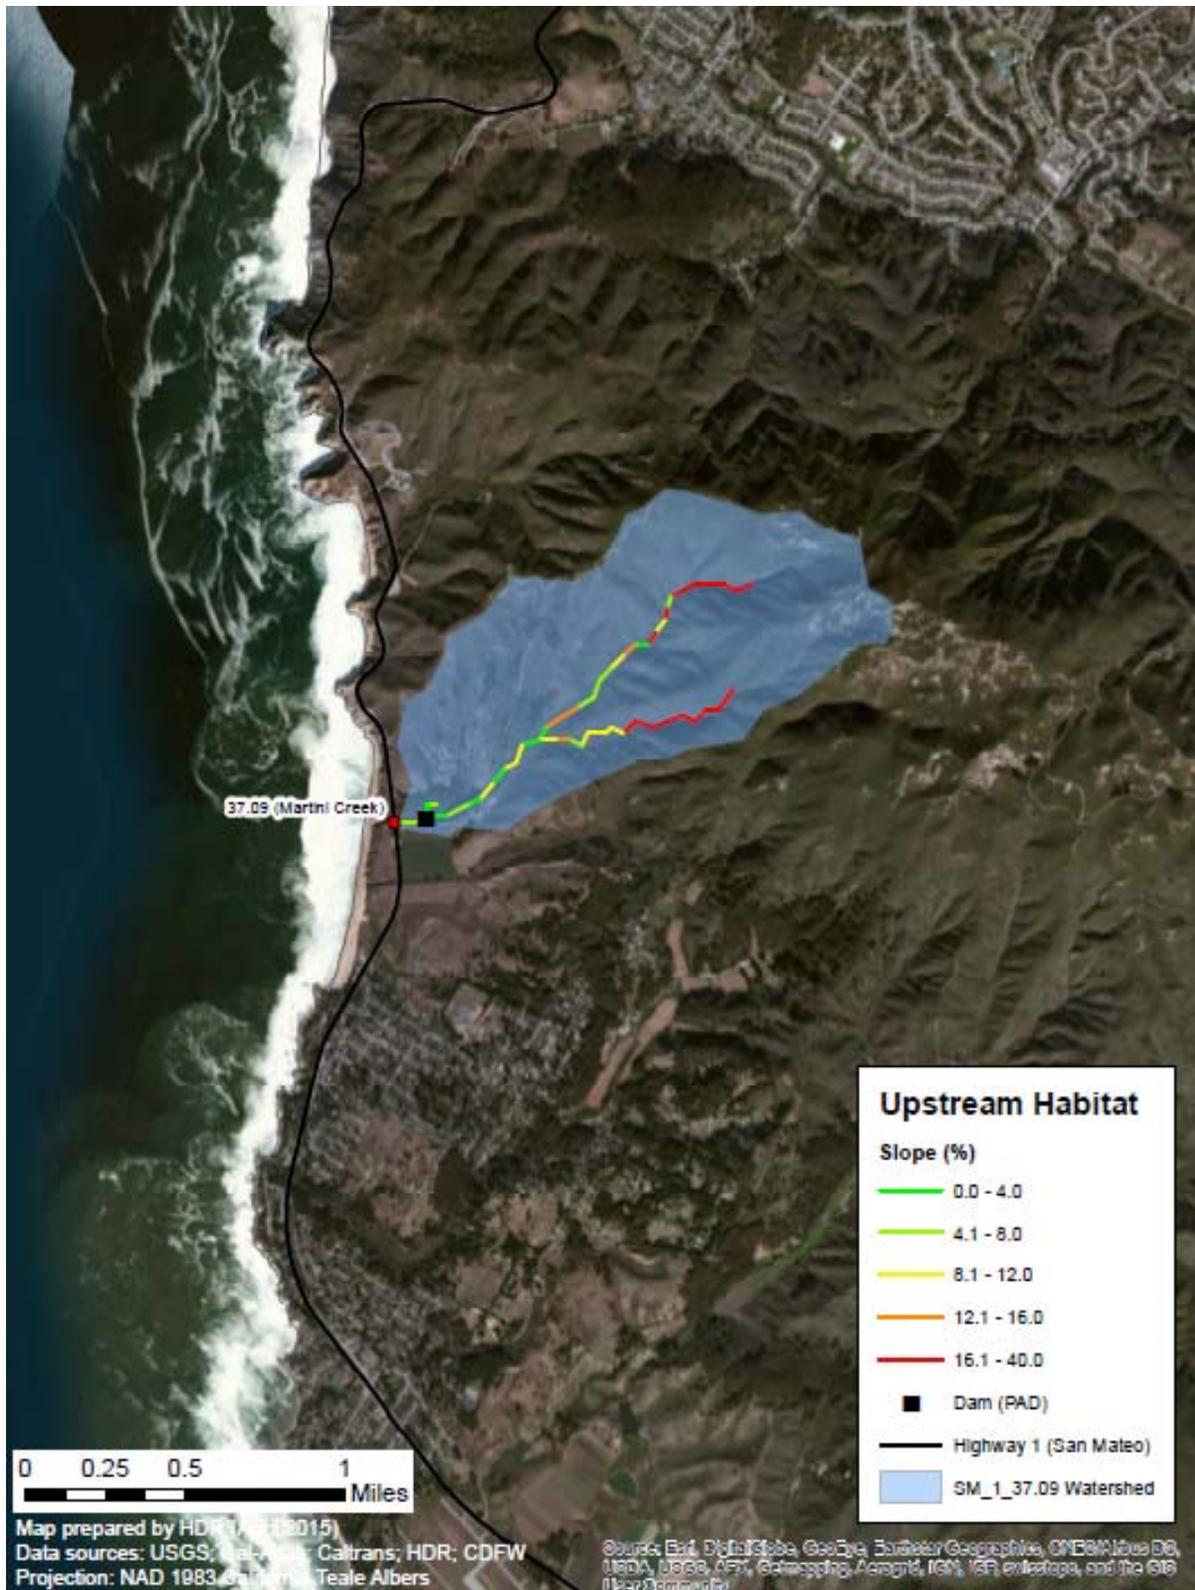
This site was identified as “red” by the CDFW Passage Evaluation Filter. In a 1976 memo regarding Martini Creek, CDFG staff noted that the creek is in a 100 foot long culvert under Highway 1 (CEMAR 2008). The culvert was suspected to be a barrier to upstream passage of steelhead (DFG 1976a, as cited in CEMAR 2008).

The estimated potential habitat upstream of the crossing was approximately 0.7 miles before the stream gradient increased above 12% over more than 100 m in stream length (**Figure 23**). CEMAR (2008) reported that an undated CDFW creek inventory states, “The Highway 1 culvert, which has a four foot drop at both ends, represents an impassable barrier to any migratory fish. Additionally, an instream impoundment blocks the flow approximately 100 yards upstream from highway 1” (DFG ca 1994, as cited in CEMAR 2008). This dam is identified in the PAD and appears to be approximately 0.1 miles upstream from the highway 1 crossing, but its presence could not be confirmed with aerial imagery.

Figure 23. Stream gradient and potential barrier upstream of SM 1 37.09 (Martini Creek).

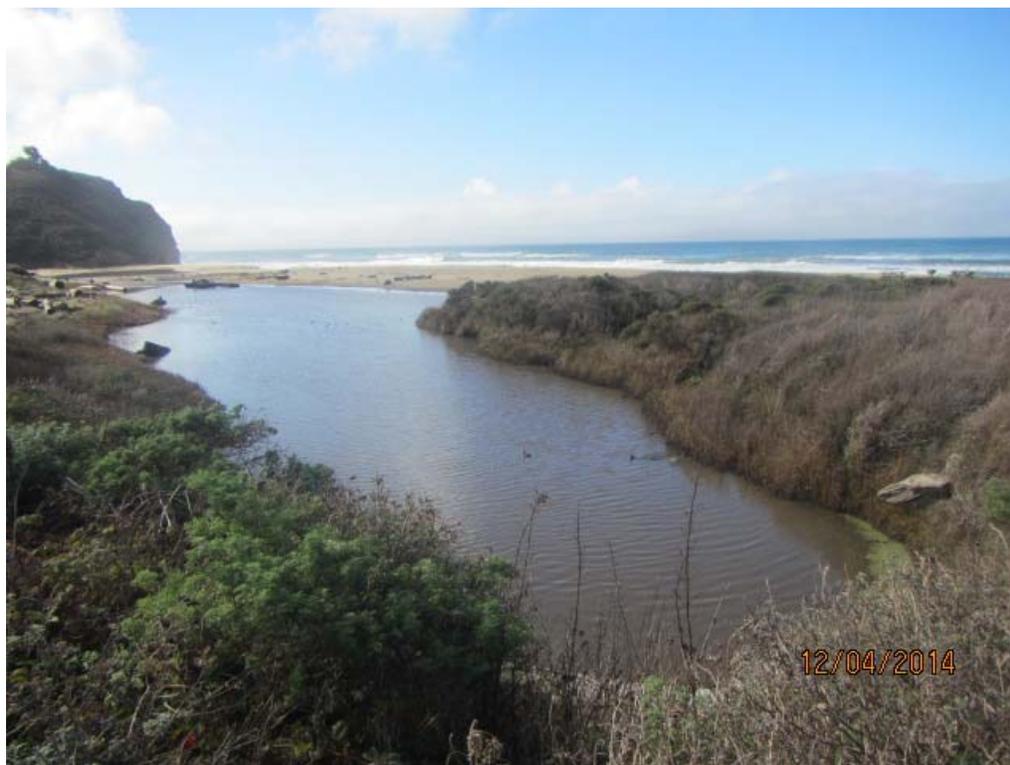
This site was identified as “red” by the CDFW Passage Evaluation Filter. However, as previously discussed, this determination is not necessarily appropriate due to tidal hydrodynamics and the filling of the lagoon just downstream of this crossing (**Figure 24**). Additional surveying of the site, including the lagoon downstream of the crossing, and taking additional measurements not required by the Caltrans survey protocols (e.g. water depth through the crossing at different outflows and tidal conditions) during the steelhead upstream migration season and when sufficient flow is present to allow access to the site by adult salmonids, is suggested prior to conducting hydraulic modeling and making a fish passage determination at this site.

Figure 24. Lagoon immediately downstream of SM 1 16.49 crossing. December 2014.

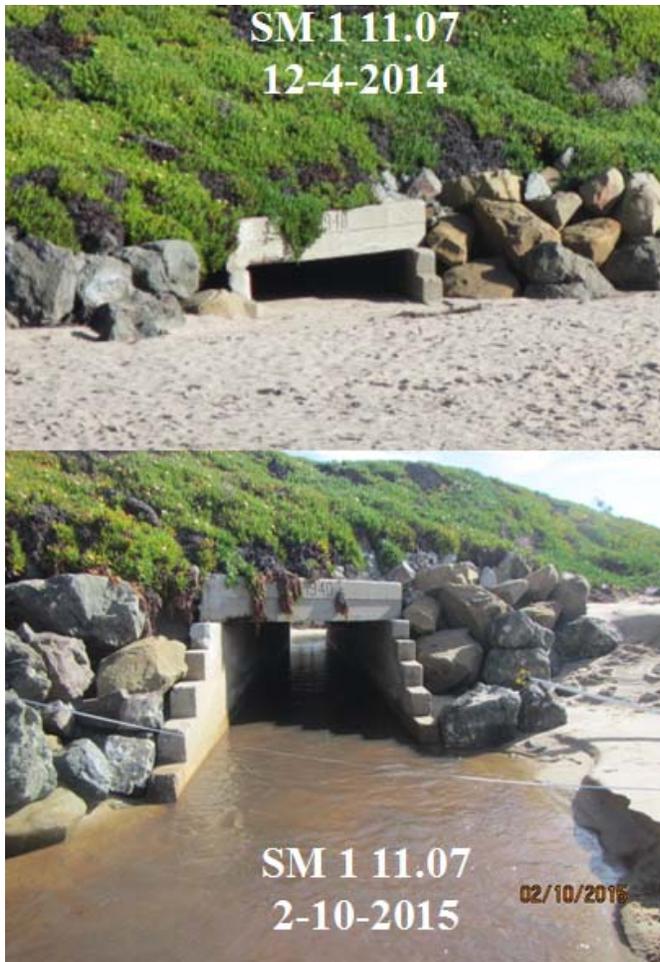
SM 1 11.07 – While this site ranked as “gray” due to insufficient inlet width and insufficient residual outlet depth, due to the highly variable sediment dynamics at the crossing, the residual outlet depth is highly variable depending on freshwater outflow and potentially tidal conditions. Although there is currently no spawning habitat upstream of the crossing (further described below), if an adult fish passage

This site was identified as “gray” by the CDFW Passage Evaluation Filter. However, as previously discussed, this determination was due to insufficient inlet width and insufficient residual outlet depth. As shown in **Figure 26**, due to the highly variable sediment dynamics at the crossing, the residual outlet depth is highly variable depending on freshwater outflow and potentially tidal conditions. Therefore, it is recommended that this site be surveyed during the upstream migration season and when hydrologic conditions allow for adult salmonid access to the site, and take additional measurements not required by the Caltrans survey protocols (e.g. water depth through the crossing at different outflows and tidal conditions), prior to conducting hydraulic modeling for the site and making a fish passage determination.

Figure 26. Comparison of highly variable sediment conditions at SM 1 11.07.
