# 2014–2015 Detailed Fish Passage Assessment Evaluations

District 4 – Marin and San Mateo Counties | Highway 1

April 2015

California Department of Transportation  
Division of Environmental Analysis  
Office of Biology and Technical Assistance  
Sacramento, CA USA

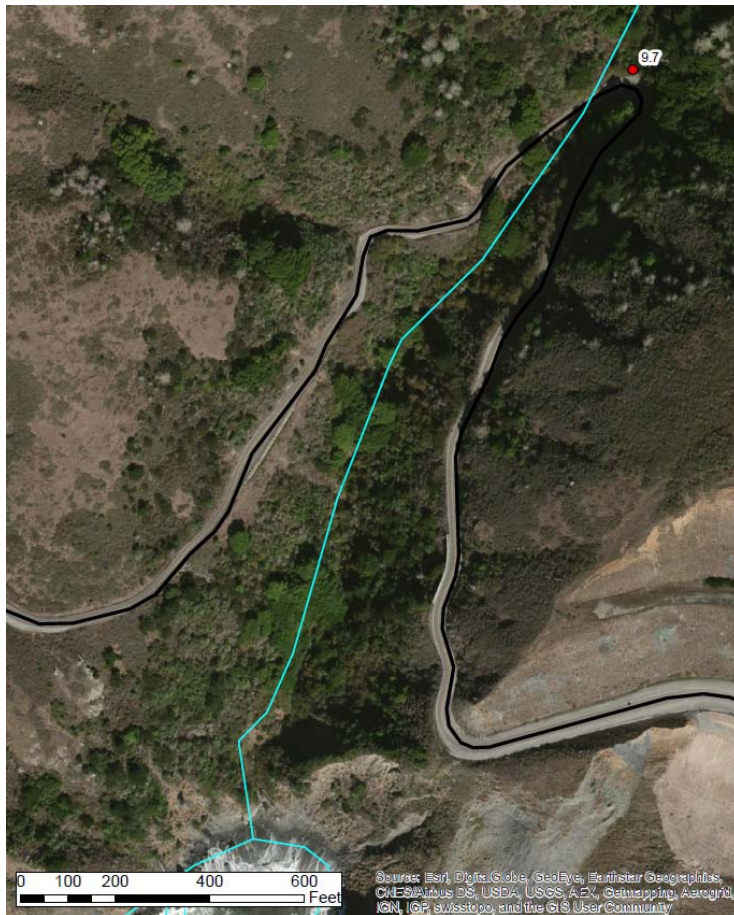
Examination of aerial imagery downstream of the MRN 1 9.70 crossing to the Pacific Ocean (see **Figure 3**) indicated a very steep natural gradient. GIS analysis estimated gradient of up to 25-30% downstream of the crossing, indicating that this drainage did not historically support anadromous salmonids. A literature review also did not indicate historical use of this watershed by anadromous fish. Therefore, this site was not carried forward for further fish passage evaluation.

**Figure 3. Aerial view of MRN 1 9.70 downstream to the Pacific Ocean.**

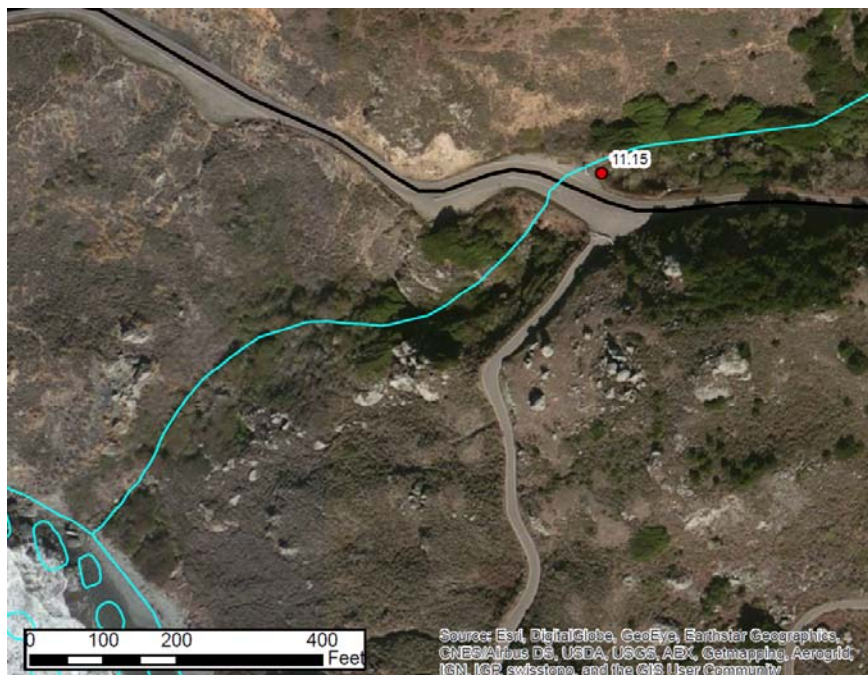
Examination of aerial imagery downstream of the MRN 1 11.15 (Webb Creek) crossing to the Pacific Ocean (see **Figure 4**) indicated a very steep natural gradient. GIS analysis estimated gradient of up to 25-30% downstream of the crossing, indicating that this drainage did not historically support anadromous salmonids. A literature review also did not indicate historical use of this watershed by anadromous fish. Therefore, this site was not carried forward for further fish passage evaluation.

**Figure 4. Aerial view of MRN 1 11.15 downstream to the Pacific Ocean.**

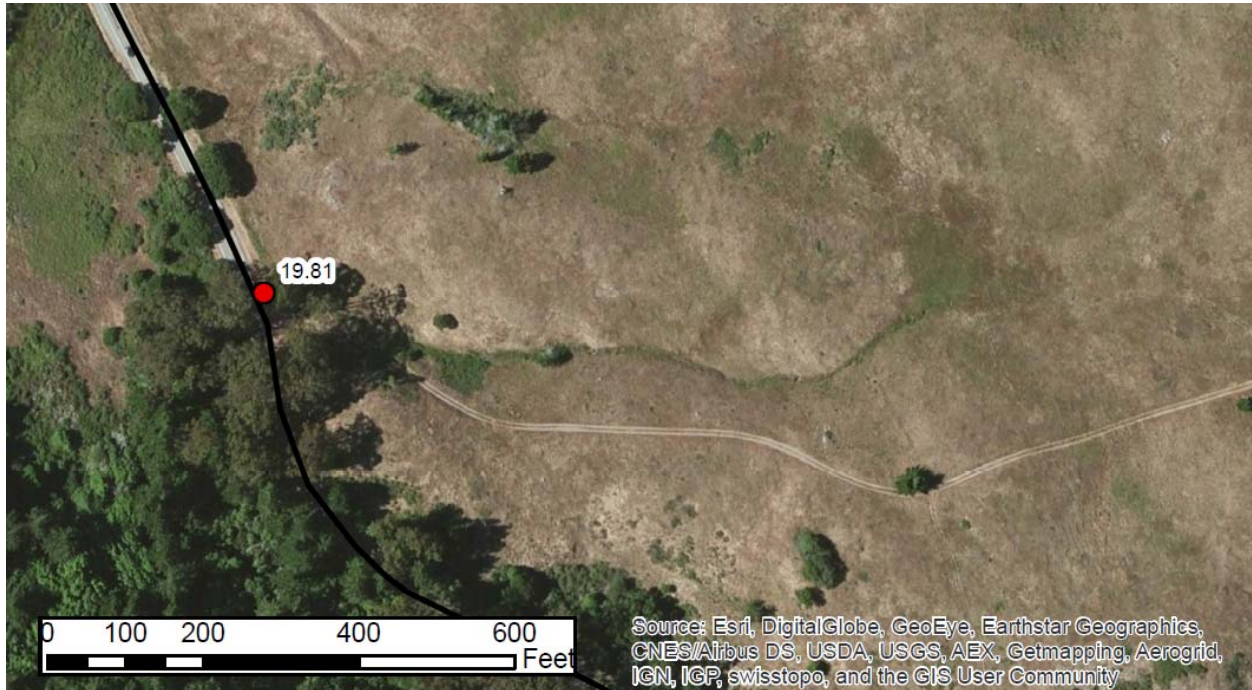
Review of aerial imagery, site photos and hydrologic GIS analysis indicates that very little flow generally passes through this crossing, and the site lacks suitable fisheries habitat. Therefore, this site was not further evaluated for fish passage. An aerial view of the crossing and its upstream drainage is provided in **Figure 7**.

**Figure 7. Aerial view of MRN 1 19.81 and its upstream drainage.**

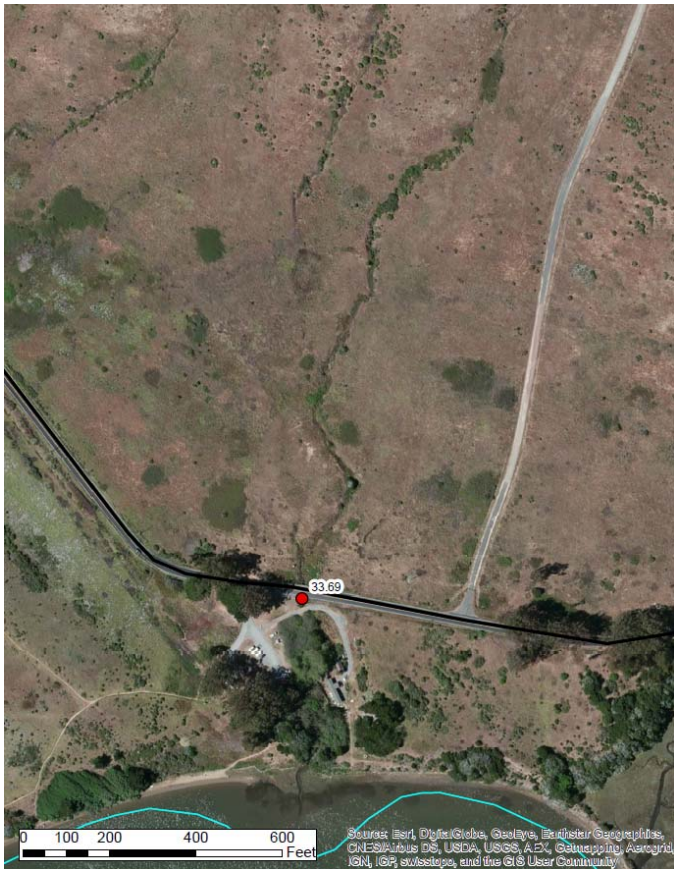
Review of aerial imagery, site photos and hydrologic GIS analysis indicates that very little flow generally passes through this crossing, and the site lacks suitable fisheries habitat. Therefore, this site was not further evaluated for fish passage. An aerial view of the crossing and its upstream drainage is provided in **Figure 9**.

**Figure 9. Aerial view of MRN 1 33.69 and its upstream drainage.**

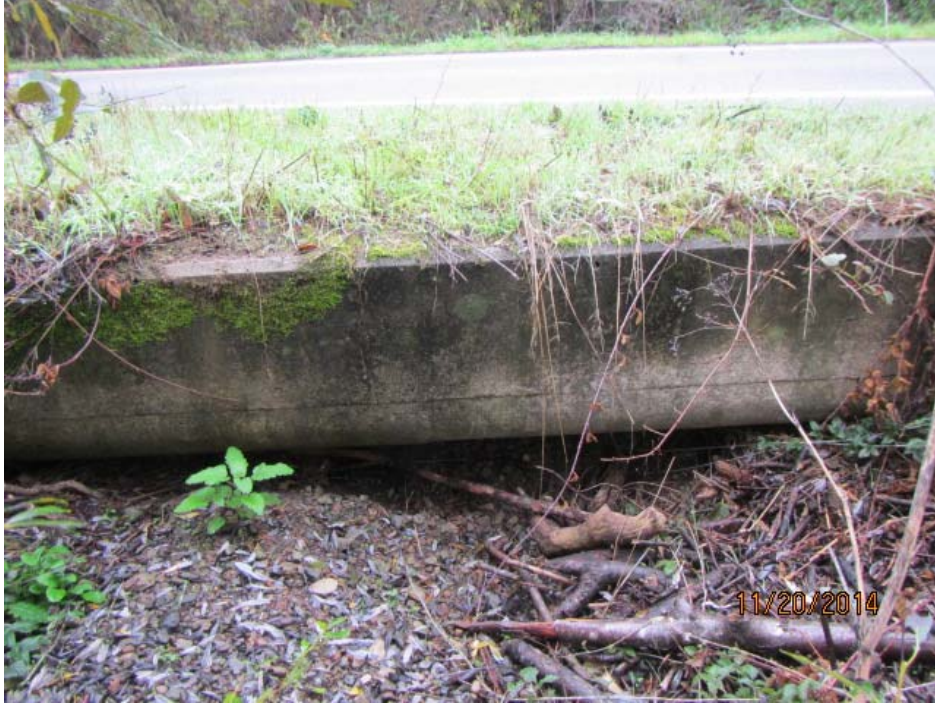
**MRN 1 14.86** – Although this site ranked as “green”, unimpeded fish passage is not provided due to the concrete box culvert being nearly full with sediment (**Figure 10**). Sediment excavation is recommended prior to re-surveying the site and making a fish passage determination.

**Figure 10. Sediment accumulation in culvert at MRN 1 14.86. Upstream looking downstream. November 2014.**

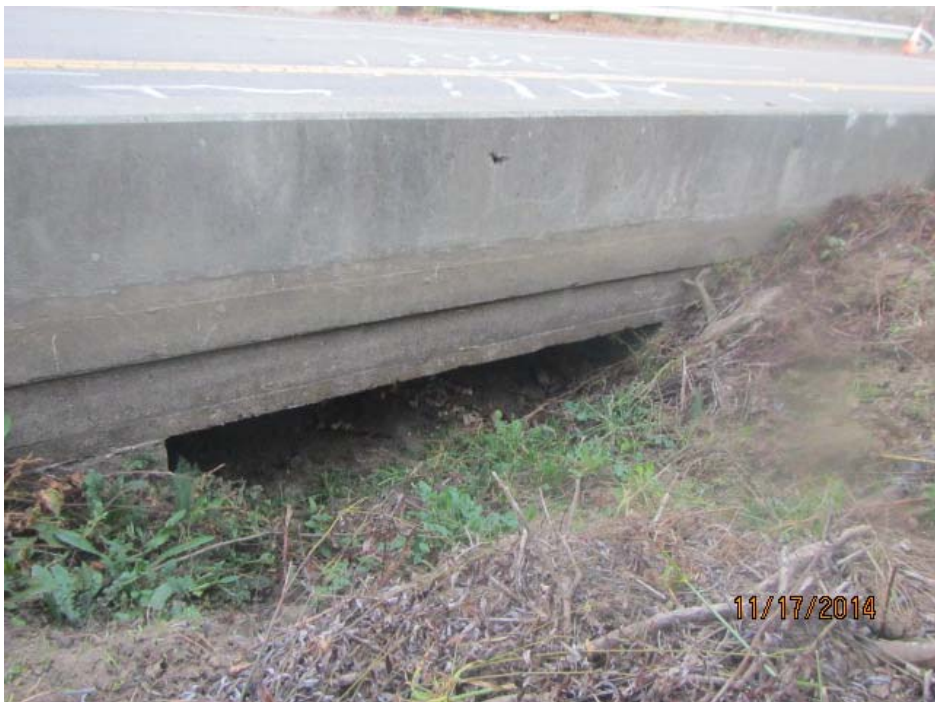
**MRN 1 27.92** – Although this site ranked as “green”, unimpeded fish passage is not provided due to the concrete box culvert outlet being nearly full with sediment (**Figure 11**). Sediment excavation is recommended prior to re-surveying the site. In addition, the channel enters the culvert at a 90 degree angle.

**Figure 11. Sediment accumulation in culvert at MRN 1 27.92. Downstream looking upstream. November 2014.**

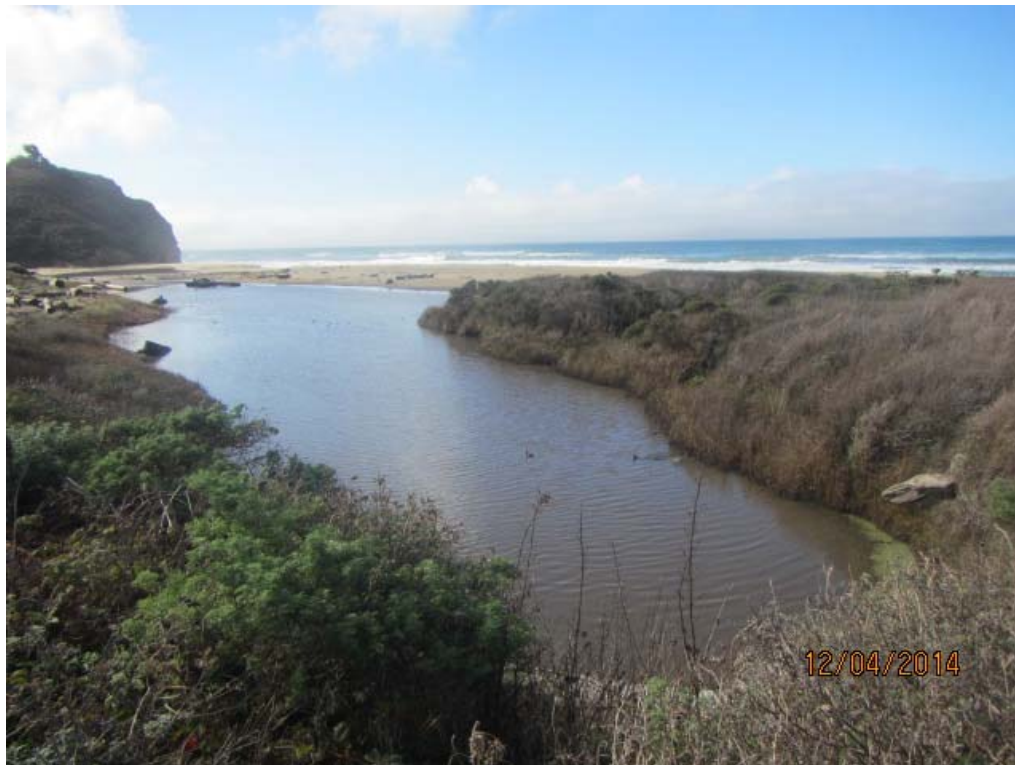
This site was identified as “red” by the CDFW Passage Evaluation Filter. However, as previously discussed, this determination is not necessarily appropriate due to tidal hydrodynamics and the filling of the lagoon just downstream of this crossing (**Figure 24**). Additional surveying of the site, including the lagoon downstream of the crossing, and taking additional measurements not required by the Caltrans survey protocols (e.g. water depth through the crossing at different outflows and tidal conditions) during the steelhead upstream migration season and when sufficient flow is present to allow access to the site by adult salmonids, is suggested prior to conducting hydraulic modeling and making a fish passage determination at this site.

**Figure 24. Lagoon immediately downstream of SM 1 16.49 crossing. December 2014.**

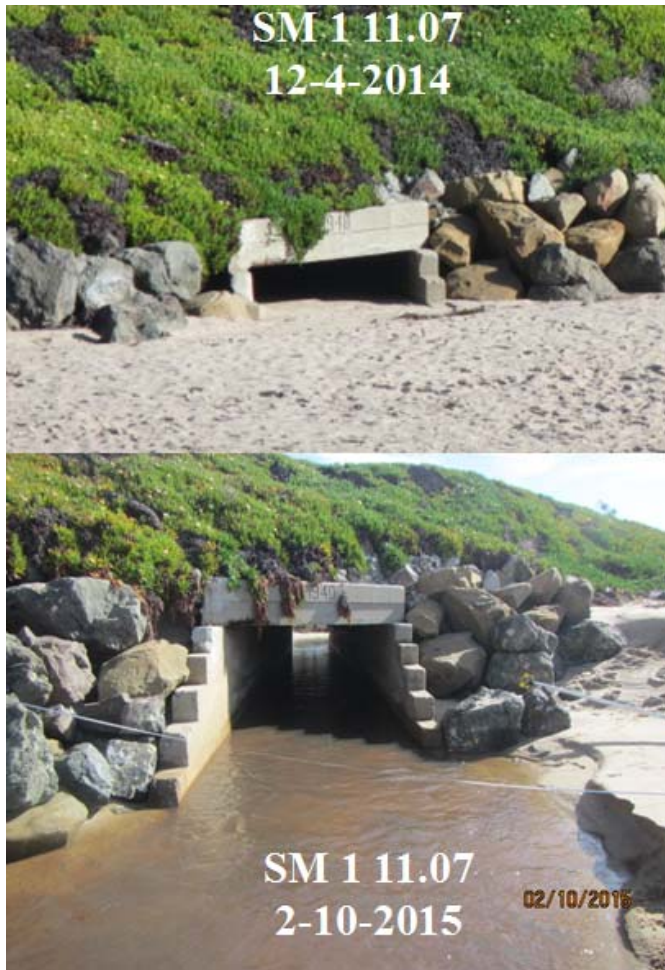
This site was identified as “gray” by the CDFW Passage Evaluation Filter. However, as previously discussed, this determination was due to insufficient inlet width and insufficient residual outlet depth. As shown in **Figure 26**, due to the highly variable sediment dynamics at the crossing, the residual outlet depth is highly variable depending on freshwater outflow and potentially tidal conditions. Therefore, it is recommended that this site be surveyed during the upstream migration season and when hydrologic conditions allow for adult salmonid access to the site, and take additional measurements not required by the Caltrans survey protocols (e.g. water depth through the crossing at different outflows and tidal conditions), prior to conducting hydraulic modeling for the site and making a fish passage determination.

**Figure 26. Comparison of highly variable sediment conditions at SM 1 11.07.**

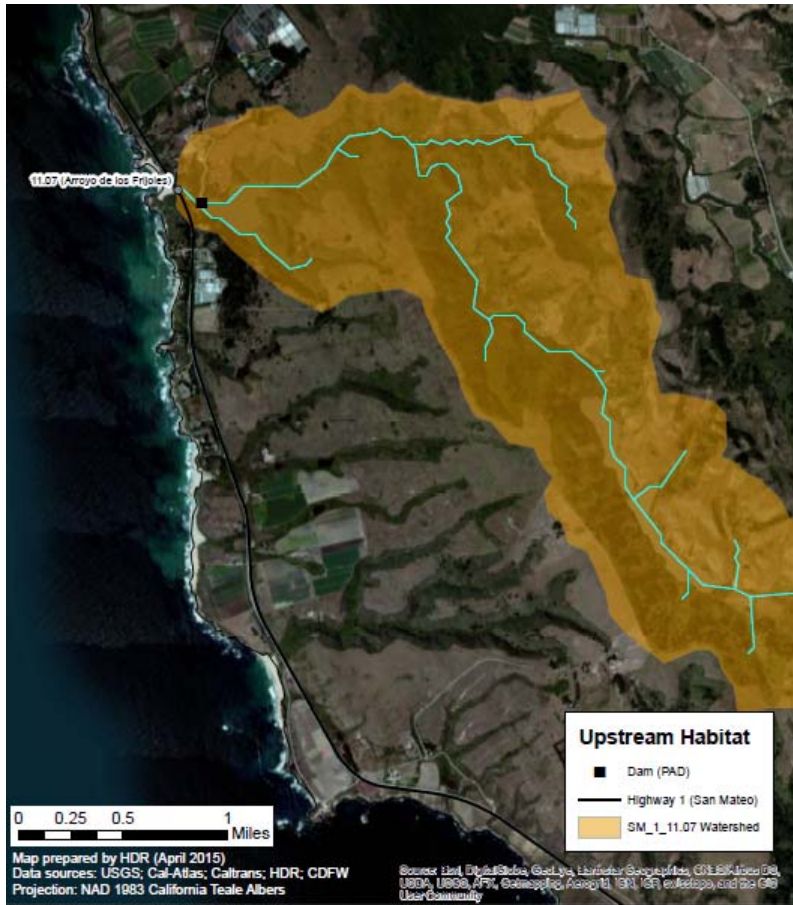
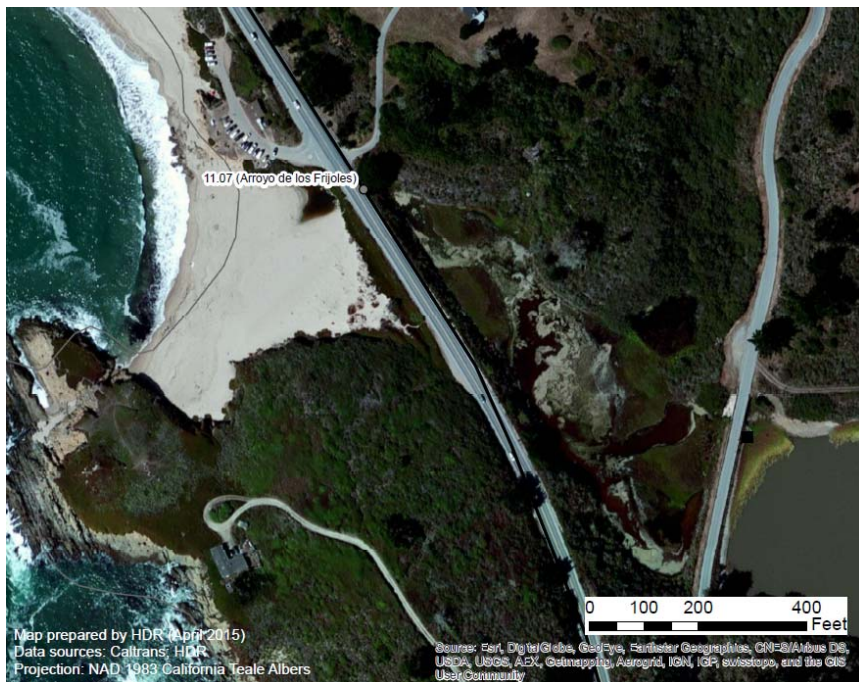
An impassable dam forming Lake Lucerne is located on Arroyo de los Frijoles about 0.2 miles upstream from the mouth (CEMAR 2008; **Figures 27 and 28**). Therefore, a stream gradient analysis was not performed on the watershed upstream of this crossing. Because no spawning habitat is available to anadromous fish on this creek, it is unclear if any substantive benefits to anadromous fish would be realized if this crossing was remediated to allow unimpeded fish passage (if needed). However, because no upstream spawning habitat is accessible, there are unlikely to be steelhead rearing in the lagoon upstream of the highway 1 crossing. Although it may be conceivable that non-natal juvenile steelhead may enter the lagoon from a nearby lagoon during the spring, no thermal refugia would be accessible to juvenile steelhead upstream of the lagoon as water temperatures warm during the summer. Therefore, it is not expected that the lagoon upstream of the highway 1 crossing currently represents suitable steelhead habitat.

**Figure 27. Watershed upstream of SM 1 11.07 (Arroyo de los Frijoles).**

**Figure 28. Lagoon and Lake Lucerne upstream of SM 1 11.07 (Arroyo de los Frijoles).**
