2017 Reconnaissance and Detailed Fish Passage Assessment Evaluations

Highway 101 – Santa Barbara County

Highway 192 – Santa Barbara County

July 2017

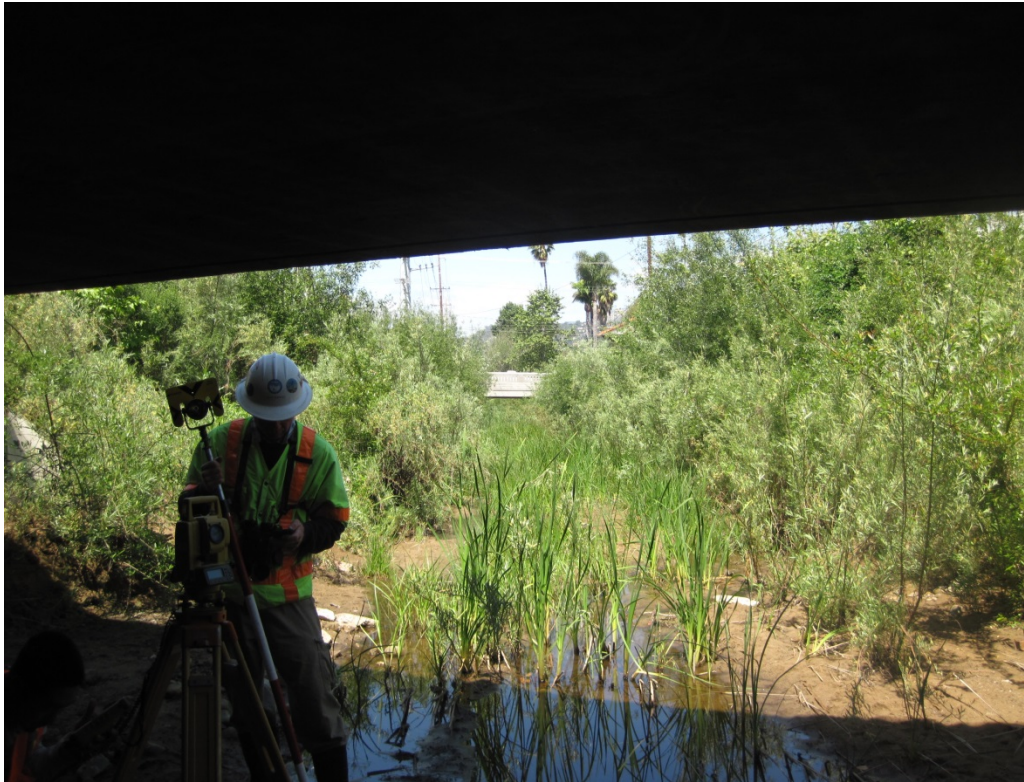
SB 101 12.34 – This site ranked as “green” because the inlet to the crossing was greater in width than the active channel and the active channel substrate was natural streambed (**Photo 1**).

Photo 1. Route 101 (PM 12.34), looking upstream from crossing along Sycamore Creek.

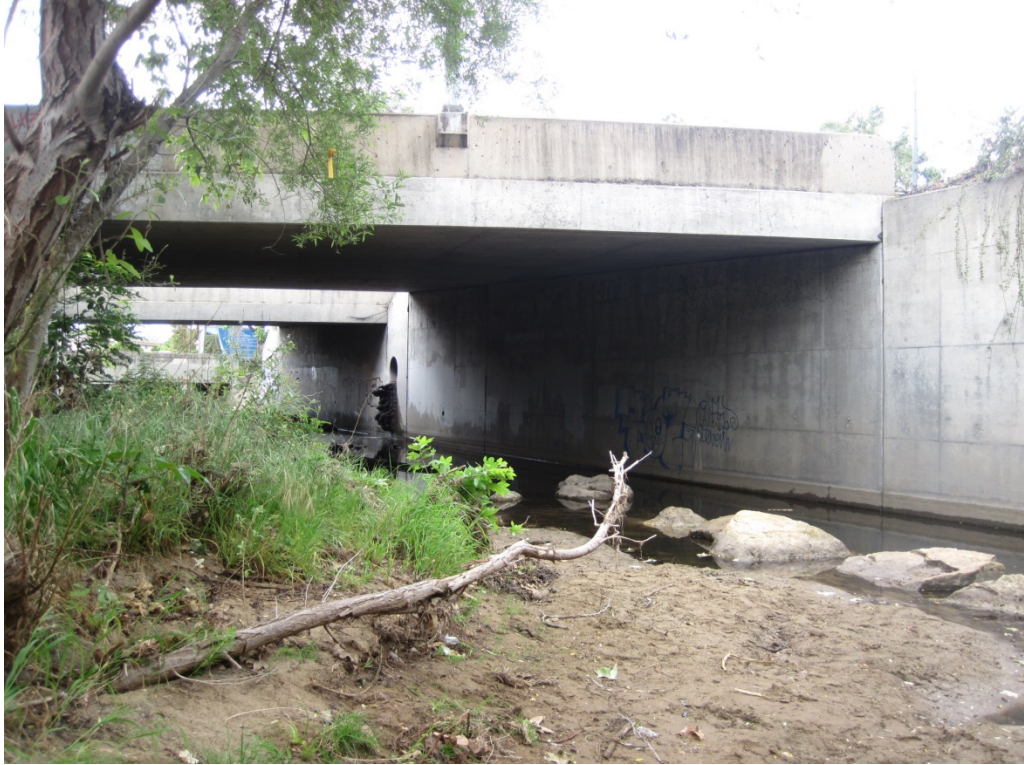
SB 101 13.96 - This site ranked as “green” because the inlet to the crossing was greater in width than the active channel and the active channel substrate was natural streambed; there was an additional crossing downstream of the survey site which was constricting the active channel width (**Photo 2**).

Photo 2. Route 101 (PM 13.96), looking upstream along Mission Creek.

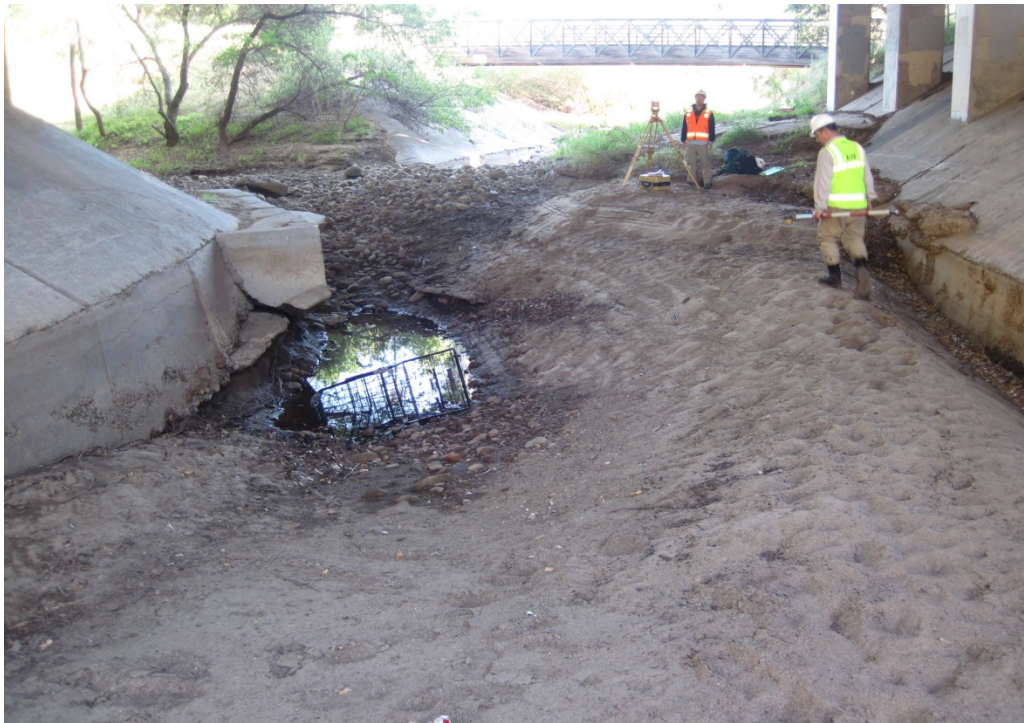
SB 101 20.95 – This site ranked as “green” because the inlet to the crossing was greater in width than the active channel, however, the crossing is directly downstream of the Maria Ygnacio Creek and San Antonio Creek confluence and there may be some potential constriction of the natural width of the confluence (**Photo 3**). However, the crossing does not appear to be limiting fish passage conditions. Downstream of the crossing there is an abrupt drop in elevation of approximately 7 feet which is unrelated to the crossing (**Photo 4**).

Photo 3. Route 101 (PM 20.95), looking upstream at the confluence of Maria Ygnacio Creek and San Antonio Creek.

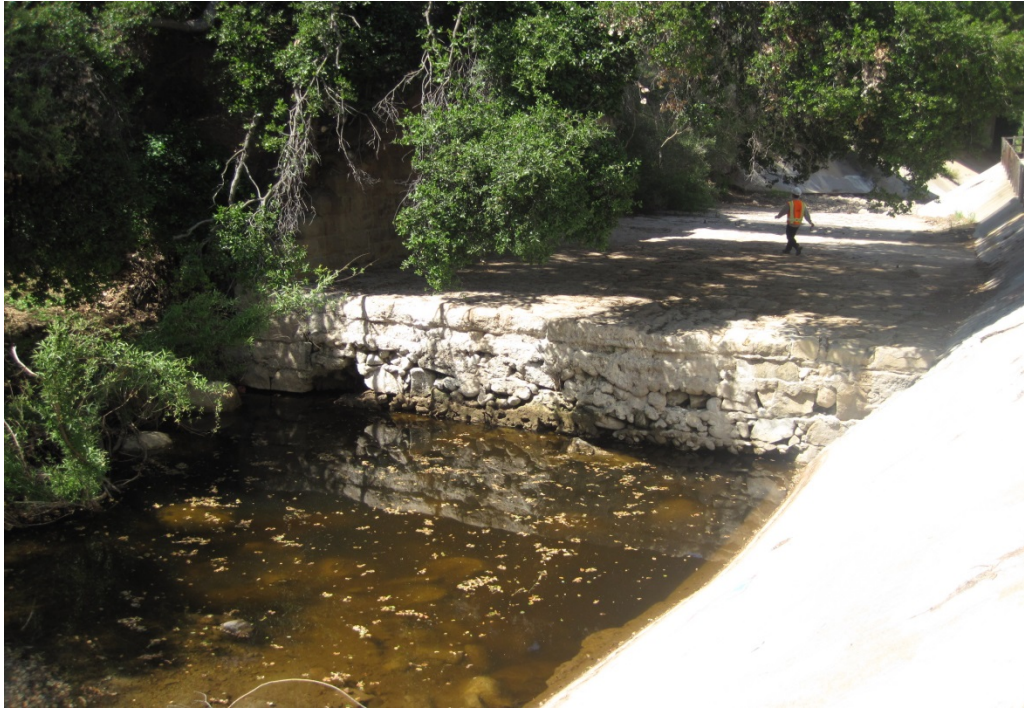
Photo 4. Route 101 (PM 20.95), looking upstream at abrupt channel elevation drop approximately 250 ft. downstream of surveyed crossing.

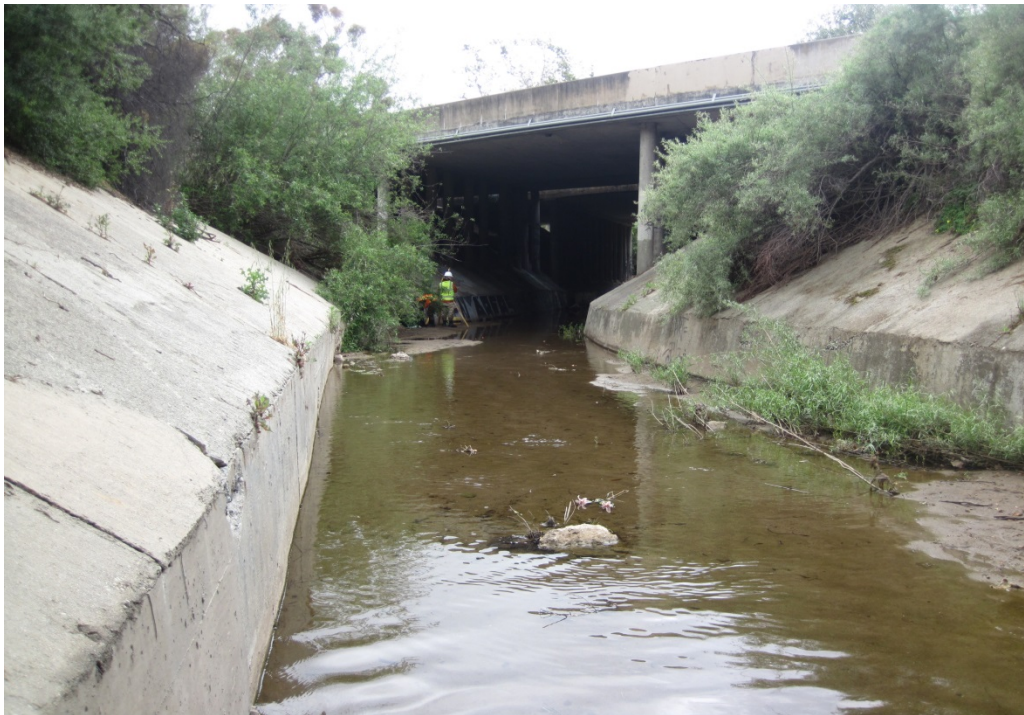
SB 101 21.63 – This site ranked as “green” because the active channel is equal in width to the inlet width of the crossing. Concrete flood control walls channelize the stream throughout the reach, both upstream and downstream of the crossing survey site (**Photo 5**).

Photo 5. Route 101 (PM 21.63), San Jose Creek, looking upstream at concrete walls throughout survey site.

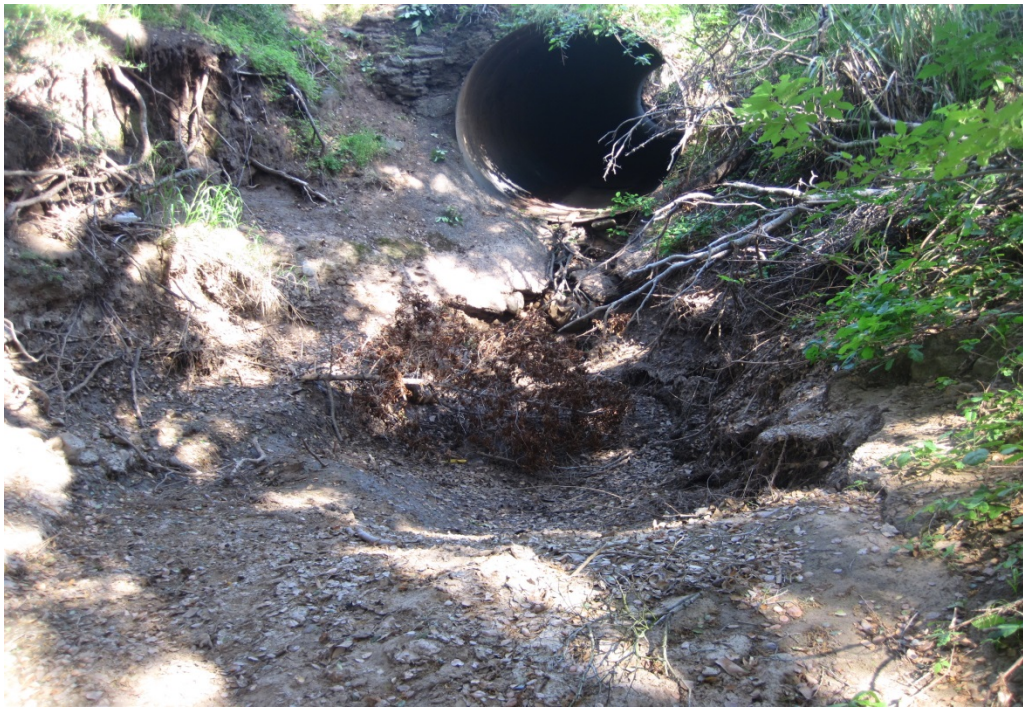
SB 192 0.37 – This site ranked as “red” because the active channel width was greater than the culvert width and the downstream hydraulic drop was greater than two feet (**Photo 6**).

Photo 6. Route 192 (PM 0.37), Cieneguitas Creek, looking upstream at outlet drop.

The one site identified as “red” (PM 0.37 on highway 192) by the CDFW Passage Evaluation Filter was further evaluated in terms of the potential quantity of habitat that could be recovered upstream of a crossing if the crossing was remediated to allow unimpaired fish passage. Information to conduct this evaluation included site-specific habitat information collected during the Reconnaissance and Detailed surveys, quality and quantity of potential habitat upstream of a crossing based on GIS analyses, a literature review of fisheries habitat surveys, and previously-conducted fish passage assessments.

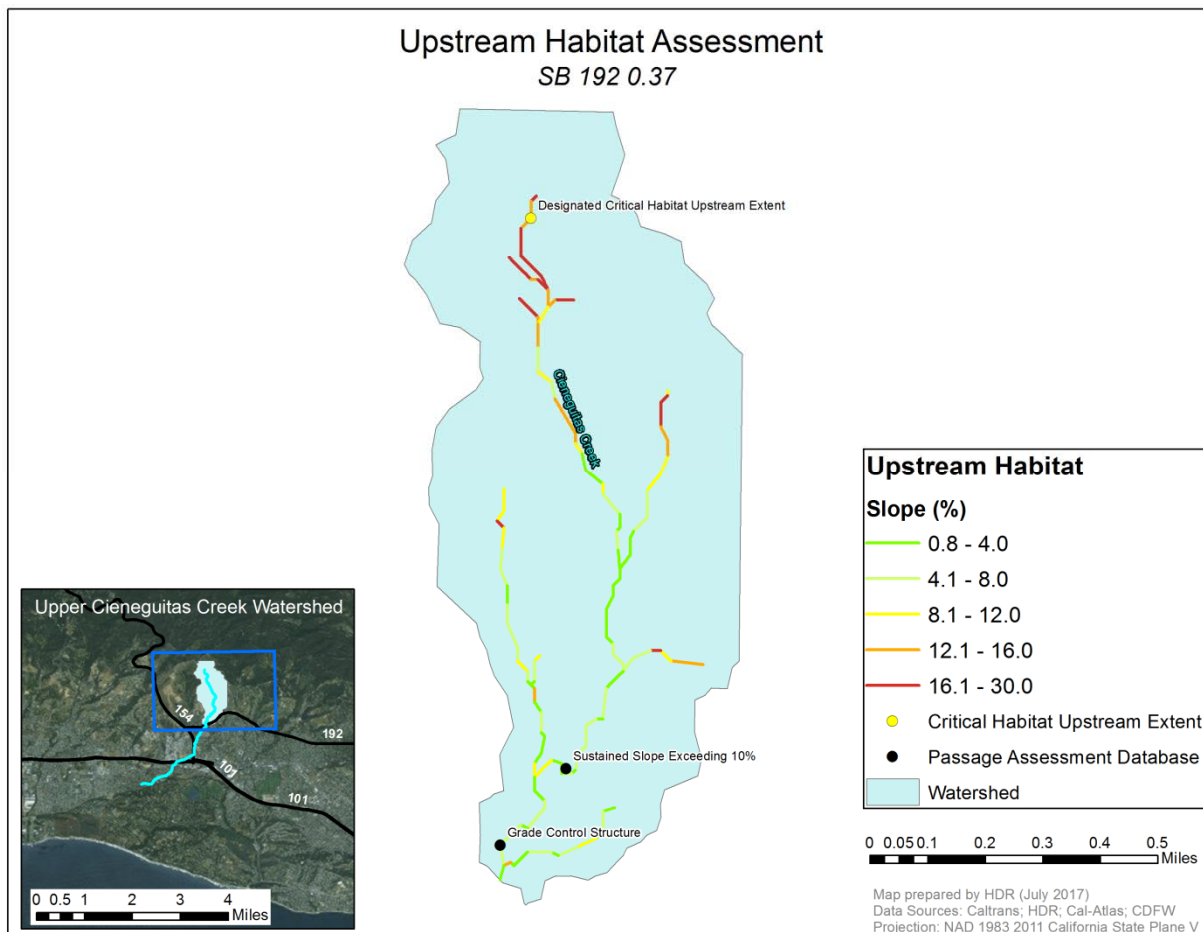
Figure 3. Stream gradient analysis and previously recorded barriers upstream of SB 192 0.37 (Cieneguitas Creek).

GIS gradient analysis suggests that an extended section of creek with an average gradient of greater than 12% is located approximately one mile upstream of the crossing (Figure 3). The upstream extent of critical habitat designated by NMFS for the Southern California Steelhead ESU is located approximately 0.5 mile further upstream and 1.5 miles upstream from the surveyed crossing (70FR52580; Figure 3). The CDFW Passage Assessment Database (PAD) noted two additional upstream locations as potential fish barriers - a gradient control structure located approximately 0.05 miles upstream of the crossing, and

a reach of creek with a gradient slope of 10% or greater located approximately 0.25 miles upstream of the crossing (CDFW 2015; Figure 3).

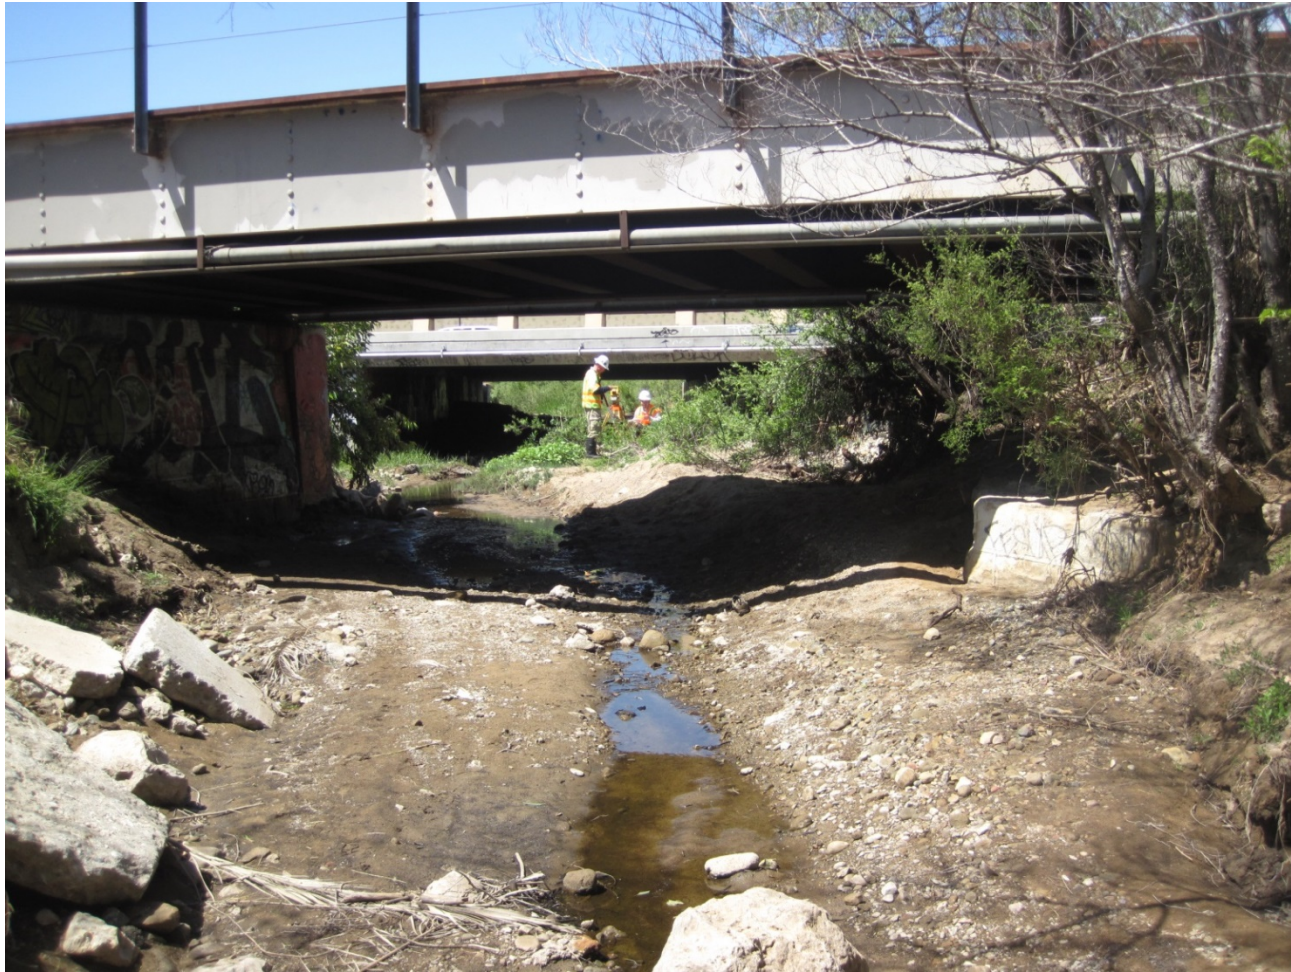
Photo C-1. Downstream looking upstream at Sycamore Creek (Route 101, PM 12.34) no identifiable tailwater control.

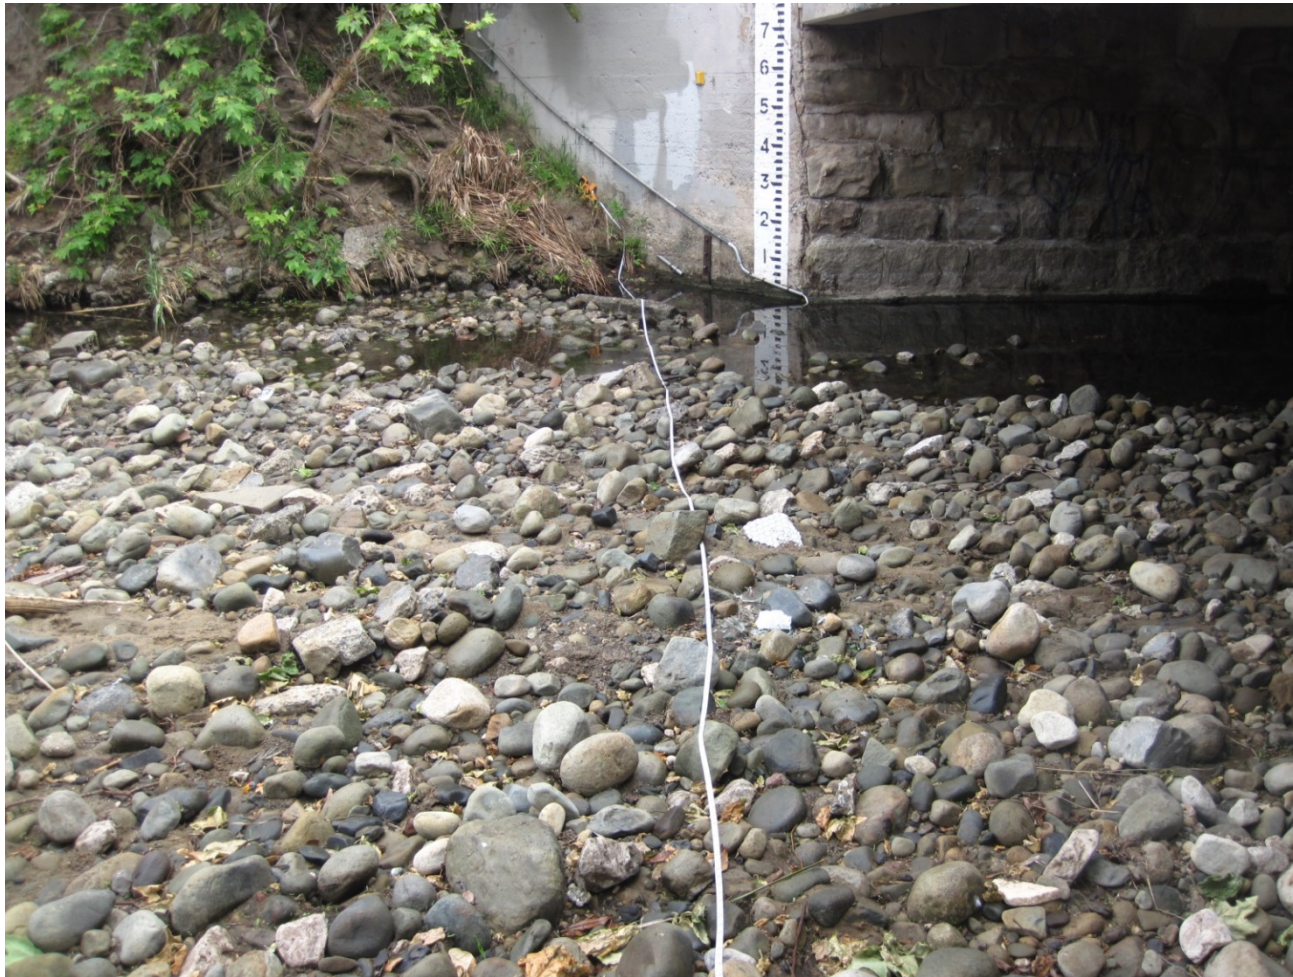
Photo C-2. Mission Creek (Route 101, PM 13.96) tailwater control.

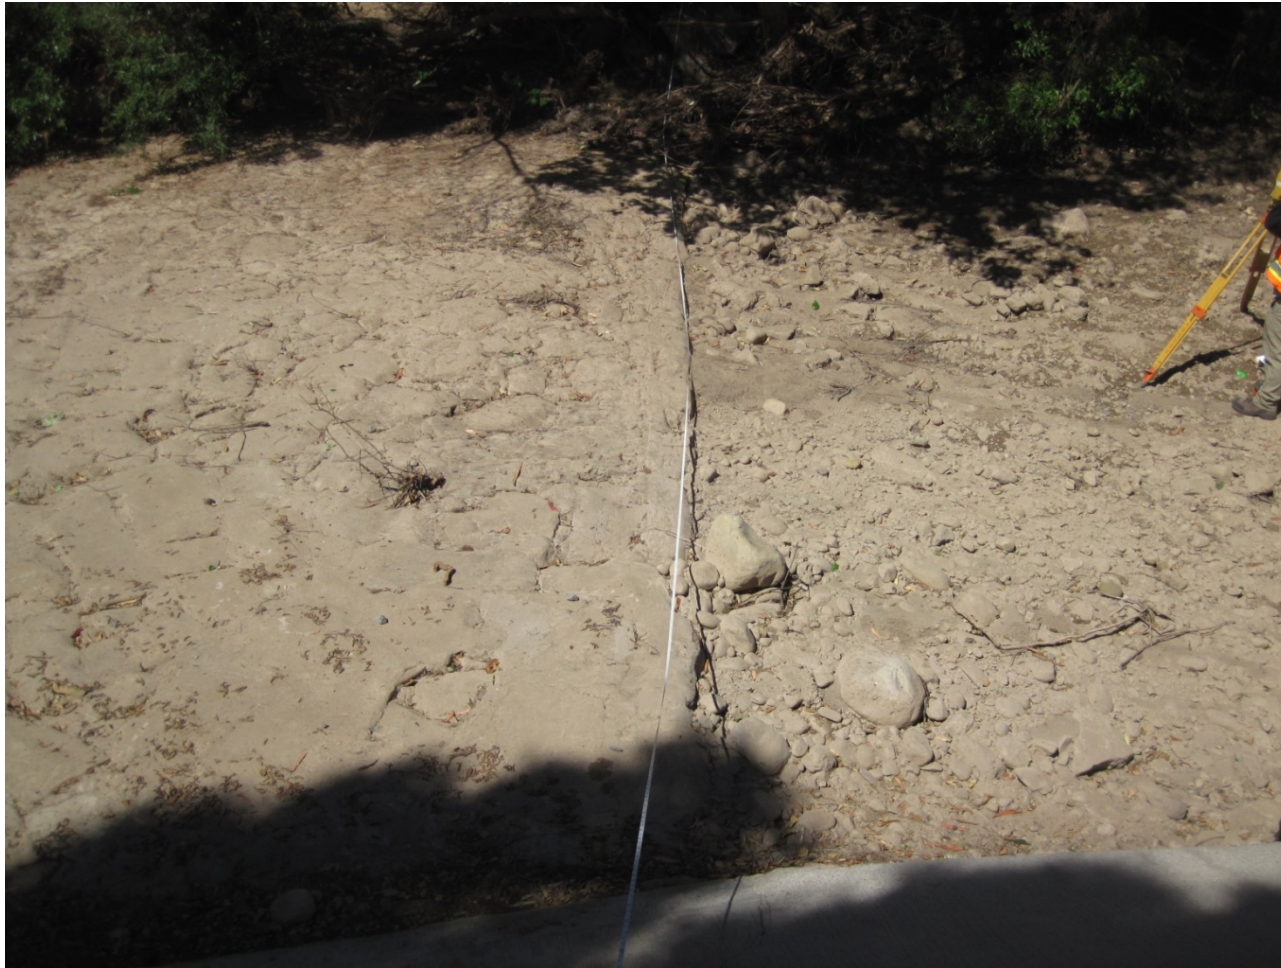
Photo C-3. Maria Ygnacio Creek (Route 101, PM 20.95) no tailwater control point; break in natural streambed channel downstream of crossing.

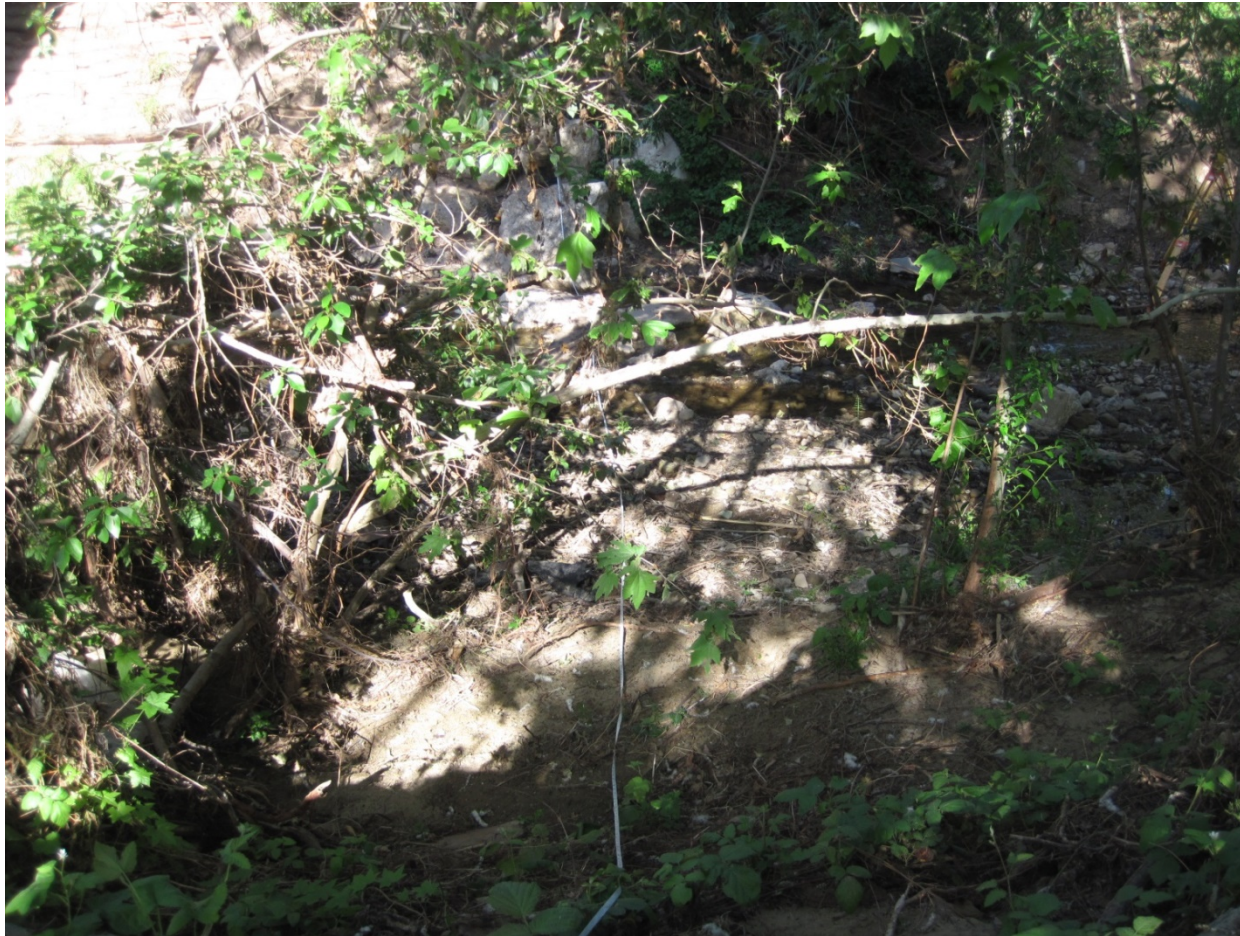
Photo C-4. San Jose Creek (Route 101, PM 21.63) tailwater control point downstream of crossing.

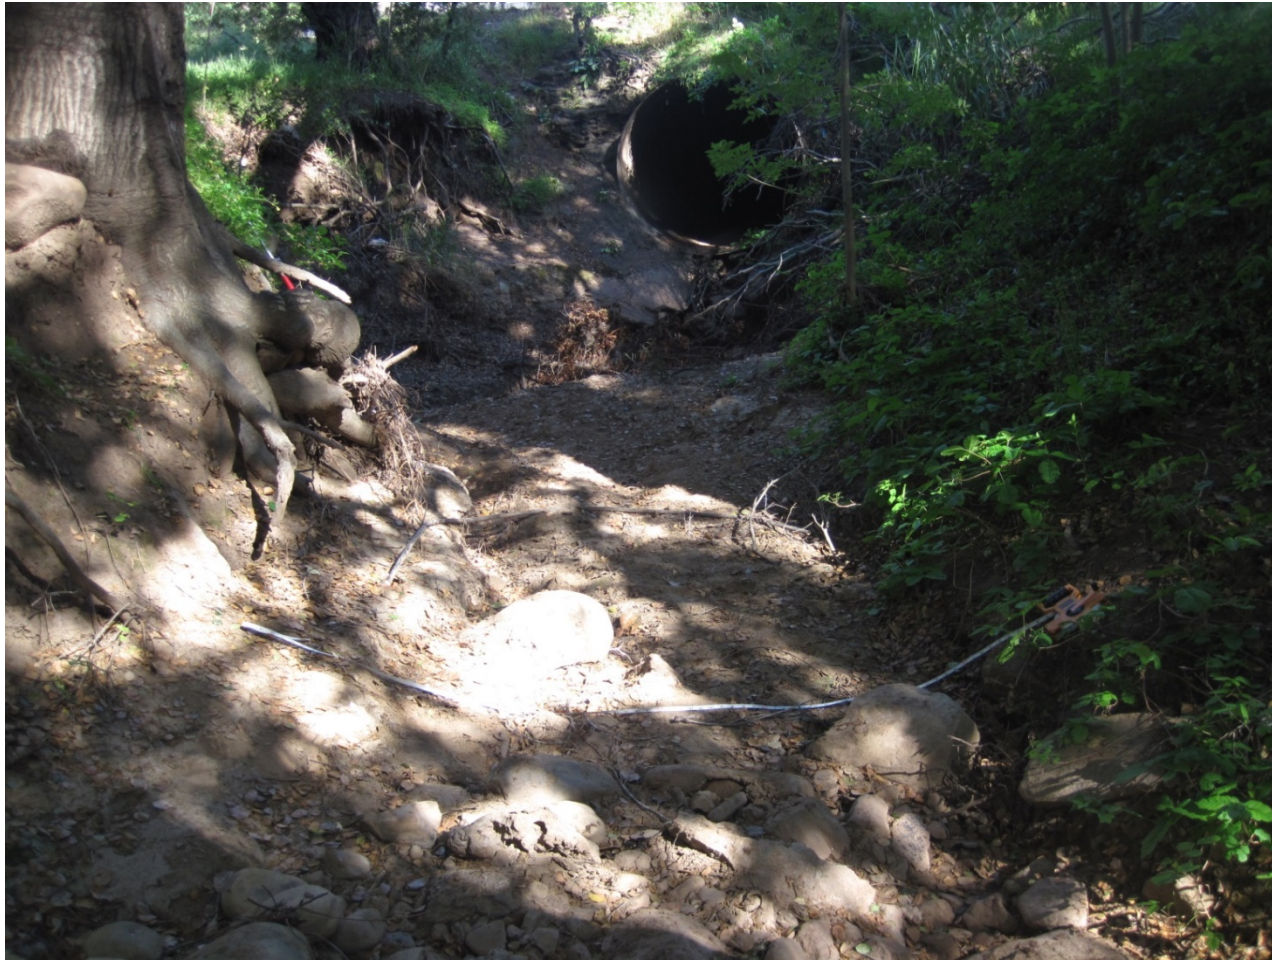
Photo C-5. Cieneguitas Creek (Route 192, PM 0.37) tailwater control point downstream looking upstream.
