Memorandum

Date: 12/19/2018

Subject: Site assessment of Georgetown Creek, El Dorado County.

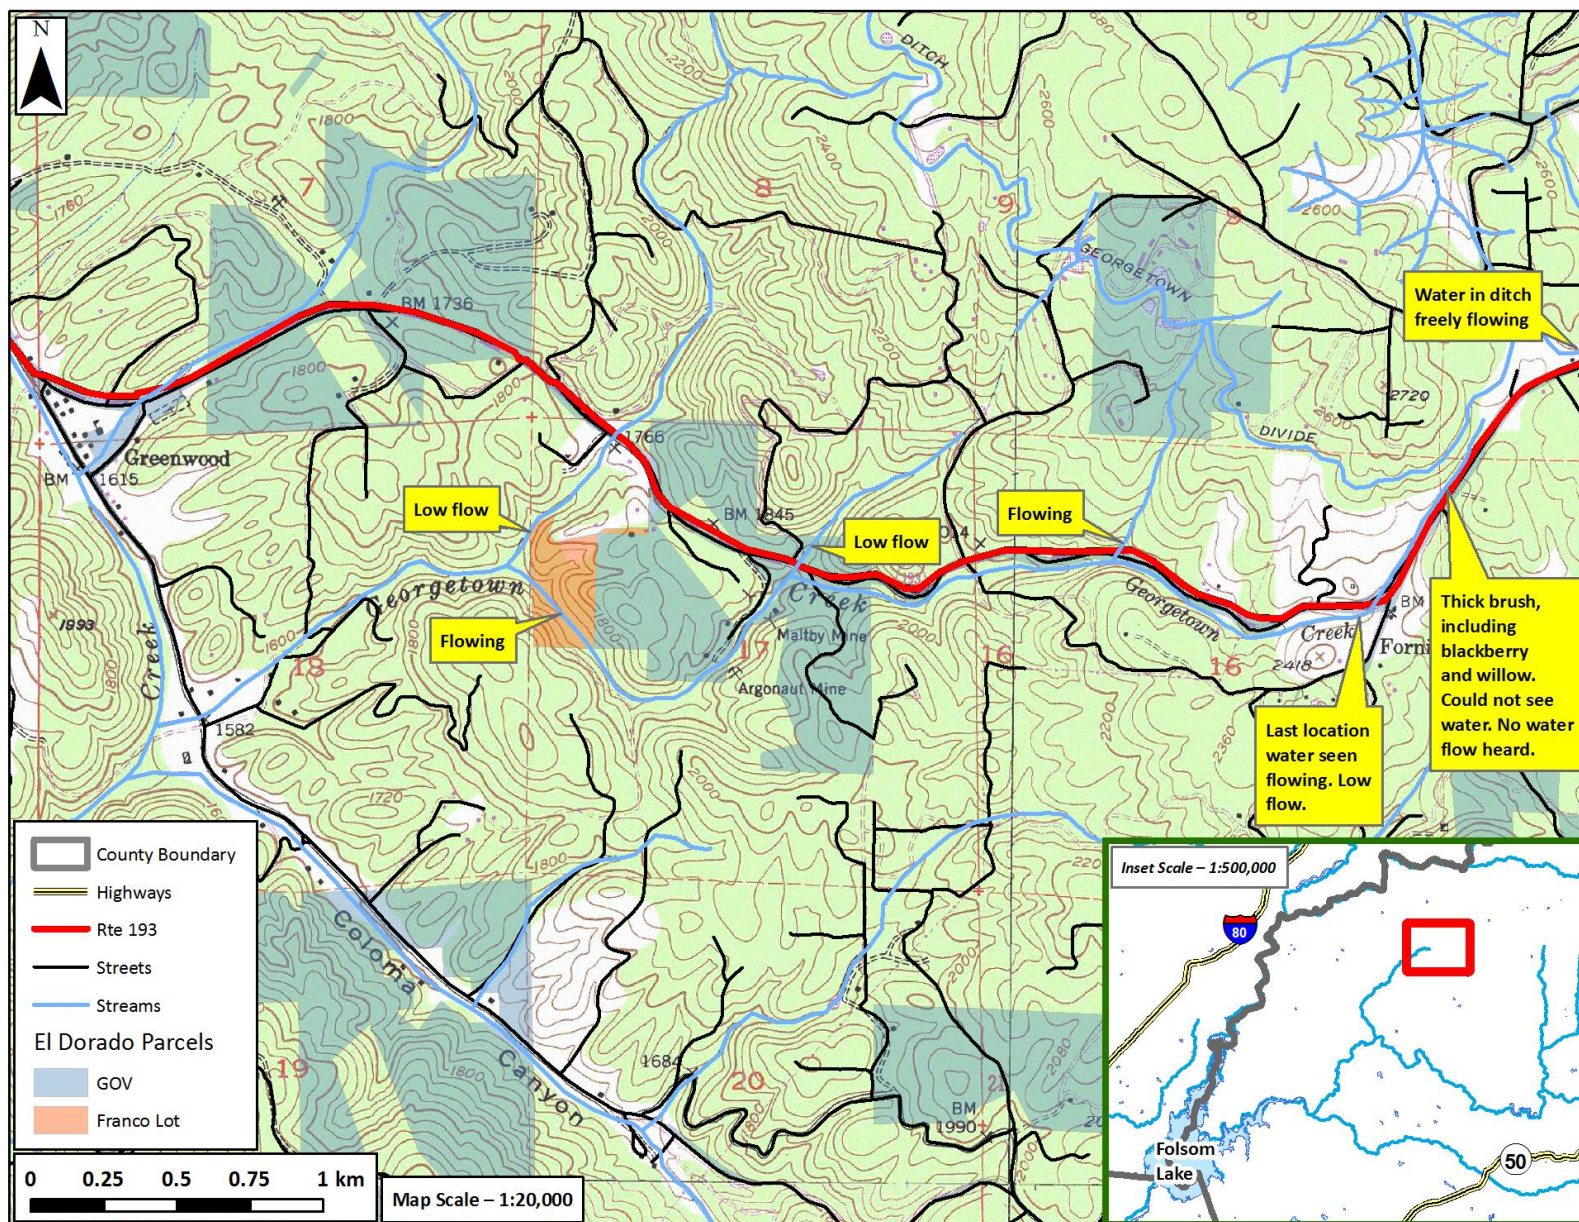
Figure 1. Area of Georgetown Creek (El Dorado County, CA) surveyed on 11/20/2018. Key observations of water flow are noted on the map. The text boxes are pointing directly to the locations at which observations were made. No fish were observed in Georgetown Creek or the marked tributaries. The Georgetown Divide Ditch was only briefly examined to see if there was flowing water (therefore, no fish observations were made).

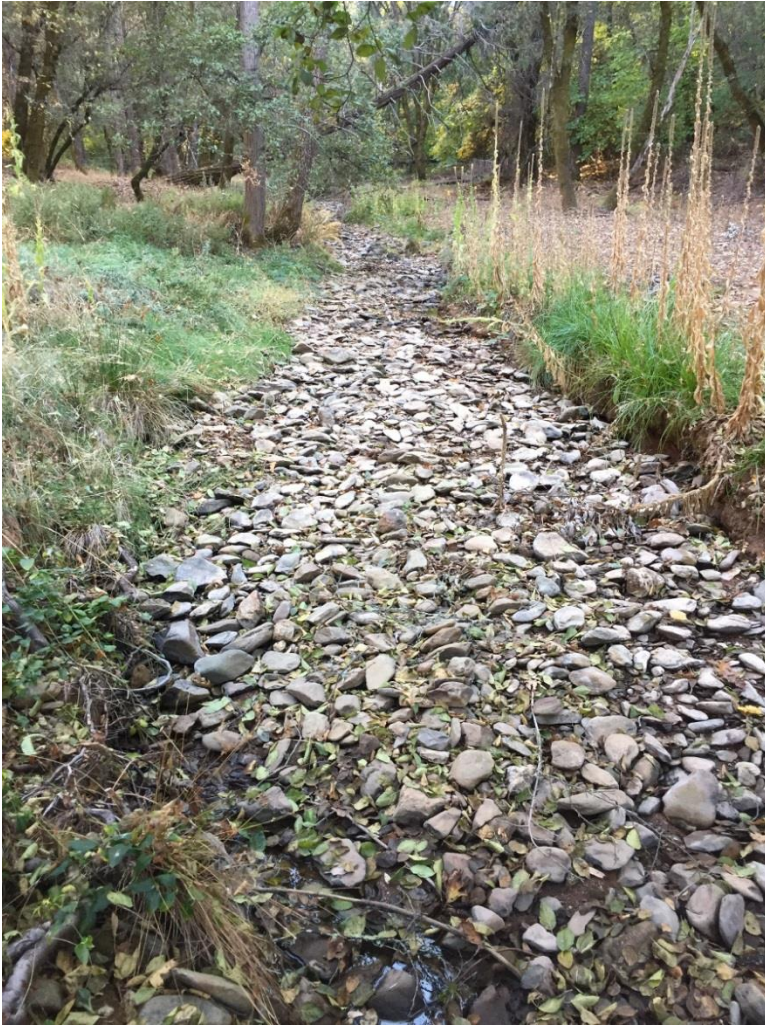
- Water began pooling in the creek on 11/9/2018, soon after Mr. Franco observed water being released into the ditch. Mr. Franco took photos of the creek on his property on 11/10/2018 (Figure 2).
- On 11/15/2018, Zach Mayo (Engineering Geologist with the State Water Resources Control Board) visited the creek with Mr. Franco. On this date, the creek was completely dry. Mr. Franco also did not observe any water in the ditch on this date.

Figure 2. Georgetown Creek as viewed from the Franco lot on 11/10/2018. According to Mr. Franco, water had been recently released into the ditch. (Tony Franco photo)

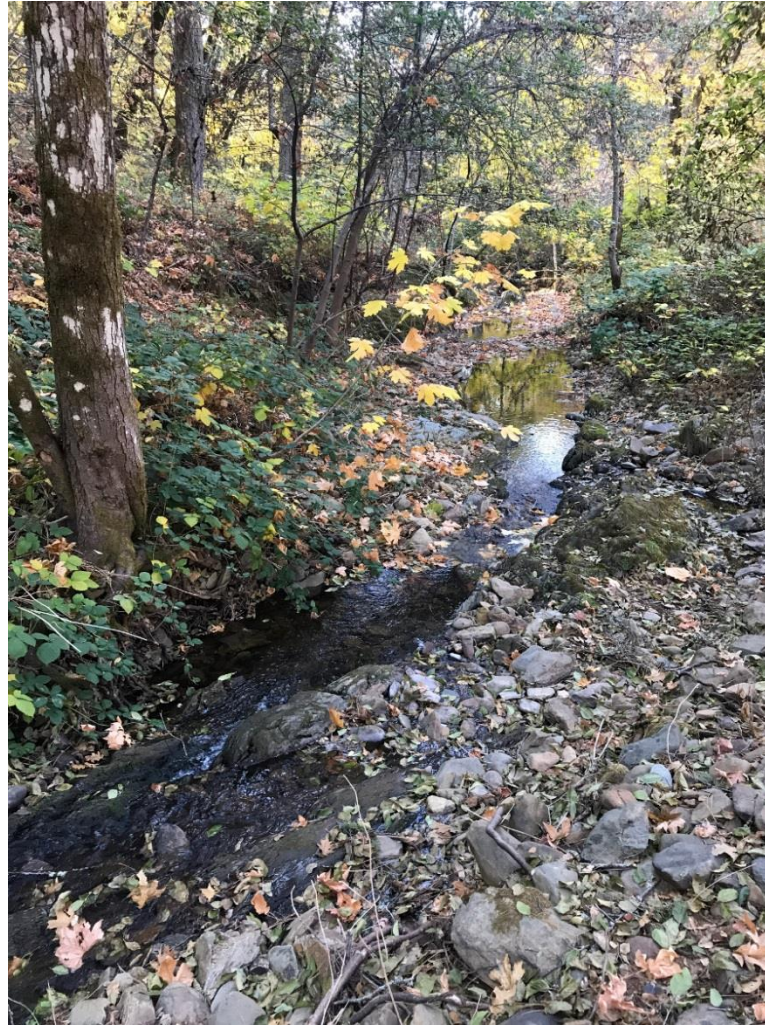
On 11/20/2018, after gaining permission, I went out to Mr. Franco’s property to look at the condition of the creek. Once arriving at the lot in the early afternoon, I observed that water was once again flowing in the creek (Figures 3–5). As would be expected following recent dewatering, I did not observe any fish in the creek. After leaving Mr. Franco’s property, I went east on state route 193 to observe upstream areas of the creek. During the assessment, I also examined three small tributaries flowing into the creek from the north. I only examined mapped tributaries in the proximity of the creek (Figure 1). All small tributaries shown on the map appear to originate from the area of the ditch (Figure 1).

Figure 3. Georgetown Creek as viewed from the Franco lot on 11/20/2018. According to Mr. Franco, water had been rereleased into the ditch beginning on 11/18/2018. (CDFW photo)

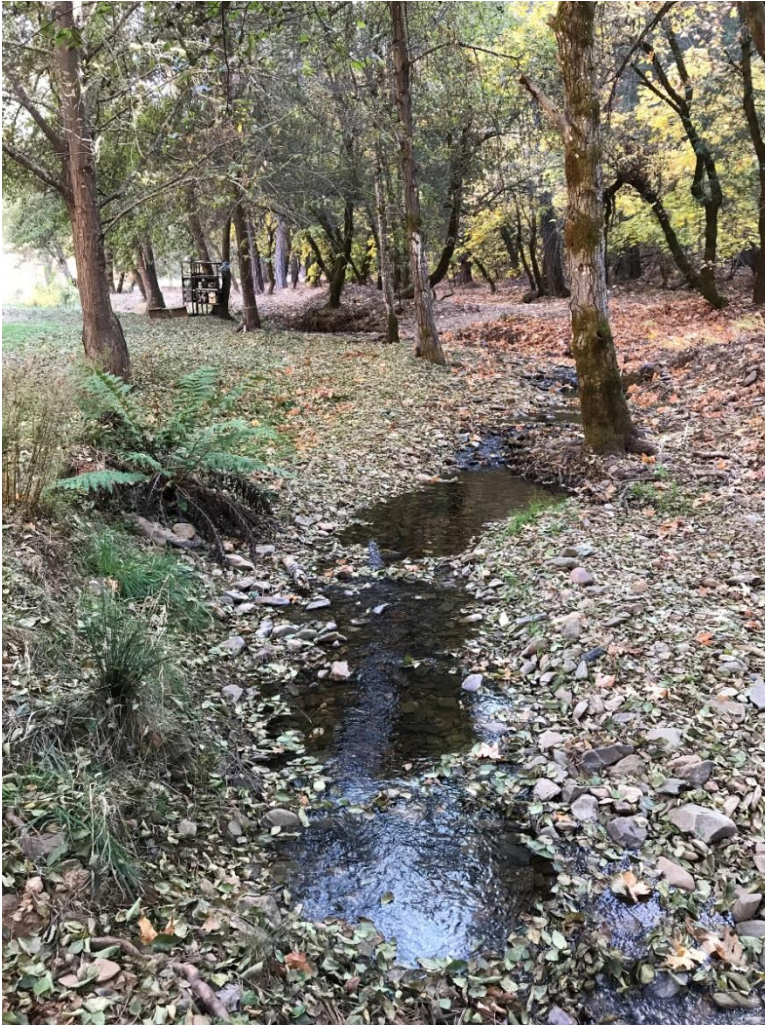
Figure 4. Georgetown Creek as viewed from the Franco lot on 11/20/2018. According to Mr. Franco, water had been rereleased into the ditch beginning on 11/18/2018. (CDFW photo)

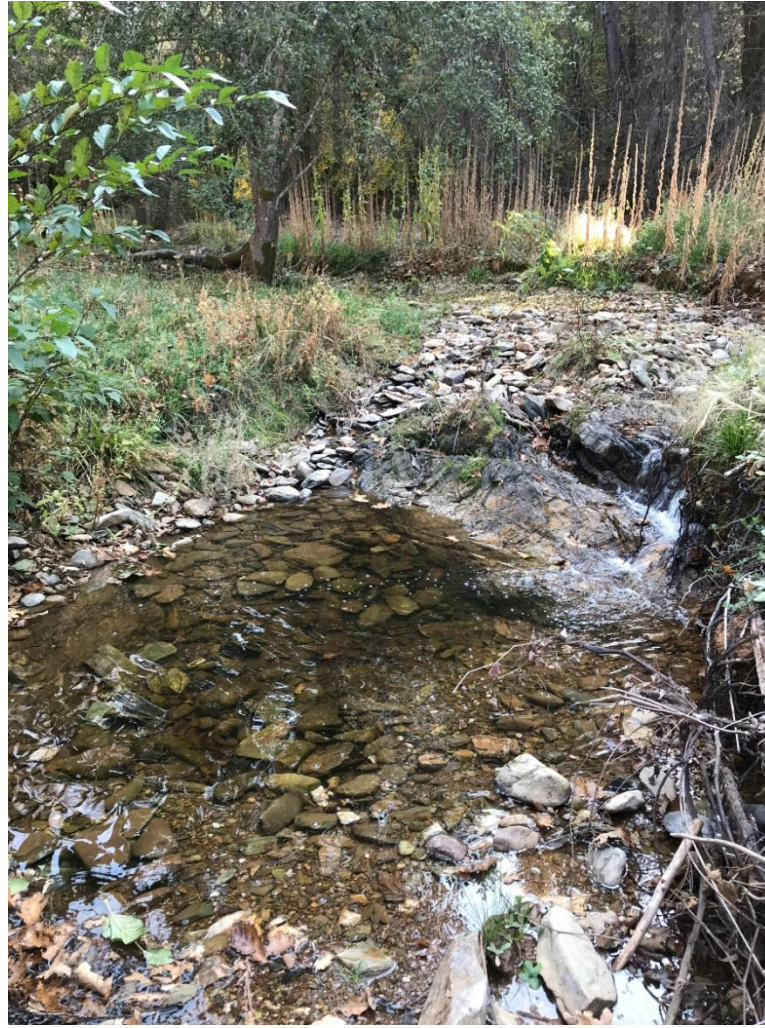
Figure 5. Georgetown Creek as viewed from the Franco lot on 11/20/2018. According to Mr. Franco, water had been rereleased into the ditch beginning on 11/18/2018. (CDFW photo)

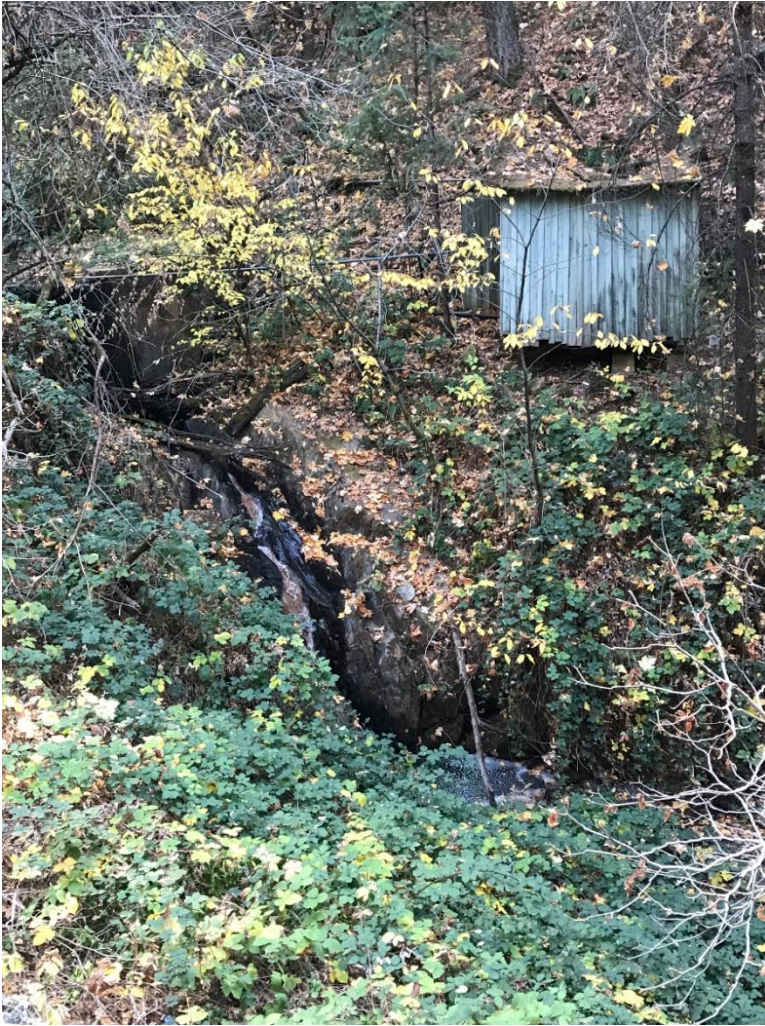
In all tributaries I examined, water was present. The small tributary flowing into the creek immediately below Mr. Franco’s lot (UTM Zone 10S 682474 E, 4307085 N) contained very little flow. The next small tributary to the east, which flows into the creek at Serene Drive (UTM Zone 10S 683506 E, 4307139 N) also contained water, but was barely flowing. The final and most eastern tributary I examined (located adjacent to a private drive) was small, but flowing well (UTM Zone 10S 684505 E, 4307209 N). It appeared that this small tributary was providing the most water to the creek. However, the creek was flowing above its confluence with this small tributary (Figure 6).

Figure 6. Georgetown Creek, upstream of the confluence with the last flowing side tributary feeding the creek, as observed on 11/20/2018. This photo was taken from the edge of state highway 193 (UTM Zone 10S 684716E, 4307140N). (CDFW photo)

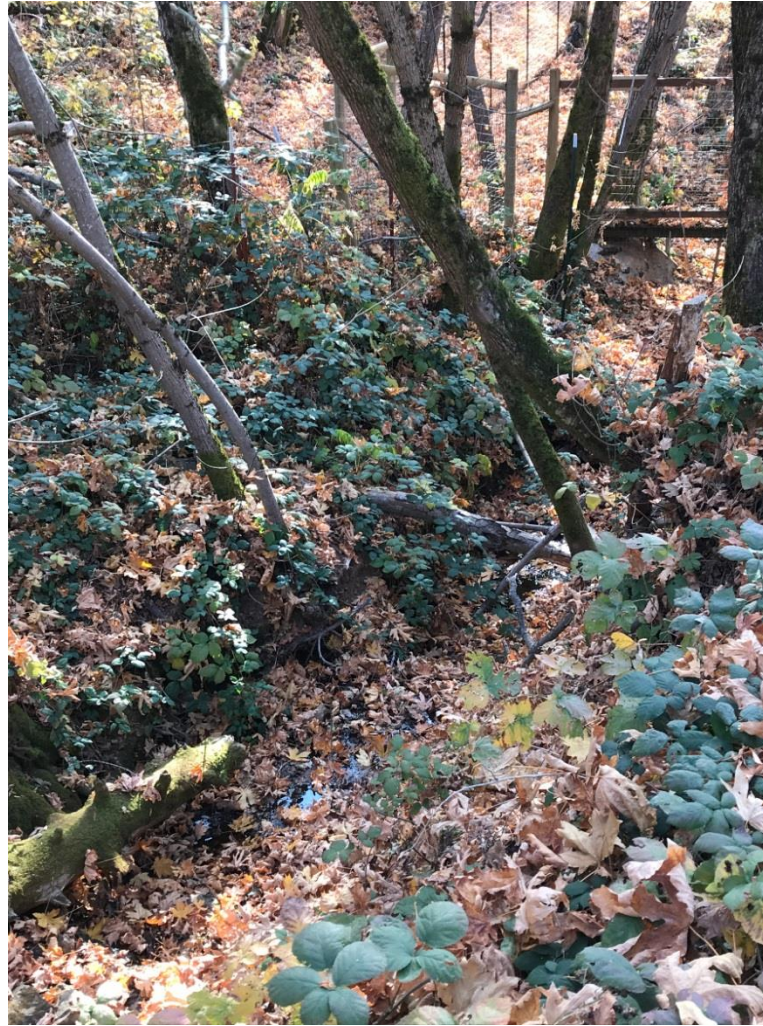
The final stretch of the creek is located directly adjacent to route 193. The final location at which I could see any water in the creek (UTM Zone 10S 685172 E, 4307024 N; Figure 7) was immediately downstream of where the creek flows underneath route 193. Upstream of this point, the creek was masked by a virtually impenetrable curtain of brush, including blackberry and willow. I was not able to observe any water in the final stretch of the creek (as shown on the topographic map), which is located on the western side of route 193.

Figure 7. The last area where water was observed in Georgetown Creek on 11/20/2018. This photo was taken facing downstream while standing on state highway 193. (UTM Zone 10S 685172E, 4307024N). (CDFW photo)

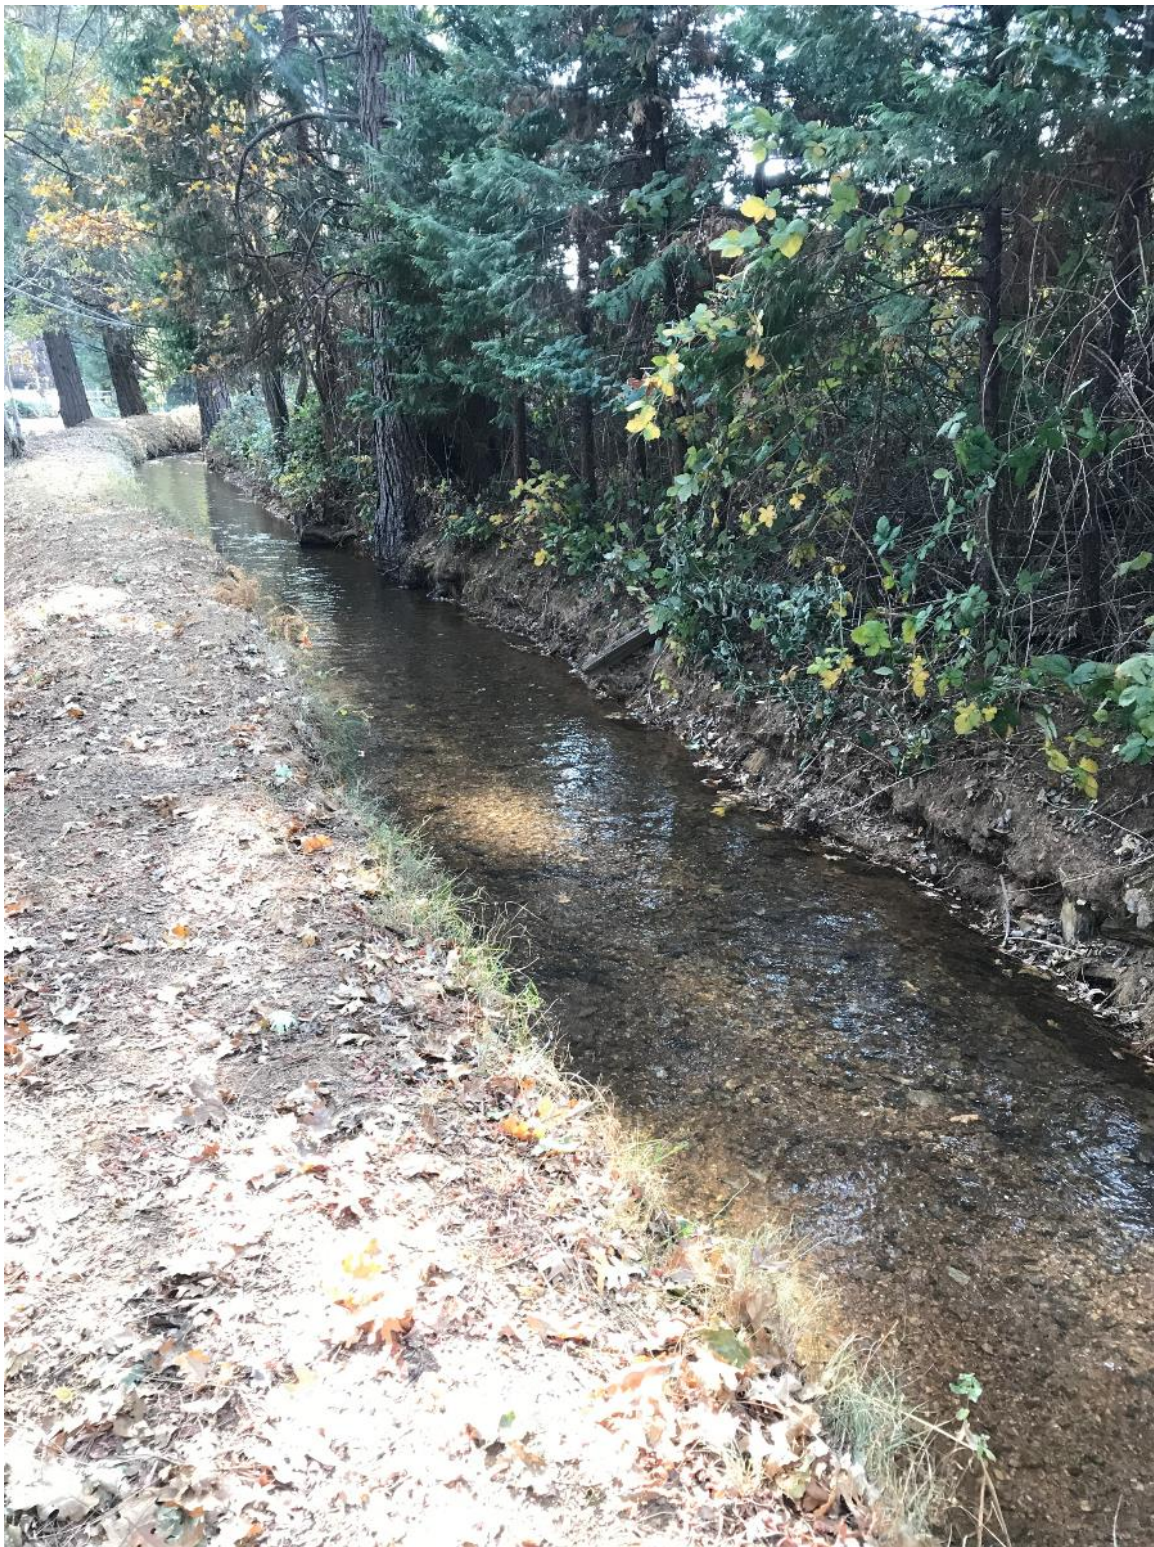
Lastly, I examined the ditch where it flows directly adjacent to route 193 (UTM Zone 10S 686163 E, 4307947 N). At this location, the ditch was flowing freely and appeared to be unmodified with any new lining (Figure 8). I only briefly examined the ditch, so I did not attempt to observe any fish that may have been present.

Figure 8. Georgetown Divide Ditch, viewed from the edge of state highway 193, on 11/20/2018. (UTM Zone 10S 686163E, 4307947N). (CDFW photo)
