Pacifica Pier Restoration Project: Final Programmatic Report (AMENDED)

Recipient Organization/Agency: City of Pacifica

Date Submitted: Revised July 2, 2018

Project Number: #8006.12.033220/33220

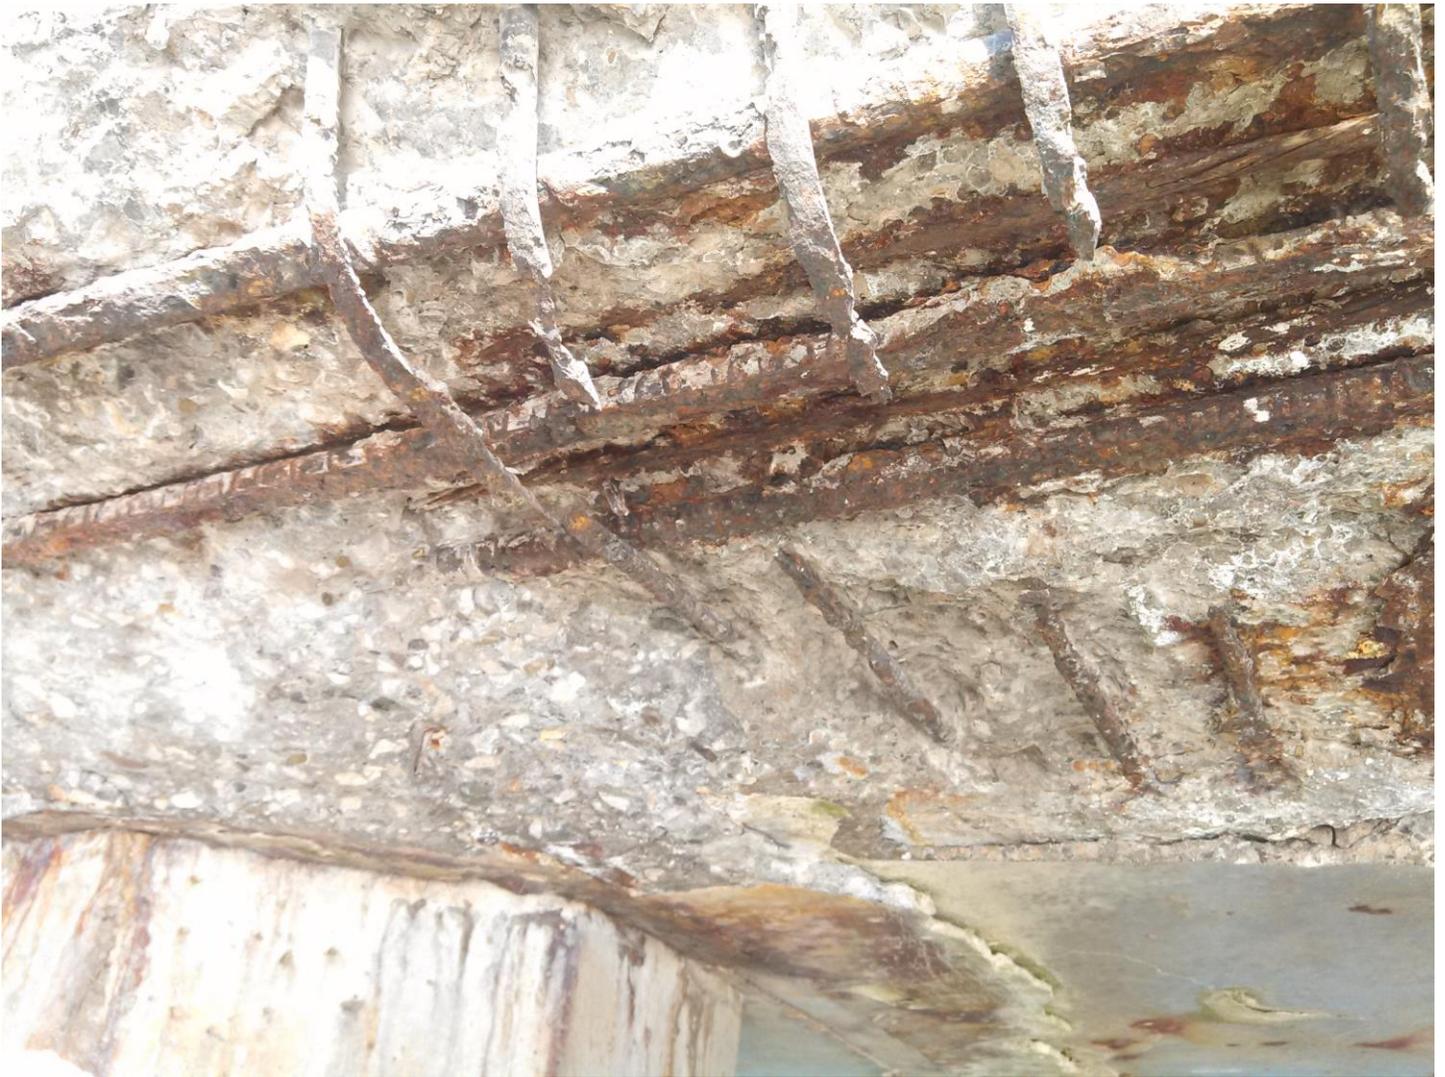
The underside of the Pier was spalling badly, and the reinforcing was rusting away. This project replaced the most degraded reinforcing and placed a protective layer of waterproof mortar where the original concrete had spalled away.

Figure 2: Spalling of the concrete had exposed the reinforcing, and many of the outer bars had rusted completely through. (Photo by Lee Panza)

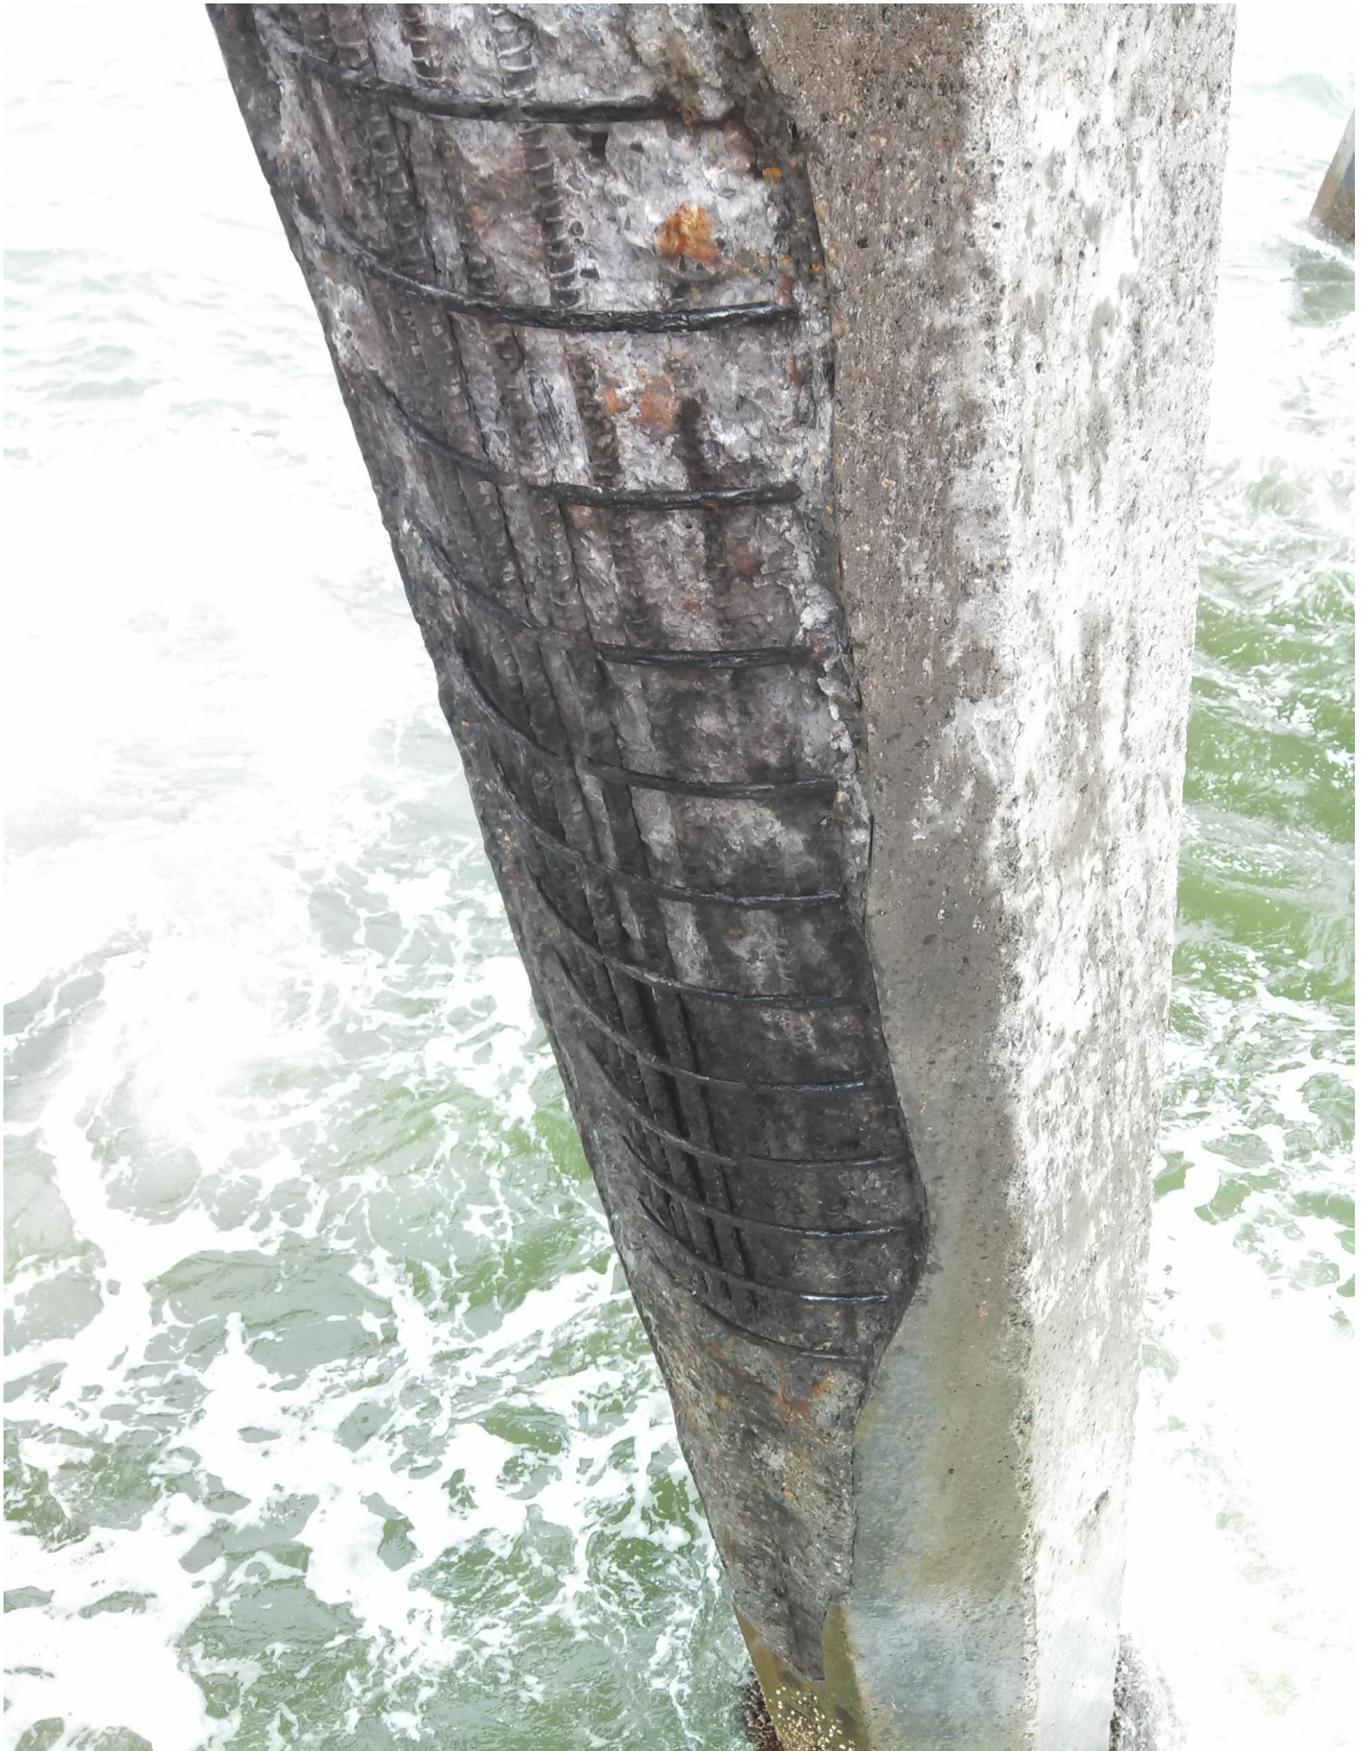
Most of the concrete piles were not in need of immediate attention, but at several locations where spalling had exposed the reinforcing the project repaired the damage.

Figure 5: On the deteriorating piles, the loose concrete was chipped away, but the reinforcing was found to be still in reasonable condition; it was wire-brushed clear of rust. (Photo by Lee Panza)

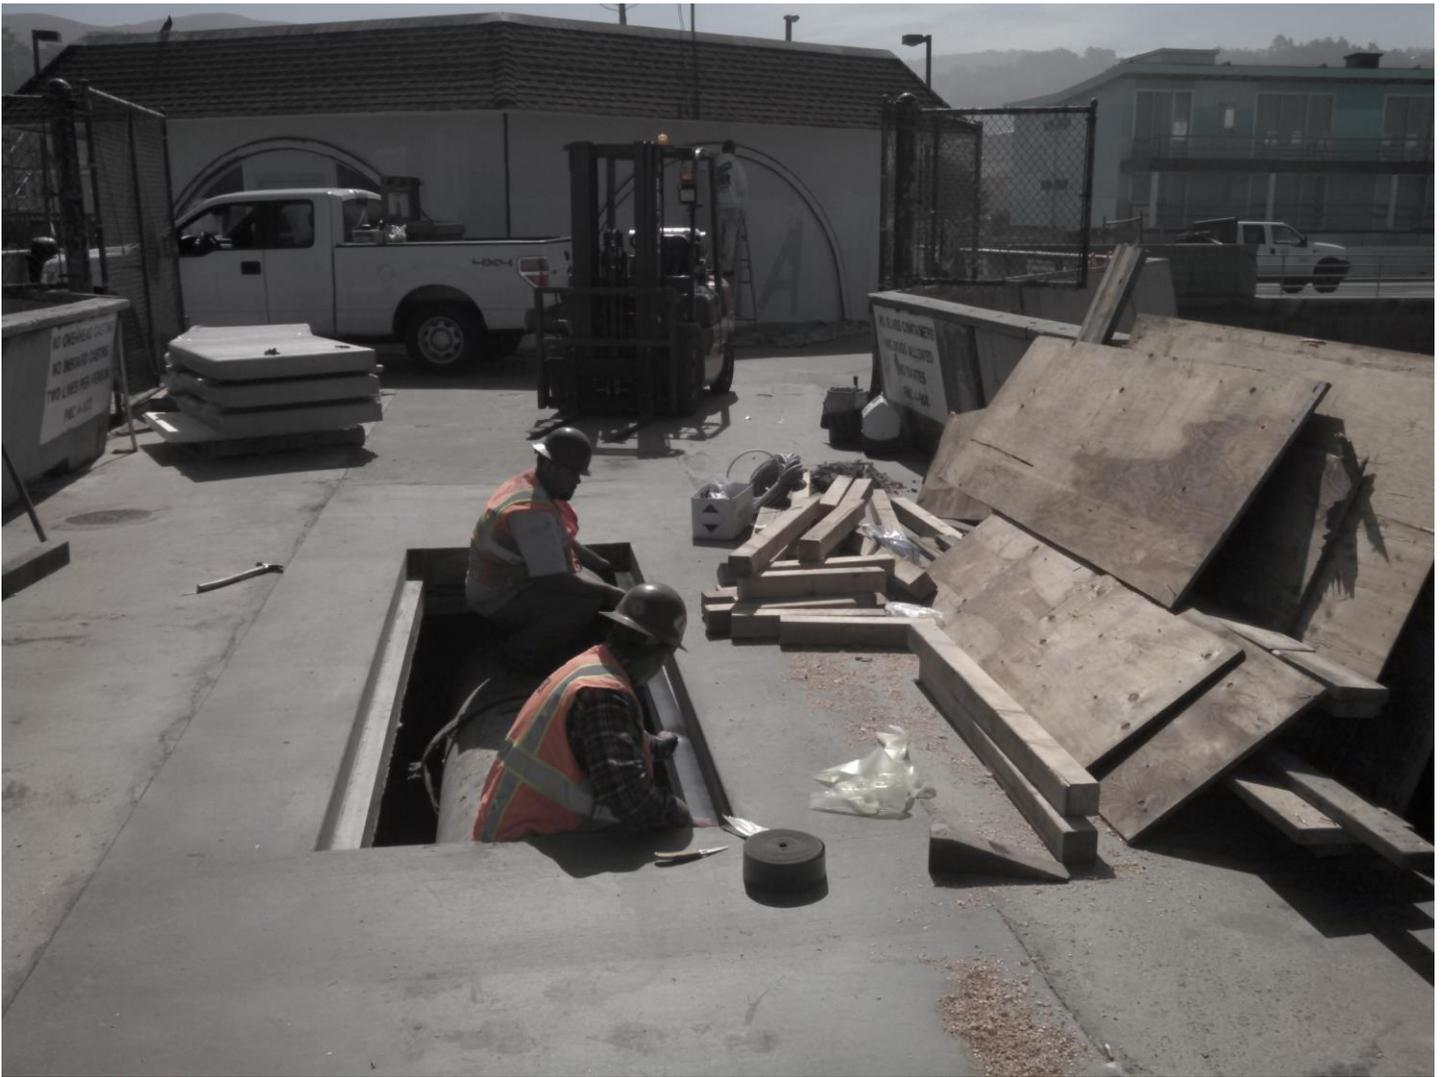
Each section of the Pier has hatches in the upper deck allowing access to the chamber for maintenance. At three locations, the steel support ledges around the edges of the openings had rusted through, and the hatches had collapsed into the chambers. This project replaced the failed hatches and the supporting deck areas around them.

Figure 7: The crew is just completing the replacement of a portion of deck that would support the new pre-cast concrete hatch units, which are stacked on dollies at the left rear of the photo. (Photo by Lee Panza)

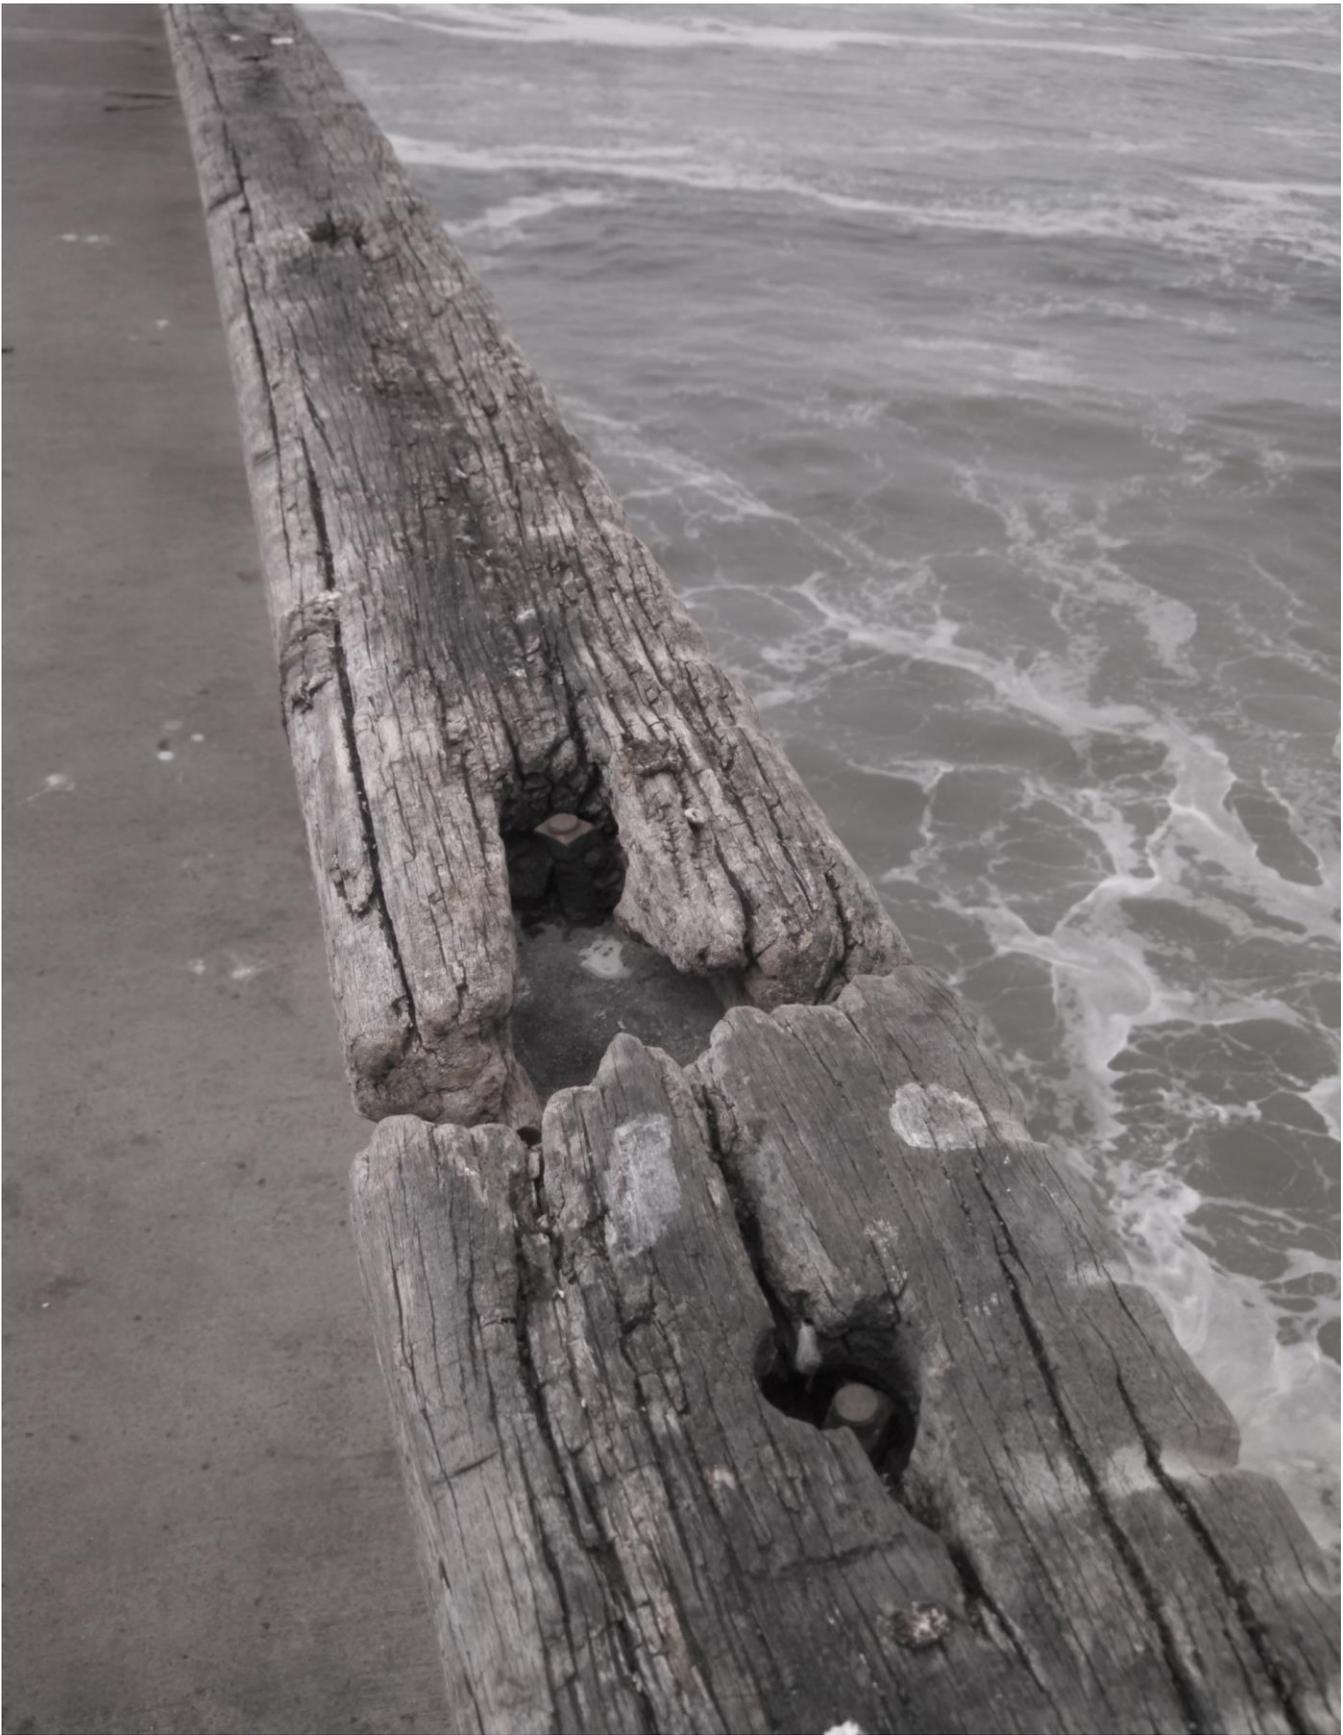
Low concrete parapet walls run along both sides of the deck, with wood caps on their top edges. The original wood caps had become badly cracked and splintered from exposure to the elements. Some pieces had deteriorated so badly that they had fallen off entirely. This project replaced the wood caps with a long-lasting hardwood, imported from Asia, which is so tough it is used for truck beds. New expansion bolts anchor the wood down, and the holes were sealed with matching wood plugs.

Figure 8: The wood caps on the parapet wall guardrails had deteriorated to such an extent that some had already fallen off and those remaining were not much better off. (Photo by Lee Panza)
