moffatt & nichol

DRAFT MEMORANDUM

Subject: Berkeley Pier Bird Habitat Field Evaluation

Job Number: 10658

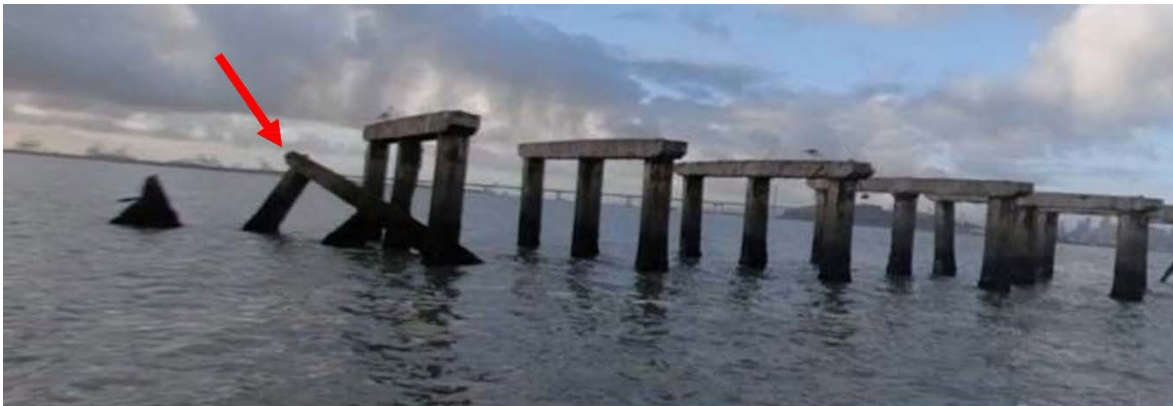
Overall, a significant amount of deterioration of many of the remaining piles and bent caps has occurred, which is to be expected from a 90-year-old structure exposed to salt spray. Large sections of the Pier structure have collapsed. Some bents can be seen having hinged below the water line and are now being supported by the piles of the nearest bent cap (See Photo 1 for an example of this behavior).

Photo 1: Example of Leaning Bent

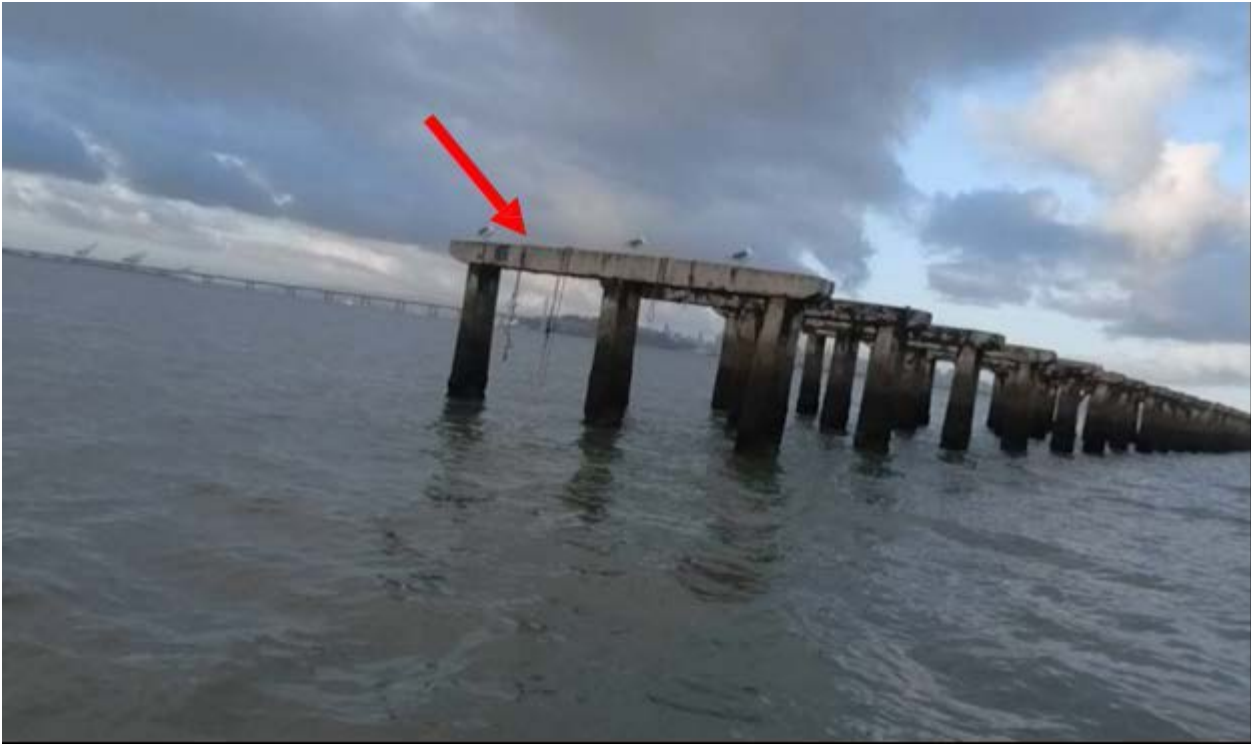
- 24 ft long bent caps supported by 3 piles.
- No cormorants observed during the inspection.
- This section had previously been deemed too close to shore and the likelihood of human disturbance to the birds and other risks associated with human presence is deemed high (rope ladders can be seen hanging on several bents of this section, Photo 2).

Photo 2: Multiple Rope Ladders Present at Section A

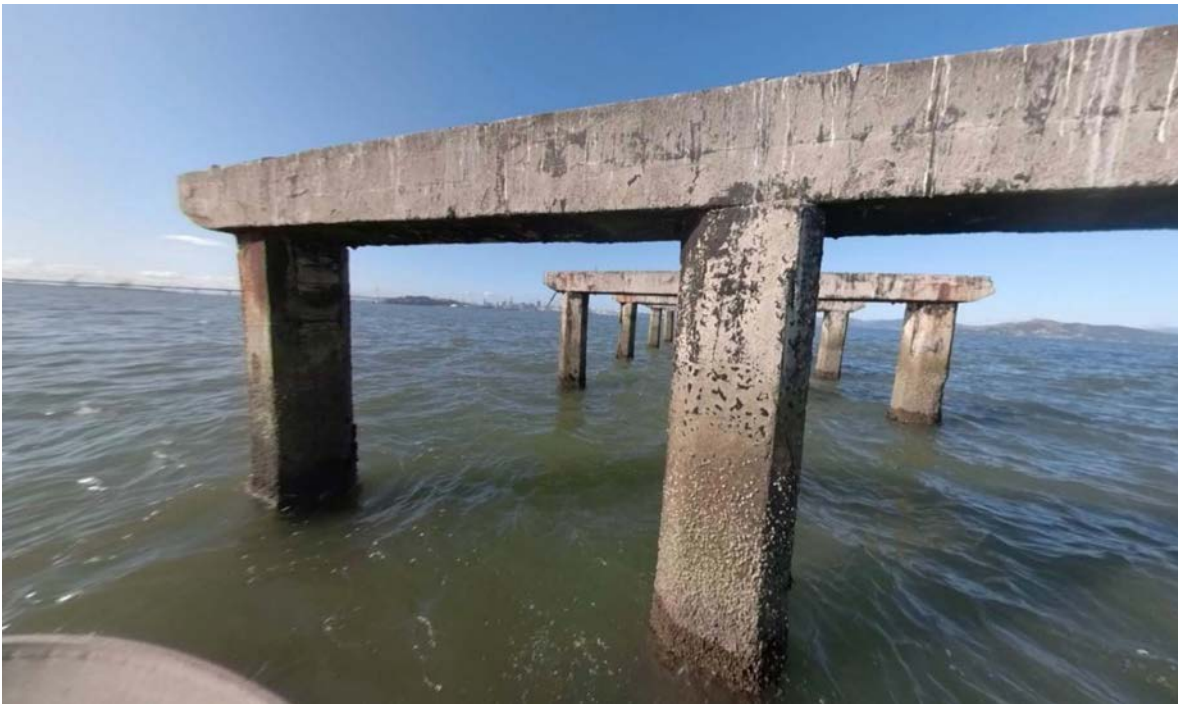
- 24 ft long bent caps supported by 3 piles.
- Cormorants present (~24) at the time of inspection on the easternmost portion of Section C.
- Structural conditions vary throughout section C. Overall, the east end of this section is in better condition than the rest of section C (Photo 3).

Photo 3: East Face of Section C Bent Cap in Good Condition

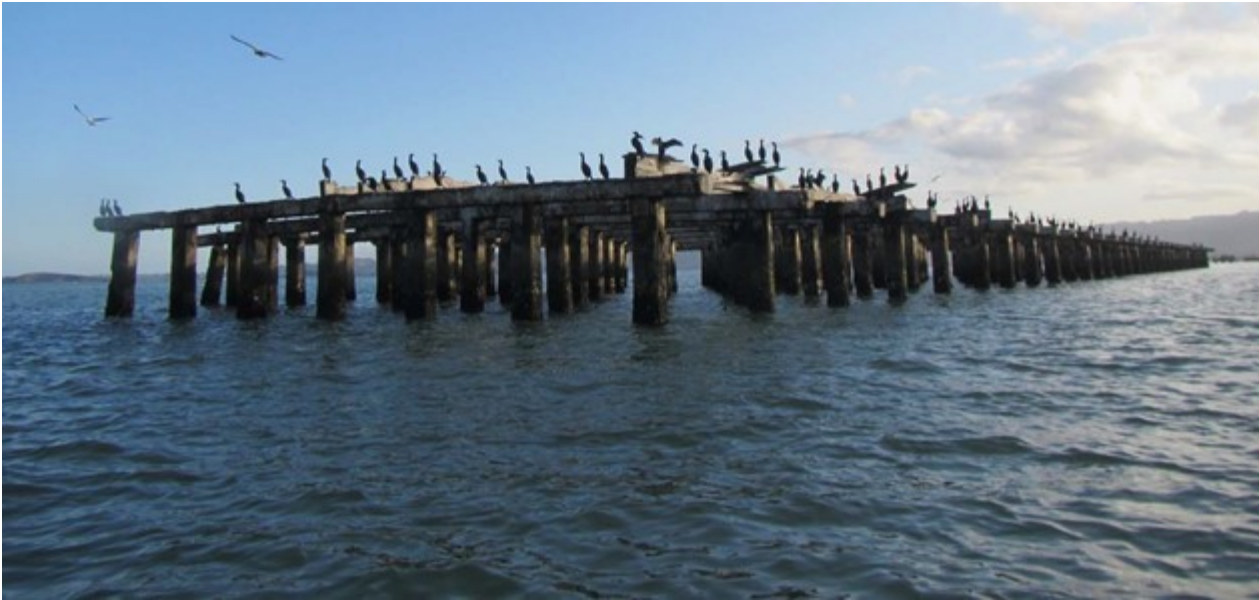
- This section is primarily composed of 62 ft long bent caps supported by 7 piles.
- The largest congregation of cormorants seen during this inspection was perched within this section of the Pier (estimated at around 100 individuals). Particularly on the westernmost portion of Section D (Photo 4).
- Being at the tip of the Pier, this Section is subject to the most exposure as it is directly facing into the west winds and at the edge of deeper water. The 3 most westerly bents have large structural deteriorations consisting of large spalls to both the piles and bent caps (Photo 5 and Photo 6).

Photo 4: West End of Section D Featuring the Greatest Number of Cormorants

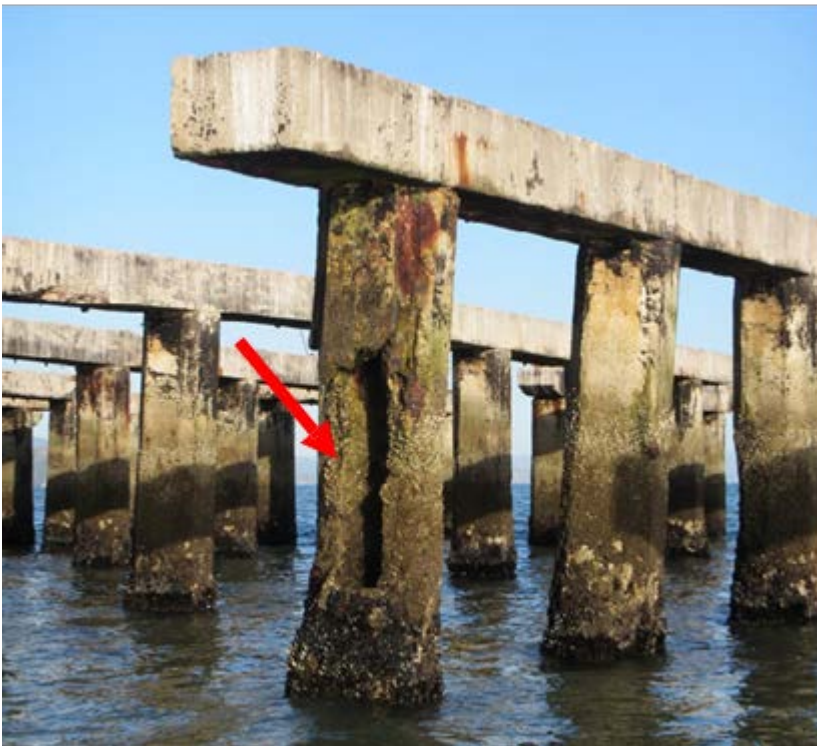
Photo 5: Large Pile Spall at End of Bent in Section D

The proposed bird habitat is located to the east end of section C and to the west end of section D (Figure 4 and Figure 5). These locations were selected to avoid areas of the Pier with the greatest observable structural deterioration and located where birds currently perch. The areas selected may require some rehabilitation to the existing structure prior to the installation of bird habitat, such a grout patching large spalls in pile caps, to slow structural deterioration.

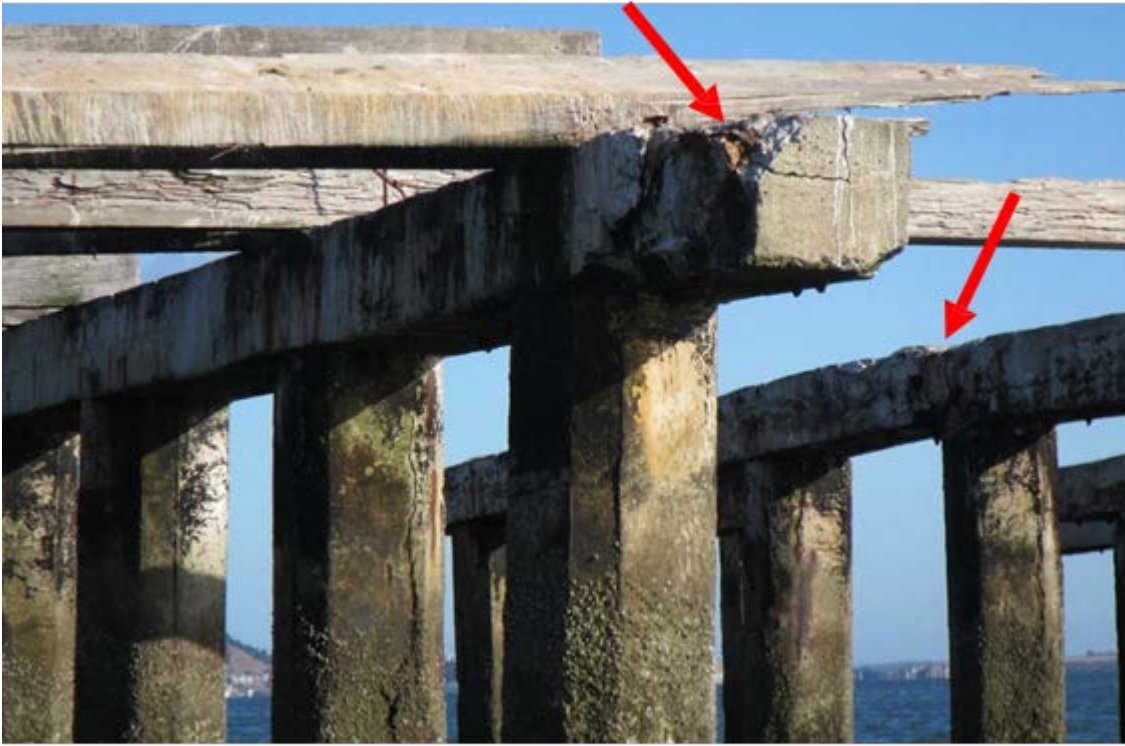
Photo 6: Typical Bent Cap Spalls
