Monitoring and Evaluation of Salmonid Habitat Restoration  
Program

Contract P2196001

Final Report

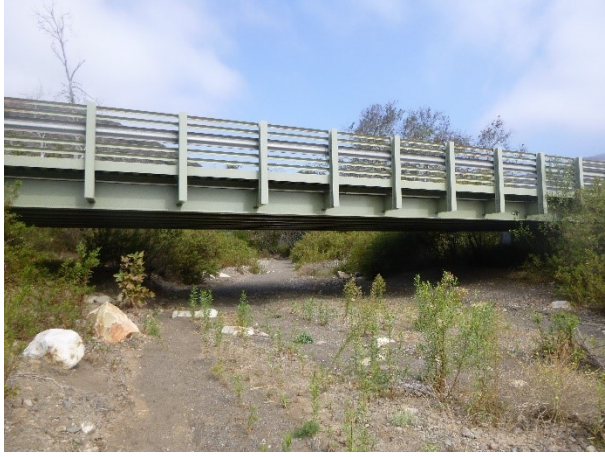
Photo\_24\_Leo Carrillo State  
Park\_FP\_Post

Project sites were monitored for effectiveness in October 2022 and two barriers to steelhead trout passage along Arroyo Sequit were successfully removed. Components of bridges and abutments were in good condition and functioning as intended. The boulders and cobble installed in the reconstructed stream channel at both sites were either washed out or buried by sediment, potentially because the channel consisted primarily of gravel and sand. The survival and vigor of planted vegetation was difficult to evaluate as revegetated areas at both sites showed evidence of being burned during the Woolsey Fire. Many native planted species survived or regrew after the fire, though non-native mustard and thistle were observed in the revegetation treatment areas. The project received an overall fair rating.

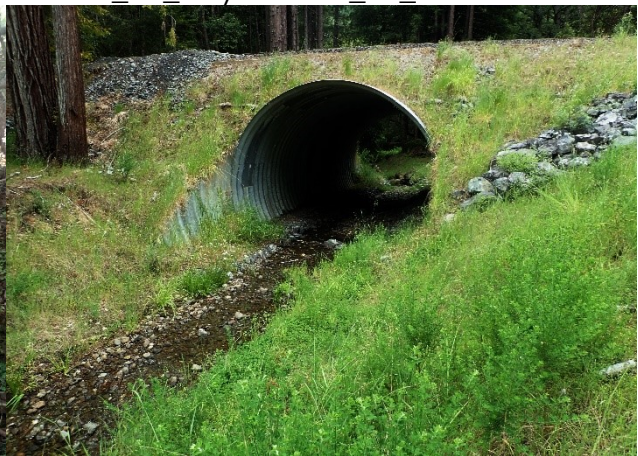
Photo\_34\_Gulch C\_FP\_Post

In 2023, post-treatment monitoring found the crossings were no longer barriers to fish passage, but at low flows the lower crossing had subsurface flow within the culvert. Rock armoring along the lower crossing had also eroded at points, especially on the downstream and right bank. Rock weirs scoured out pools and fish were visible from the surface below the lower crossing. Logs and rootwads were stable and keyed in, but the uppermost rootwad was mostly out of the active channel.

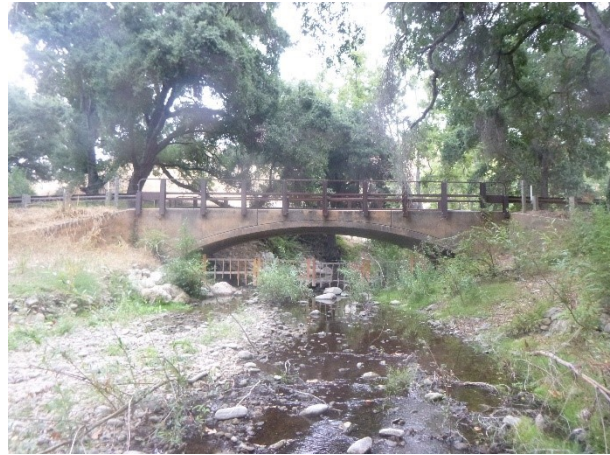
Photo\_43\_ Quiota Crossing 3\_FP\_Post

Post-treatment monitoring in September 2023 documented that the bottomless arch culvert and wingwalls appeared to be in good condition and functioning as intended. The reconstructed channel retained the intended gradient and substrate composition, and the fish passage barrier was successfully removed with no apparent visible barriers remaining throughout the reconstructed channel. The attempt to redirect flow in the channel upstream of the crossing towards river right was unsuccessful, as the channel was observed shifting back towards river left with continued erosion of the left bank. Most of the large RSP was in place and functioning as intended to protect crossing abutments from scour, but the smaller fill material between the larger rocks appeared to have washed out, exposing the large rock intended to be buried. Some of the large RSP at the upstream ends of both banks had shifted out of its original placement and settled within the channel. The project received an overall fair rating.

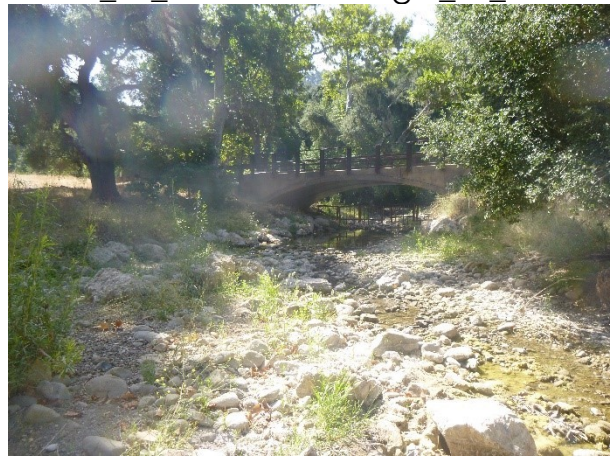
Photo\_45\_ Quiota Crossing 4\_FP\_Post

Post-treatment monitoring was completed in September 2023. Components of the bottomless arch culvert and wingwalls appeared to be in good condition and were functioning as intended. The reconstructed channel retained the gradient and substrate composition as intended. The project met its main objective of providing fish passage to all life stages of steelhead trout. The fish passage barrier was successfully removed, and no visible barriers remained throughout the reconstructed channel. The attempt to fill in the river left side channel and direct flow towards the river right main channel upstream of the crossing was unsuccessful. The channel upstream of the crossing was braided and flowing in both the intended channel and the previously filled-in side channel, which caused side cutting and erosion on the left bank. Most of the large RSP was still in place and functioning as intended to protect crossing abutments from scour, but smaller fill material between the larger rocks of the RSP had washed out. This exposed large rock intended to be buried. Some of the large RSP at the upstream ends of the left bank had shifted out of its original placement and settled within the channel. Likely because of the erosion of the small fill on the banks, these features were measured to have slightly higher bank angles than the targeted 2:1 slope. The rootwad feature at the upstream limit of the channel reconstruction was installed with the intent to form a scour pool and help direct flow into the main river right channel. The entire feature washed out and the rootwad could not be

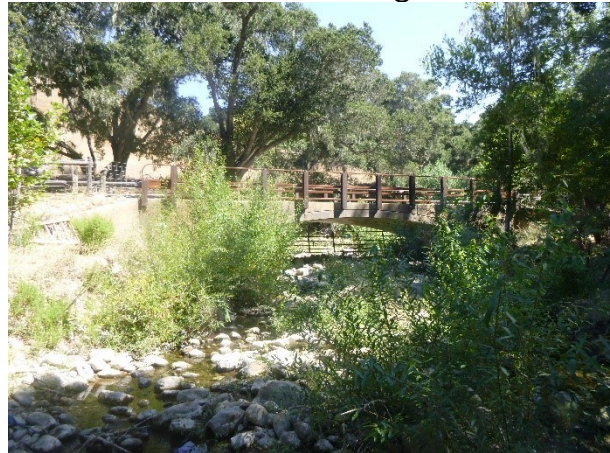
Photo\_47\_ Quiota Crossing 5\_FP\_Post

The project site was monitored for effectiveness in September 2023. The bottomless arch culvert was in good condition and functioning as intended. Channel conditions appeared ideal for passage for all steelhead life stages during passable flow conditions as the crossing replacement was successful. The channel regrading and reconstruction with ESM retained the intended gradient and good substrate even after significant flow events following implementation. Some materials shifted in the channel resulting in unintended aggradation of boulders and cobble upstream of and under the culvert, causing a reduced freeboard within the culvert. Overall, the channel feature remains passable and provides good fish habitat. The large RSP was in place and functioning as intended to protect crossing abutments from scouring. Some smaller fill material between the larger rocks of the RSP washed out, exposing the large rock that was intended to be buried. The rock riffle at the upstream limit of the channel reconstruction was riffle habitat and installed large boulders were in place, but the channel shifted to the river left side of this feature rather than mid-channel as intended. This resulted in scouring on the river left side and deposition of large sediment on the river right side. No obvious barrier formed within this riffle feature, and it appears passable to all life stages of steelhead trout. This project received an overall rating of fair.

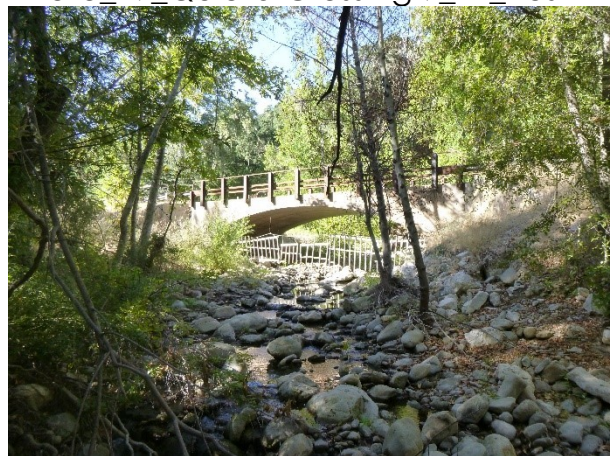
Photo\_51\_Quiota Crossing 8\_FP\_Post

Post-treatment monitoring was conducted in September 2023 and the bottomless arch culvert was in good condition and functioning as intended. Channel conditions appeared good for passage for all steelhead life stages during passable flow conditions. The RSP features installed along both banks were functioning as intended to protect crossing abutments from scour. Along the right bank, all the large RSP was in place. Some smaller fill material between the larger rocks of the RSP appeared to have washed out. On the left bank, some of the larger RSP at the upstream end of this feature shifted into the channel and much of the small fill had washed out. Side cutting into the left bank at the upper end of the RSP and upstream of it was observed. The channel reconstructed with ESM retained the intended gradient and substrate composition, even after significant flow events following implementation. Shifting of smaller materials occurred, but the larger boulders remained in place in the channel. Overall, the channel feature was passable and provided good fish habitat. A pair of rock weirs were installed within the channel reconstruction beneath the culvert intended to maintain pool

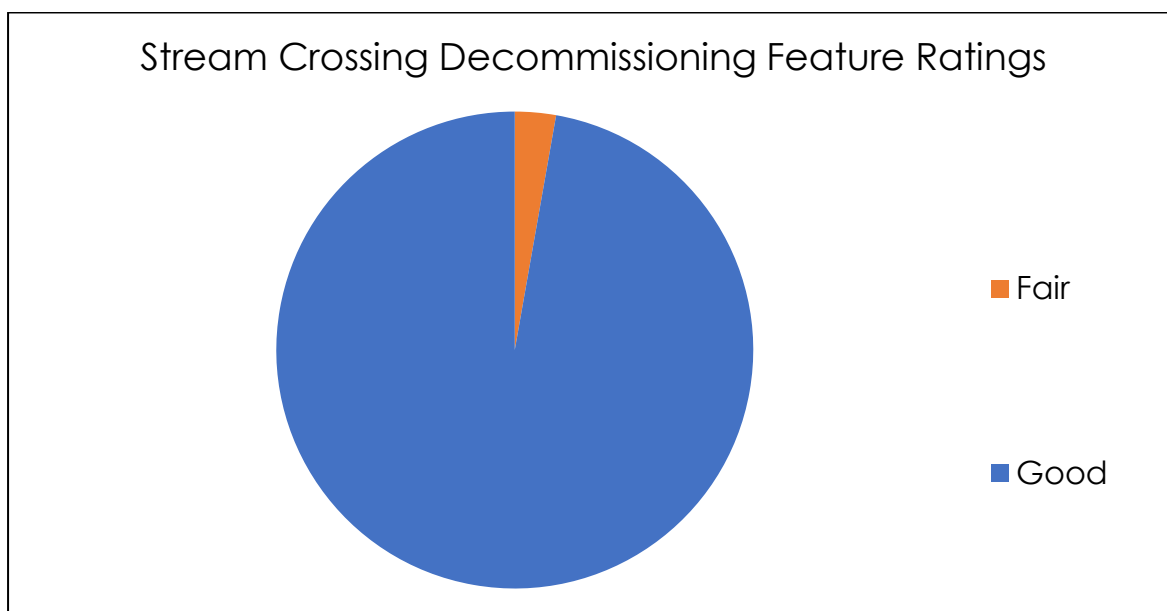
Figure 3. Ratings of stream crossing decommissions using a CD checklist, 2022-2023.

Thirty-six stream crossing decommissioning features were evaluated at post-treatment, of which 35 received a good rating, and one received a fair rating because of incision upstream and head cutting downstream of the treatment area. (Figure 3). No features had excessive erosion or incision within the treatment area, therefore no poor ratings were given.

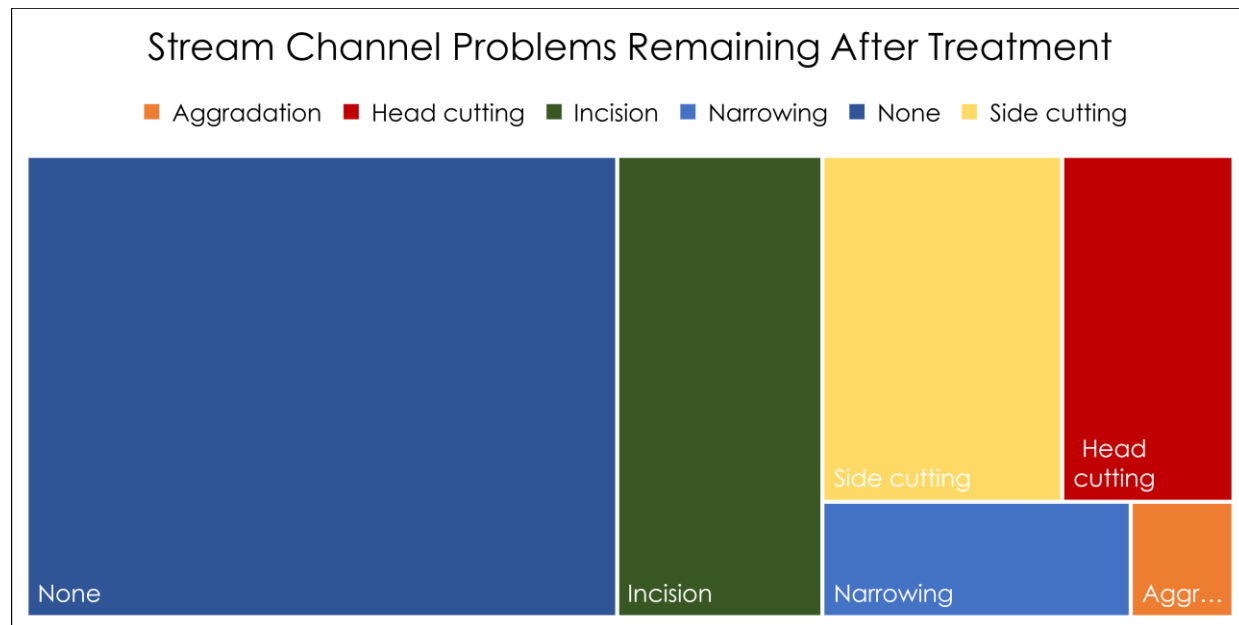
*Figure 4. Common stream channel problems observed at stream crossing decommissioning features after implementation.*

The CD checklists ask if there are channel problems remaining within the treated area. Thirty-eight percent observed no problems remaining, and 62% found remaining channel problems (Figure 4). The most common remaining problems were channel incision, side cutting and head cutting. Other problems reported were narrowing and aggradation. These problems are often due to not excavating the stream channel enough, steep gradients through the crossing, exposed soils after excavation, and LW or boulders within the crossing that alter hydrology and erode banks.

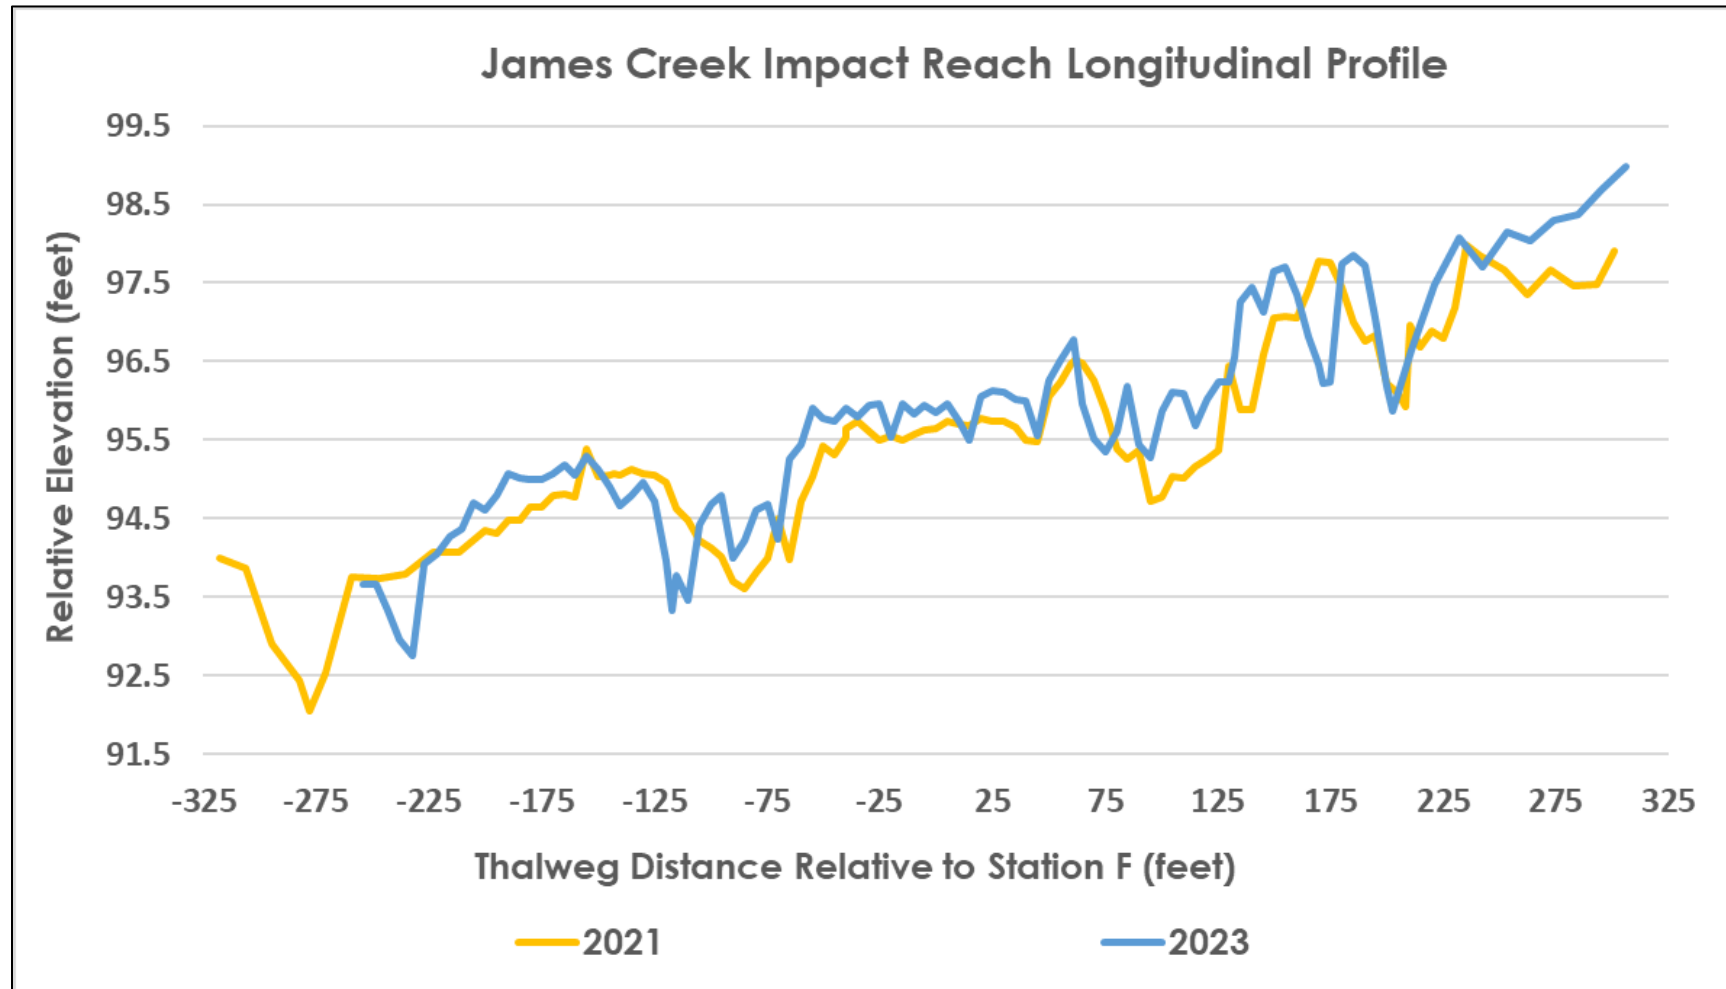
Figure 9. James Creek impact reach longitudinal profiles of post-treatment surveys (2021 and 2023). Station F is the midpoint of the reach.

Through the first year after construction (2021) the BACI longitudinal profile survey detected no large thalweg profile changes in the James Creek impact reach, likely due to the passage of only one mild winter since implementation. However, two additional winters passed prior to the 2023 survey and changes in the longitudinal profile were more notable (Figure 9). For example, a pool formed at the lowest point within the impact reach, moving the bottom of the longitudinal profile upstream 64 ft.
