**California Department of Fish and Wildlife**  
*Fisheries Restoration Grant Program*  
Restoration Project Case Study

**P1450011 Fish Passage Improvement at Crossing 3, Quiota Creek**

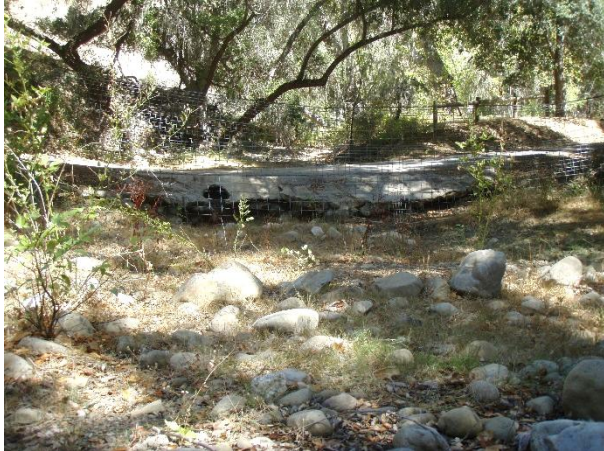
**Figure 1.** View, facing upstream, of the concrete low-flow crossing and the undercutting and plunge below the downstream side. Pre-treatment photo date: 9/16/2015

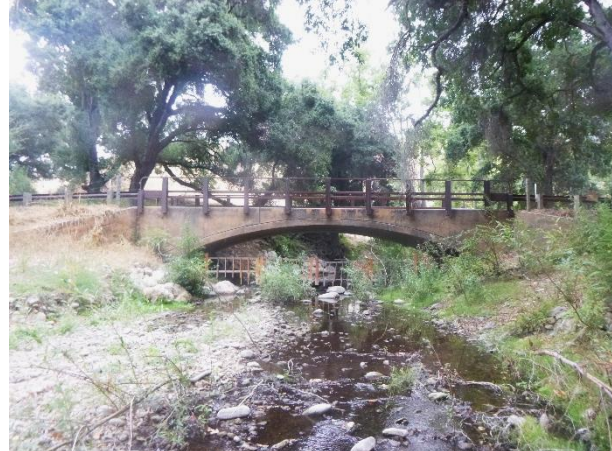
**Figure 2.** View, facing upstream, of the reconstructed channel and the upgraded bottomless arch culvert. Post-treatment photo date: 9/25/2023

The bottomless arch culvert, channel reconstruction, and rock slope protection treatments at the Quiota Crossing 3 project site were assessed for condition in September of 2023, approximately eight years after implementation. Components of the bottomless arch culvert and wingwalls appeared to be in good condition and were functioning as intended. The reconstructed channel retained the gradient and substrate composition as intended. The barrier to fish passage was successfully removed and no visible barriers were apparent throughout the reconstructed channel. The attempt to redirect the flow within the channel upstream of the crossing towards river right was unsuccessful, and channel shifting back towards river left and continued erosion of the left bank at this location was observed. Most of the large RSP was still in place and functioning as intended to protect crossing abutments from scour. Much of the smaller material installed as fill between the larger rocks and boulders that make up the rock slope protection appeared to have washed out, exposing the large rock that was intended to be buried. Some of the large RSP at the upstream ends of both banks had shifted out of its original placement and settled within the channel. The erosion and shifting of RSP and channel materials was likely caused by significant storm and flow events that occurred the winter before post-treatment monitoring was conducted.

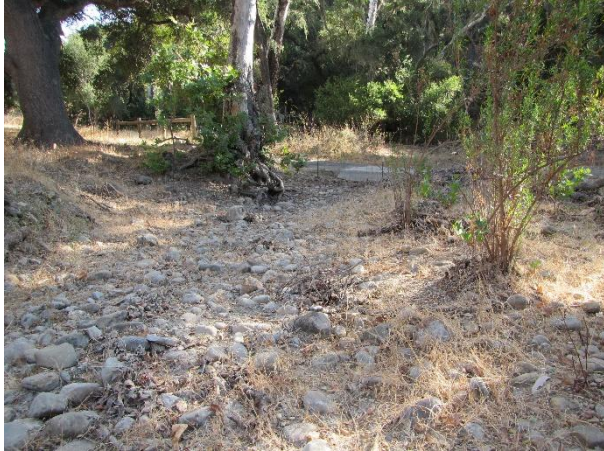
**Figure 1.** View, facing upstream, of the concrete low-flow crossing. Pre-treatment photo date: 9/28/2016

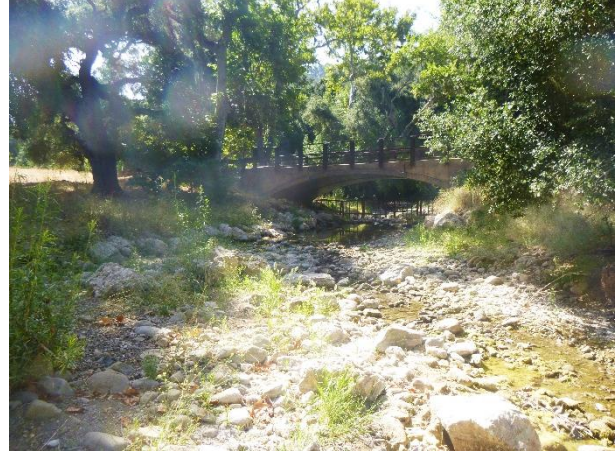
**Figure 2.** View, facing upstream, of the reconstructed channel and the upgraded bottomless arch culvert. Post-treatment photo date: 9/25/2023

The bottomless arch culvert, channel reconstruction, RSP, and root wad treatments at the Quiota Crossing 4 project site were monitored for effectiveness in September of 2023, 7 years after implementation. Components of the bottomless arch culvert and wingwalls appeared to be in good condition and were functioning as intended. The reconstructed channel retained the gradient and substrate composition as intended. The project's main objective of providing fish passage to all life stages of *O. mykiss* was met as the barrier to fish passage was successfully removed and no visible barriers were apparent throughout the reconstructed channel. The attempt to fill in the river left side channel and direct the flow towards the river right main channel upstream of the crossing was unsuccessful. At the time of the monitoring survey, the channel upstream of the crossing was braided and flowing in both the intended channel and the previously filled in side channel, which had caused some side cutting and erosion on the left bank. Most of the large RSP was still in place and functioning as intended to protect crossing abutments from scour. Much of the smaller material installed as fill between the larger rocks and boulders that make up the RSP appeared to have washed out, exposing the large rock that was intended to be buried. Some of the large RSP at the upstream ends of the left bank had shifted out of its original placement and settled within the channel. Likely as a result of the erosion of the small fill on the banks, these features were measured to have slightly higher bank angles than the targeted 2:1 slope. The root wad feature that was installed at the

upstream limit of the channel reconstruction had been installed with the intent to form a scour pool and help direct flow into the main river right channel. The entire feature had washed out and the root was could not be located anywhere within the project boundaries.

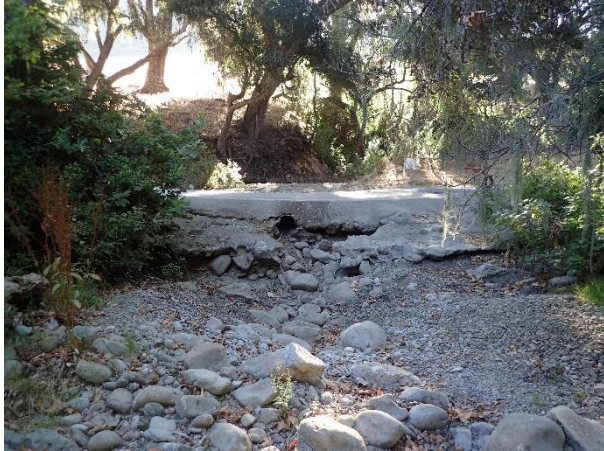
**Figure 1.** View, facing upstream, of the concrete low-flow crossing and the undercutting and plunge below the downstream side. Pre-treatment photo date: 7/23/2018

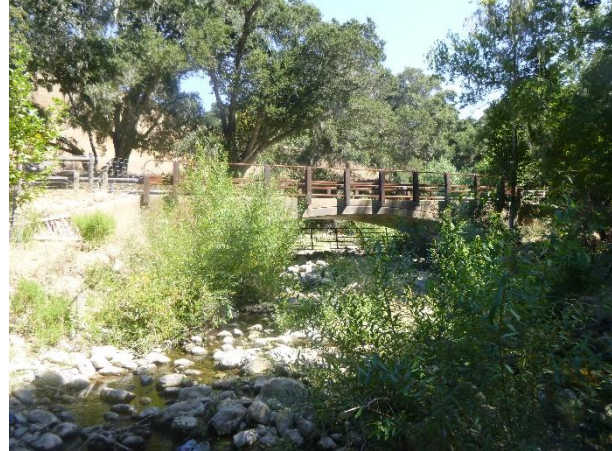
**Figure 2.** View, facing upstream, of the reconstructed channel and the upgraded bottomless arch culvert. Post-treatment photo date: 9/25/2023

The bottomless arch culvert, channel reconstruction, rock riffle, and RSP treatments at the Quiota Crossing 5 project site were monitored for effectiveness in September of 2023, five years after implementation. The bottomless arch culvert was in good condition and functioning as intended. Channel conditions appeared ideal for passage for all steelhead life stages during passable flow conditions as the crossing replacement successfully removed the barrier to fish passage. The channel regrading and reconstruction with engineered stream material retained the intended gradient and good substrate, even after significant flow events following implementation. There was some shifting of materials in the channel, resulting in the unintended effect of aggradation of boulders and cobble within the channel upstream of and under the culvert. This has led to a reduced freeboard within the culvert. Overall, the channel feature still is passable and provides good habitat for fish. The large RSP was still in place and functioning as intended to protect crossing abutments from scour. Some of the smaller material installed as fill between the larger rocks and boulders that make up the RSP appeared to have washed out, exposing the large rock that was intended to be buried. The rock riffle that was installed at the upstream limit of the channel reconstruction was still riffle habitat and the large boulders installed appear to still be in place, but the channel had shifted to the river left side of this feature rather

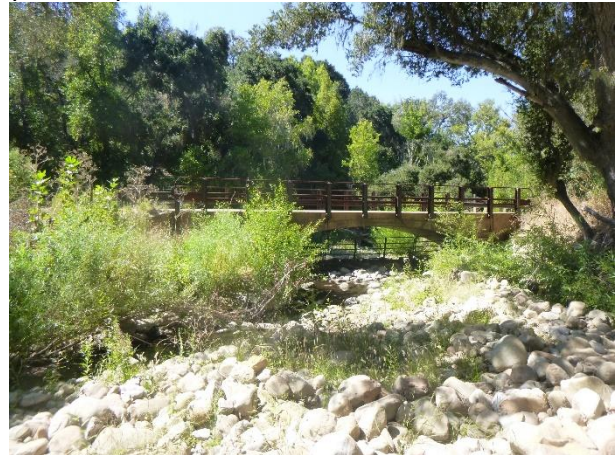
than mid-channel as intended. This resulted in some scour on the river left side and deposition of large sediment on the river right side (Figure 4). No obvious barrier has formed within this riffle feature, and it appears passable to all life stages of steelhead trout. Planning and efforts to remove the aggraded material beneath the crossing are in progress.

**Figure 4.** View, facing downstream, of the bottomless arch culvert and upstream channel, showing the shifting of the wetted channel towards river left and aggradation of substrate upstream of and beneath the crossing. Post-treatment photo date: 9/25/2023

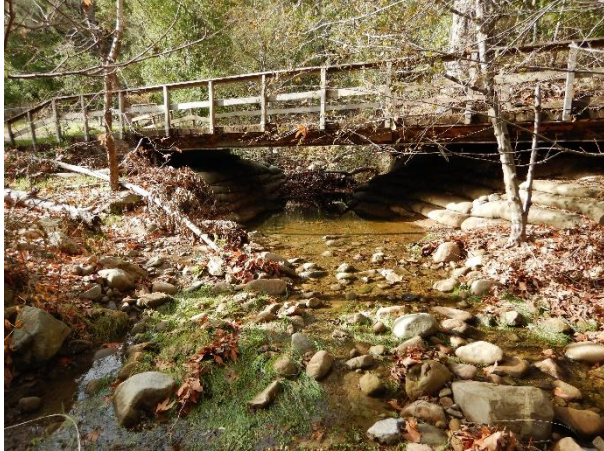
**Figure 1.** View, facing upstream, of the dilapidated bridge and concrete abutment lining. Pre-treatment photo date: 1/8/2019

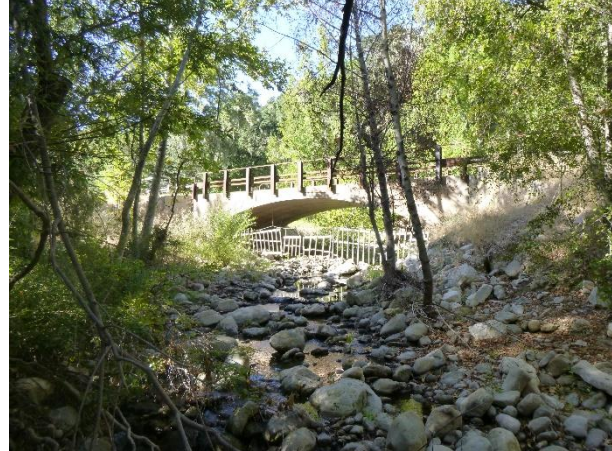
**Figure 2.** View, facing upstream, of the reconstructed channel and the upgraded bottomless arch culvert. Post-treatment photo date: 9/26/2023

The bottomless arch culvert, RSP, channel reconstruction, rock weirs, and rootwad treatments at the Quiota Crossing 8 project site were monitored for effectiveness in September of 2023, four years after implementation. The bottomless arch culvert was in good condition and functioning as intended. Channel conditions appeared good for passage for all steelhead life stages during passable flow conditions as the crossing replacement successfully removed the barrier to fish passage. The RSP features installed along both banks were functioning as intended to protect the crossing abutments from scour. Along the right bank, all the large RSP was still in place and, while only small amounts of the smaller material installed as fill between the larger rocks and boulders that make up the RSP appears to have washed out. On the left bank, some of the larger RSP at the upstream end of this feature had shifted into the channel and much of the small fill had washed out. Some sidecutting into the left bank at the upper end of the RSP and upstream of it was observed. The channel reconstructed with ESM retained the intended gradient and substrate composition, even after significant flow events following implementation. Some shifting of the smaller materials had occurred, but the larger boulders remained in place where they were installed in the channel. Overall, the channel feature still was passable and provided good habitat for fish. A pair of rock weirs installed within the channel reconstruction beneath the culvert consisted of large boulders with the intended purpose to maintain pool habitat. Following strong winter storms, the upstream weir appeared to have washed out or

potentially became partially buried under sediment. The downstream weir was still functioning, and pool habitat maintained above it as intended. The feature appeared passable to steelhead trout and the intended channel grade appeared to have been maintained. A rootwad installed at the downstream limit of the channel reconstruction was intended to form a scour pool and provide cover for fish. Although some erosion had occurred on the bank upstream of the rootwad, the feature remained in place, formed a scour, and was providing instream cover.

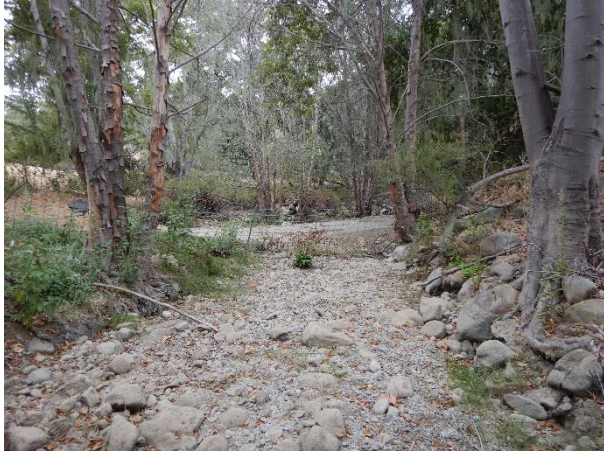
**Figure 1.** View, facing downstream, of the concrete low-flow crossing. Pre-treatment photo date: 9/5/2018

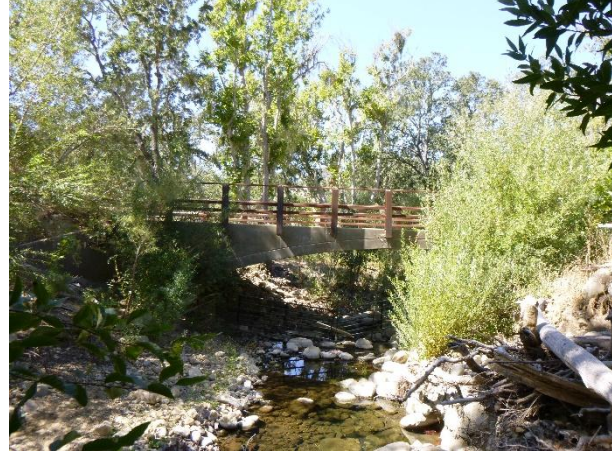
**Figure 2.** View, facing downstream, of the reconstructed channel and the upgraded bottomless arch culvert. Post-treatment photo date: 9/26/2023

The bottomless arch culvert, channel reconstruction and grade control rock weirs, and RSP treatments at the Quiota Crossing 9 project site were monitored for effectiveness in September of 2023, 5 years after implementation. Components of the bottomless arch culvert and wingwalls appeared to be in good condition and were functioning as intended. The RSP on both banks was functioning as intended to protect crossing abutments from scour. All of the large RSP was still in place, though small amounts of the smaller material installed as fill between the larger rocks and boulders that make up the RSP appeared to have washed out in some areas.

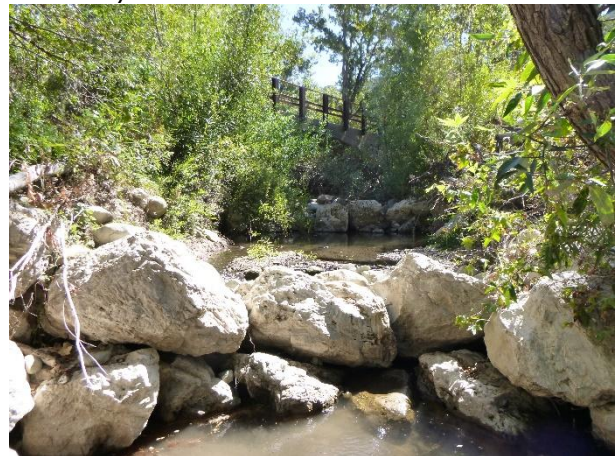
Quiota Creek experienced several severe storm and flow events during the winter prior to post-treatment monitoring which had significant effects on parts of the stream channel within this project area. The channel regrading and reconstruction with engineered stream material located upstream of and beneath the new crossing retained the intended gradient and installed ESM. Some shifting of the smaller materials might have occurred, but the larger boulders remained in place where they were installed in the channel under the culvert. Fish passage conditions through the new crossing and this section of reconstructed channel appear good. Downstream of the crossing and ESM channel section, two rock weirs consisting of large boulders that were buried under channel material were installed with the intended purpose to remain buried and maintain grade control (Figure 3). During

post-treatment monitoring, significant channel incision and scouring was observed between and downstream of the rock weirs (Figure 4). As a result, the previously buried rock weirs were fully exposed, and flow was travelling behind and through gaps in the large boulders. The condition of the boulder weirs observed during post treatment likely poses a threat to upstream fish passage. Efforts to repair these damaged and exposed grade control weirs are in progress.

**Figure 4.** View, facing upstream, of the channel incision and now exposed boulder weirs in this same section of channel. Post-treatment photo date: 9/26/2023
