Aquatic Organism Passage (AOP) Assessment

U.S. Forest Service Lake Tahoe Basin Management Unit FY 2010

By Richard Vacirca, LTBMU Forest Aquatic Biologist

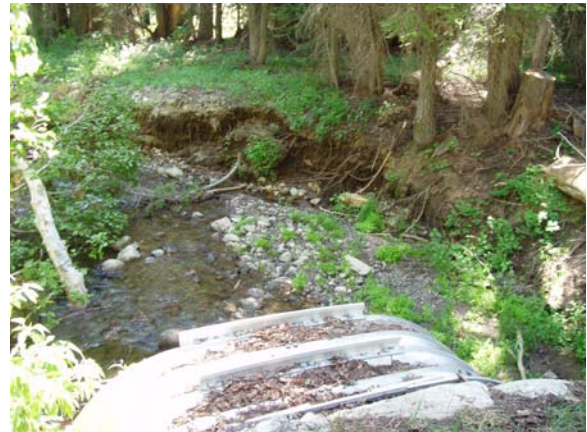
Bank erosion from an improperly aligned pipe-arch on North Fork Blackwood Creek 1

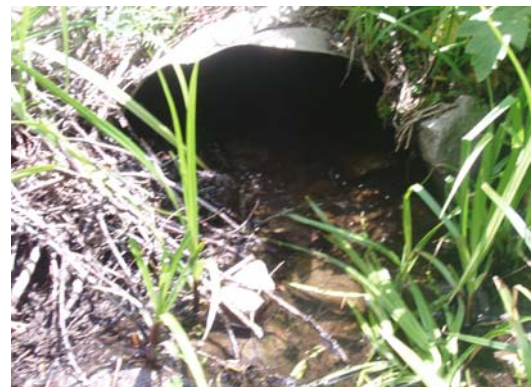
Outlet of Trout Tributary 5

An example of a crossing where conditions were not adequate to make a determination is Trout_Trib_5. Trout_Trib_5 has continuous organic substrate throughout culvert. However, the culvert width to bankfull ratio is less than 0.7 and greater than 0.5 and the culvert has no residual inlet depth. This crossing was rated grey for all lifestages of salmonid and

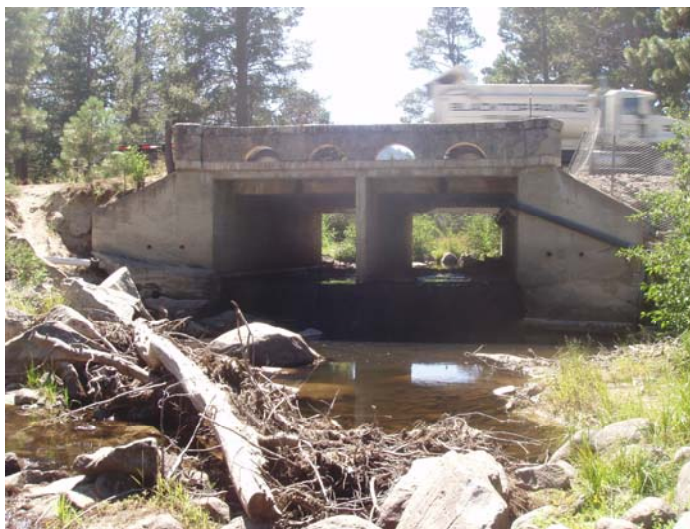
Outlet of Meeks Creek 1

The crossing at Meeks creek did not meet the criteria for fish passage (RED) and is a barrier for both life stages of salmonid due to a large outlet drop (Appendix C).

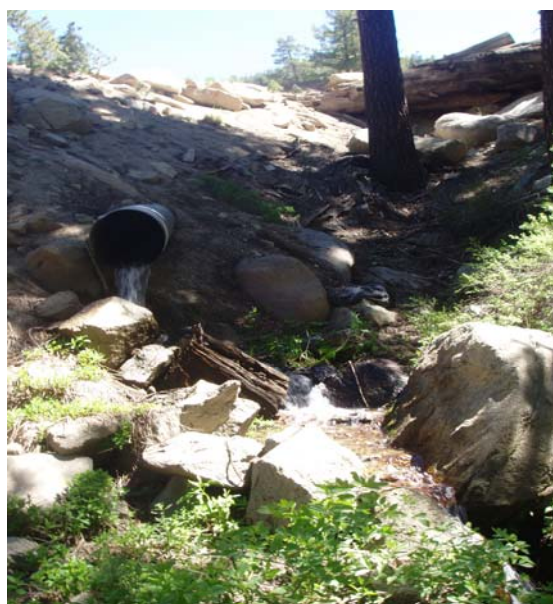
Outlet of Heavenly Valley Trib. 2

Although all full survey assessments were deemed barriers to fish passage there are a number of natural barriers that would restrict migration of salmonid in Heavenly Valley Creek. Natural barriers observed where boulder and woody debris cascades ranged from 1.5' to 5.1' in height. Appendix C is a catalog of eight natural barriers observed downstream of the Heavenly Valley Creek and Heavenly Valley tributary junction. It is currently unknown how far fish can migrate upstream from the junction of

Heavenly Valley Ski Resort is operating under a special use permit from LTBMU. The Aquatic Biologist will work with the LTBMU recreation and engineering departments on a yearly basis to upgrade crossings on Heavenly Valley Creek pertinent conditions of their operating plan.
