**HCP POND AS-BUILT REPORT  
EAST CONTRA COSTA HABITAT CONSERVANCY  
VASCO SOUZA I, HCP POND  
VASCO CAVES REGIONAL PARK  
BYRON, CALIFORNIA**

**PROJECT APN #: 005-160-005**

**September 10, 2009**

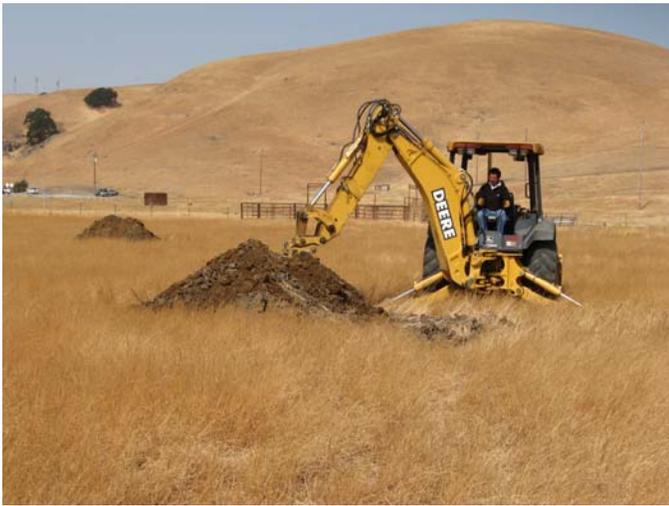
Prior to grading the new pond, subsurface soil profiles were assessed to determine if suitable soils were present in the subsoil profile (Attachment B, Photograph 1). Four “potholes” were

excavated and subsoils were examined to two feet deeper than the design elevation of the pond bottom. Soils were classified by the Soil Conservation Service (now Natural Resource Conservation Service) to be Pescadero Clay Loams. The actual soil profile determined that there were “fat” clays in the first 1 to 3 feet of the soil profile which were deemed suitable for ponding water. Fat clays are expansive and typically have low permeability (thus such soils readily pond water). From 2 feet to deeper than 5 feet soils were determined to consist of a sandy loamy/clay mix with likely moderate to high permeability, and thus were deemed less than desirable for ponding water.

Photograph 1. Assessment of soil profiles prior to construction.

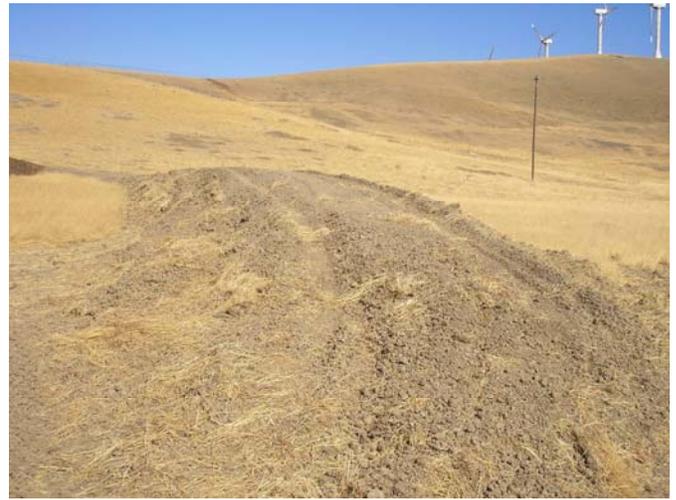
Photograph 2. Removal and stockpiling of 3" layer of organic topsoil.

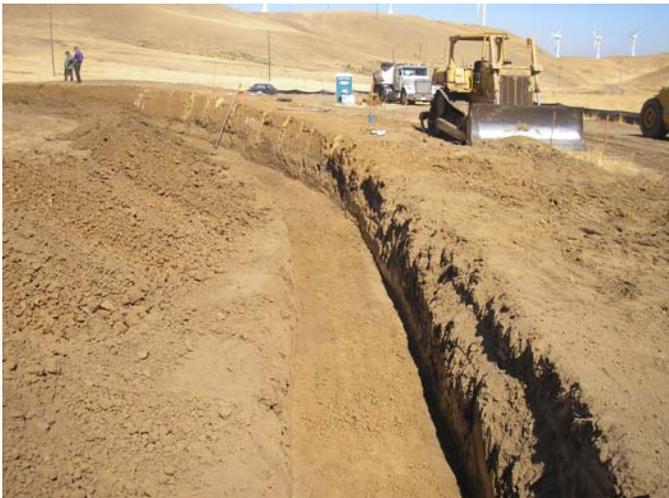
Then the pond berm was created by initially digging a 5.0-foot wide by 4 foot deep (below pre-existing grades) keyway (“trench”), and then filling and compacting clay soil in the keyway (Attachment B, Photograph 3). The berm was then constructed with native soils above the keyway. After the berm was configured and compacted, ½ the berm was graded back along he long axis of the berm. This allowed for the installation of an 80 millimeter thick high-density polyethylene (HDPE) liner, which was secured against the vertical cut using soil that was deposited in lifts and a sheep’s foot compactor (Attachment B, Photographs 11 and 12). The removed ½ of the berm was deposited and compacted to achieve the design shape of the berm. The HDPE liner was installed at an elevation that was 1-foot below the over-excavated elevation of the deepest portion of the pond (i.e., one foot below the 3-foot pool area or to 556-feet). The HDPE liner top elevation was set just below the finished grades of the berm (See Sheet 1, Section 2 – Attached).

Photograph 3. Keyway creation before installation of HDPE liner.

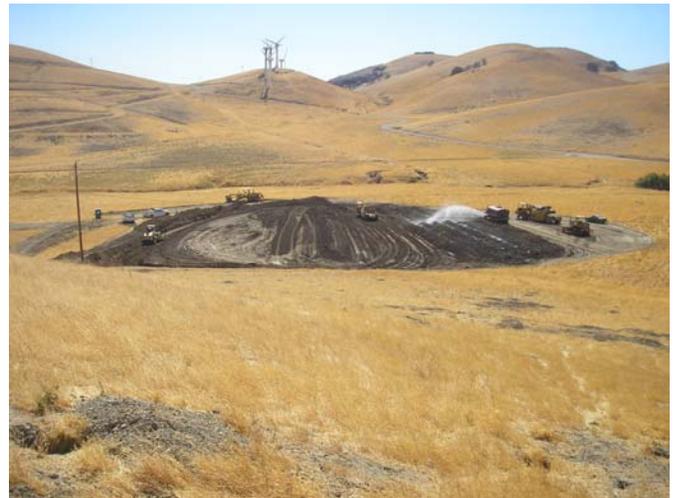
Photograph 4. Rough grading of pond basin.

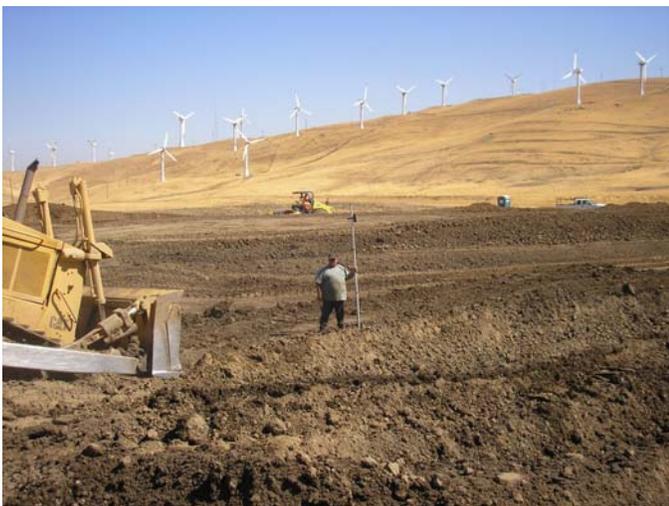
Design soil layer elevations were achieved and verified via use of a laser level (Attachment B, Photograph 5). The actual grading methods used to complete the designed soil profile in the pond bottom included over-excavation of sandy loam soils and replacement with clay soils to design elevations over 20-foot wide grader/scrapper passes that were systematically completed over the entire pond bottom (think of mowing a lawn in systematic strips). Upon over-excavation of sandy loam soils, clay was laid down and compacted in overlapping 8-inch lifts (Attachment B, Photographs 6 and 7). GIS technology was used to ensure that graders/scrapers stayed located on

Photograph 5. Use of laser level to determine basin elevation.

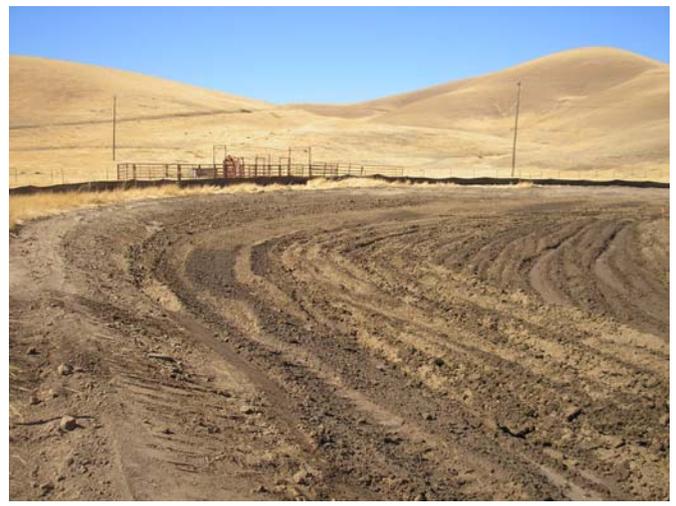
Photograph 6. Clay layer added in pond bottom.

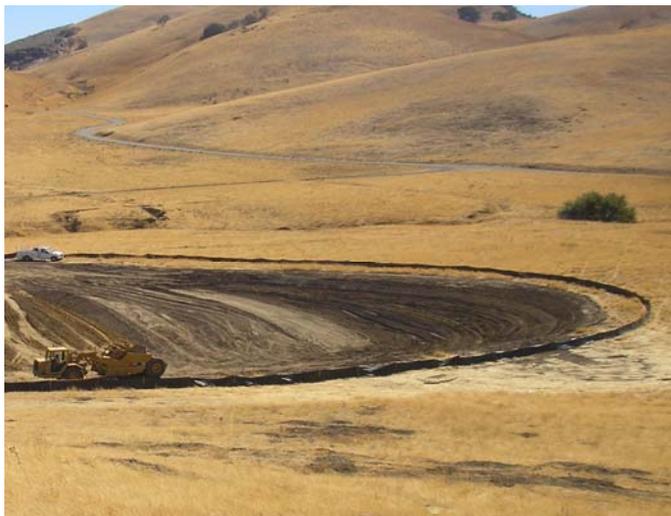
Photograph 7. Clay layer added to side-slopes.

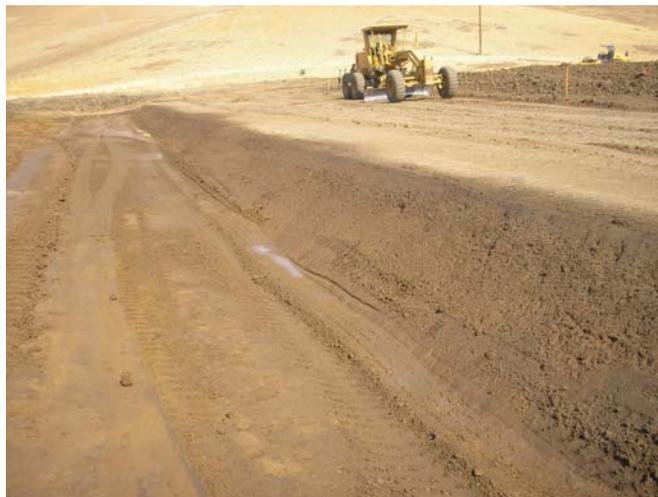
The clay liner was compacted to provide a “tight” soil profile that upon inundation would minimize the potential for vertical and lateral percolation. To achieve the design compaction specification for the clay liner, upon installation of the 8-inch clay lifts, each lift was moistened and compacted into the pond bottom with a sheep-foot compactor to achieve approximately 90 percent relative compaction or greater (Attachment B, Photograph 8). Compaction testing was completed by the contractor and verified in the field by M&A staff biologists.

Photograph 8. Placement of 2-foot compacted clay layer in bottom of pond.

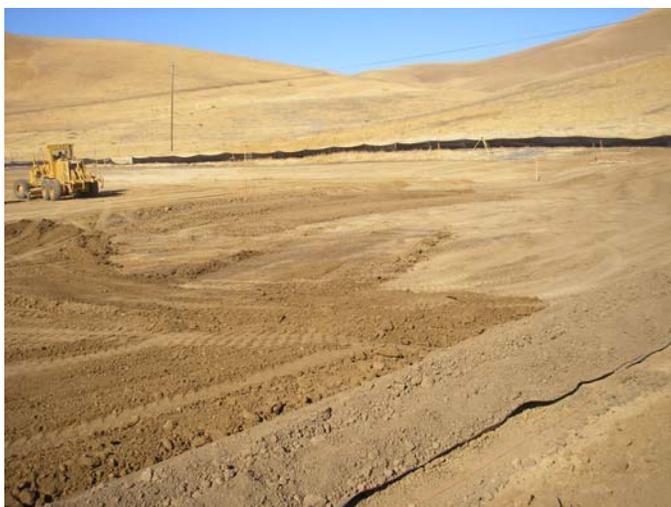
Photograph 9. Placement and compaction of sandy clay layer.

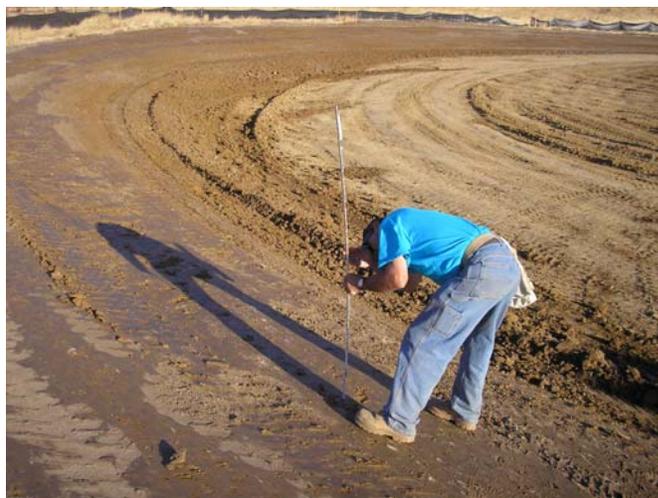
After the clay layer was completed (i.e. installed and compacted) the pond bottom was surveyed with a laser level to ensure that the targeted pond bottom was level and at 0.5-feet below the finished grade (i.e., was at 558.5-feet in elevation). These field measurements were taken by the contractor’s grade setters and verified in the field by M&A biologists. The tolerances allowed in the bottom of the pond were plus or minus 2 inches. Upon confirming a “flat bottom,” a final 6-inch lift of the excavated sandy loam soil was applied to the pond bottom and side slopes to bring the depth of the pond bottom to the design elevations (Attachment B, Photograph 9). The applied sandy clay layer (“cap”) was lightly compacted and the final pond bottom elevations were again measured and confirmed by M&A biologists to be in compliance with the designed finished grade elevations (Attachment B, Photograph 10).

Once the outline of the basin had been achieved and the desired soil layers compacted into place, the side slopes and bottom of the pond basin were further shaped to achieve a uniform bottom and side-slopes which conformed to the 3:1 slope ratio outlined in the pond design plans (Attachment B, Photograph 10). In addition, the disturbed area was “naturalized” so that the graded surface of the pond margin and side-slopes blended with the surrounding upland topography to achieve a naturalistic contour.

Photograph 10. Verifying slope during grading of side-slope of pond.

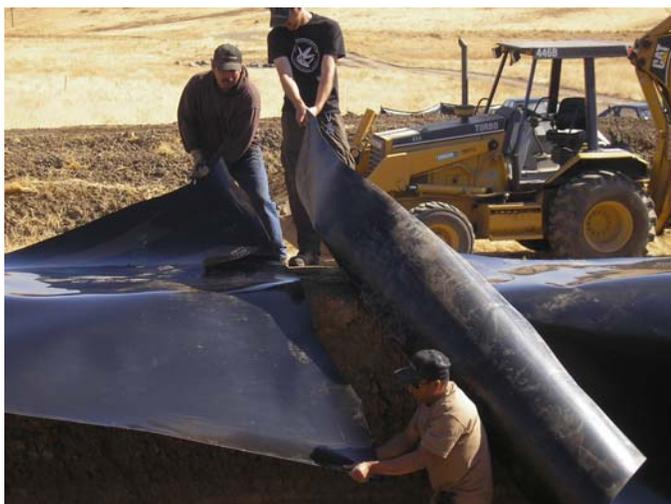
Photograph 11. Installation of HDPE liner in berm.

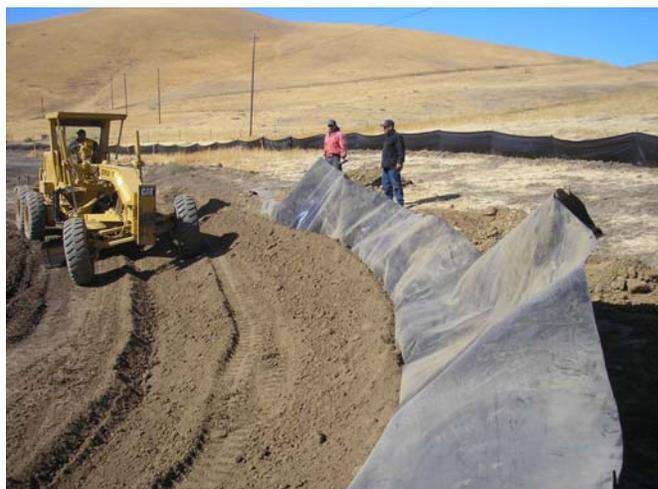
Photograph 12. Compaction of soil along HDPE liner in berm.

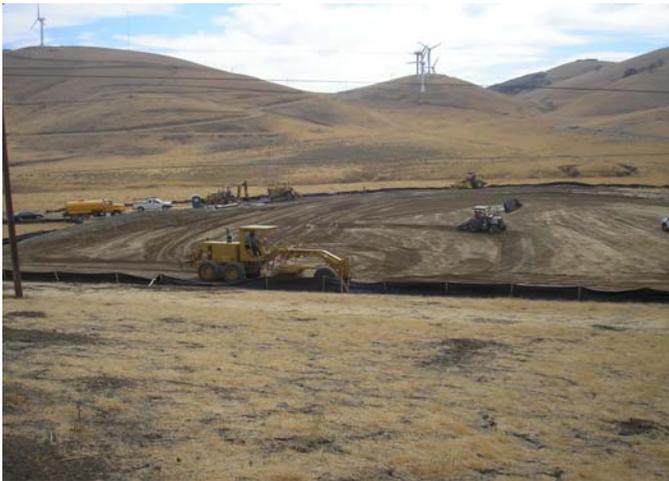
Photograph 13. Grading of 2' and 3' deep sections of the pond.

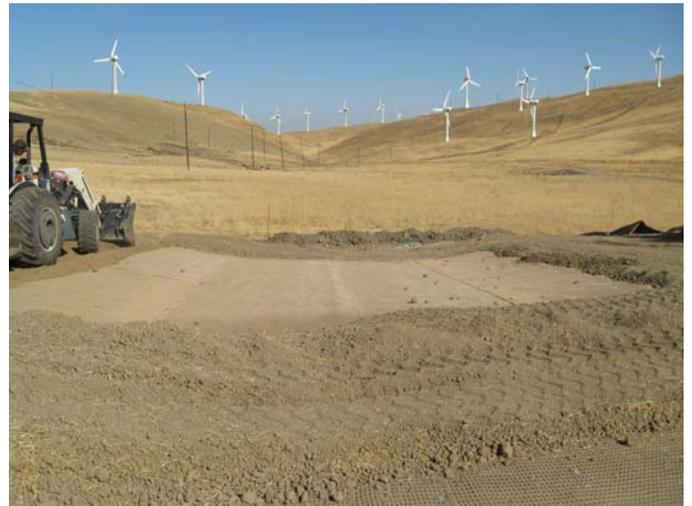
To reduce erosion, the overflow spillway was lined with Pyramat®, an erosion control geotextile. This geotextile “channel liner” is designed to trap soil and promote vegetation growth through the material. The geotextile “channel liner” was anchored on 2-foot centers within the created overflow spillway using 12 inch spikes. All outside edges of the Pyramat® were anchored with 12-inch spikes in 12-inch deep toe trenches that were backfilled and compacted. After Pyramat® installation was complete; a thin layer (1 inch) of organic soils was spread over the Pyramat® surfaces to promote vegetation growth (Attachment B, Photograph 14).

Photograph 14. Spreading of soil layer over Pyramat (geotextile) armament in exit spillway.

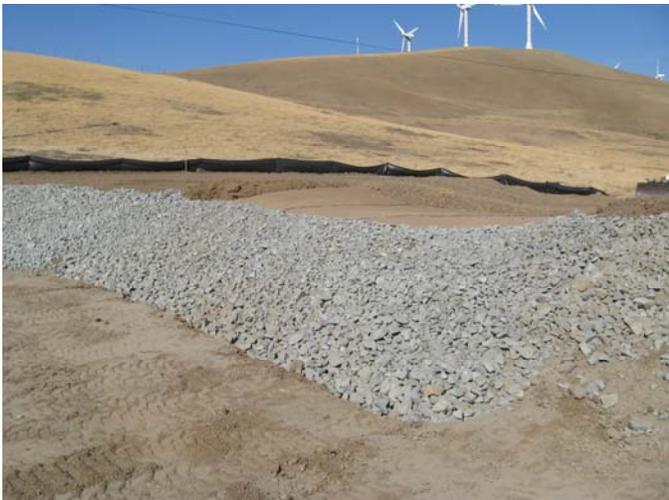
Photograph 15. Installation of rip-rap in front of berm.

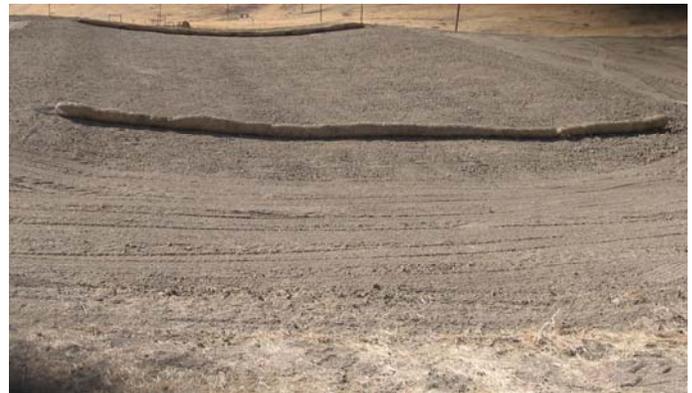
The in-board (in-pond) berm side slope was constructed to conform to the 3:1 slope ratio detailed in the pond design plans (Attachment A, Sheet 2). In addition, 3 to 4-inch riprap was installed on the face of the berm to prevent future erosion of the berm from lapping water (i.e., from “wind fetch”) (Attachment B, Photograph 15). The riprap extends along the entire length of the berm including around the spillway opening on the in-board face of the berm. This riprap was installed in contour (i.e., below finished grades) and buried with native soils to the desired berm shape, slope, and elevation so that it was all but invisible in the finished pond (Attachment B,

Photograph 16). While this rock will become exposed where erosion occurs, over the majority of the berm it will remain under soil and vegetated, and thus essentially invisible except in the erosion zone.

Photograph 16. Finished exit spillway looking west to upper edge of pond.

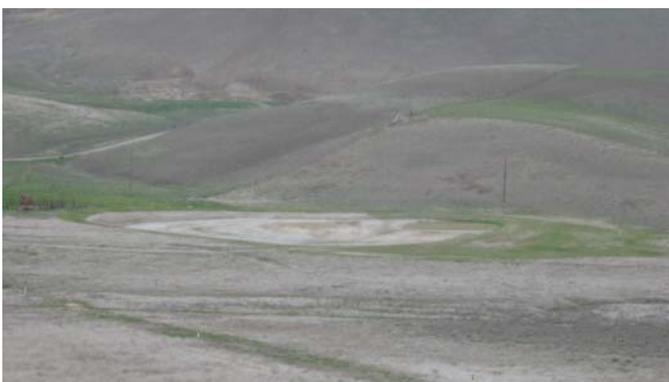
Photograph 17. Finished pool and spillway looking northwest.

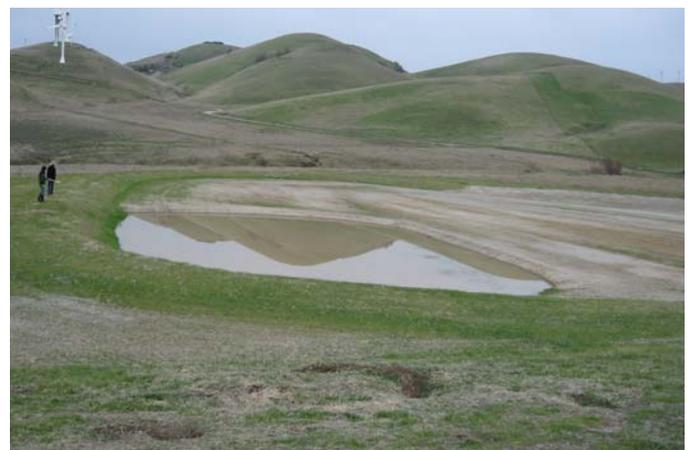
Photograph 18. Finished 1', 2' and 3' foot deep sections looking south.

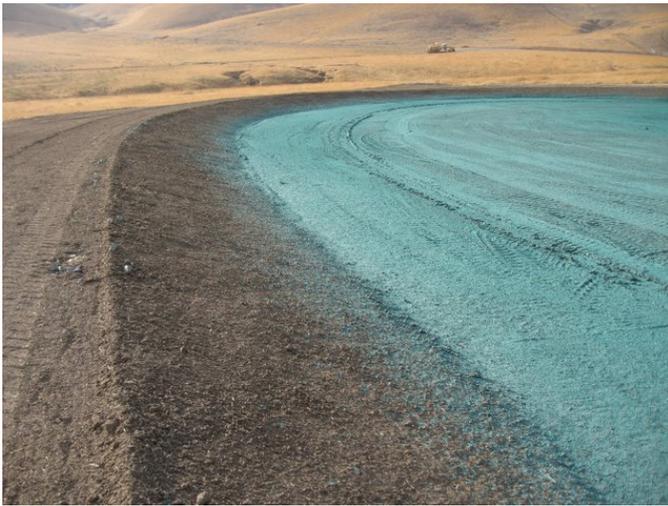
All disturbed areas around the pond were hydroseeded with a mulch matrix containing a California native seed mix. Separate prescriptions were applied to upland areas vs. the pond bottom. The pond bottom (1.09-acre) was inoculated with a seed mix provided by Pacific Coast Seed (Attachment B, Photographs 19-21). This seed mix included:

Photograph 19. Hydroseeding of pond seed mix.

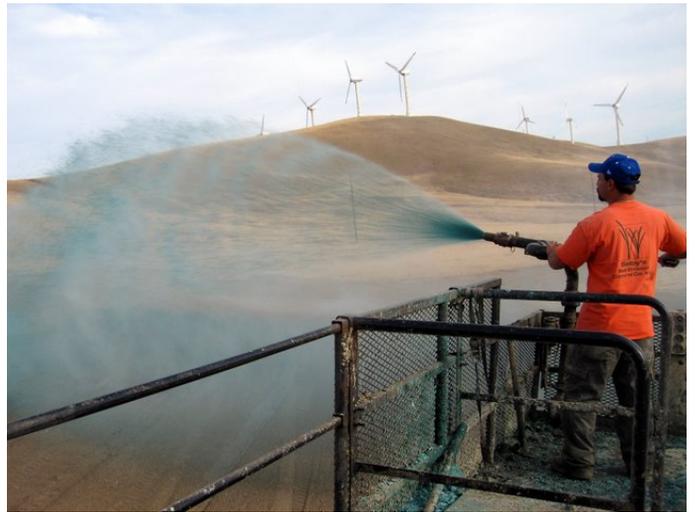
Photograph 20. Spraying of upland seed mix.

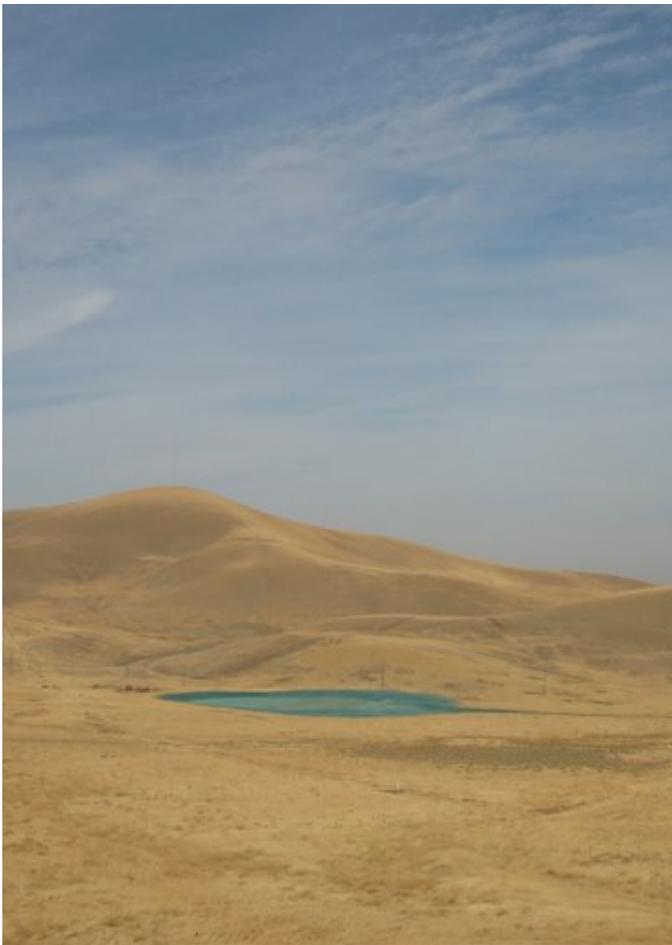
Photograph 21. Entire pond after hydroseed mix application.

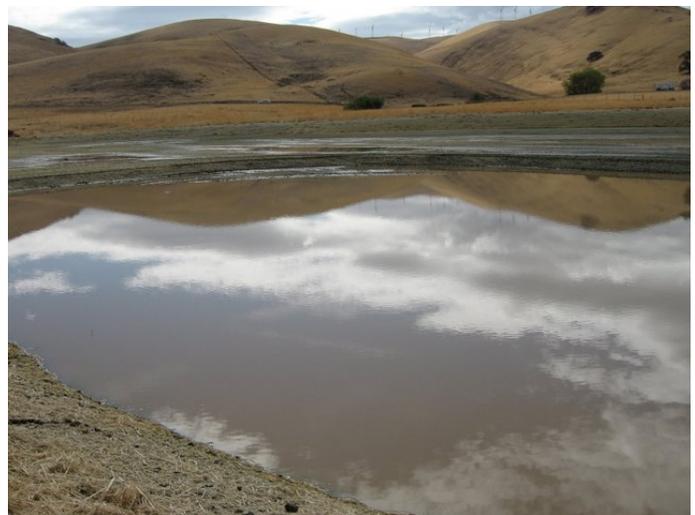
Photograph 22. Facing south, showing inundated 3' and 2' levels seen during 11/03/2008 site visit.
