Site Name: Culvert Stream Crossing

Stream Name: Gobernador Creek

PAD ID: 706499

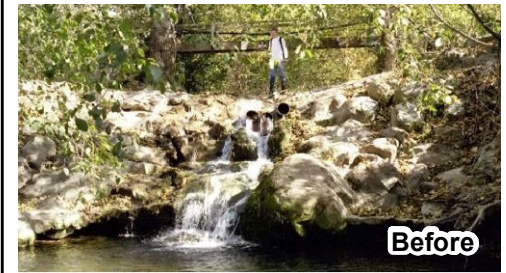
Notes: Before: Total barrier. The downstream pool has sufficient depth for a steelhead to execute a vertical jump of at least six feet and likely more during high flows as the pool becomes deeper. During migration flows, the 10-foot vertical jump and 15-foot horizontal jump to the crossing make this structure impassable to upstream migrating steelhead. The small, smooth metal culverts provide no opportunity for fish passage.

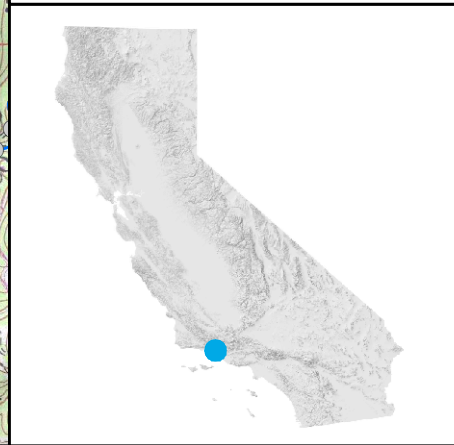
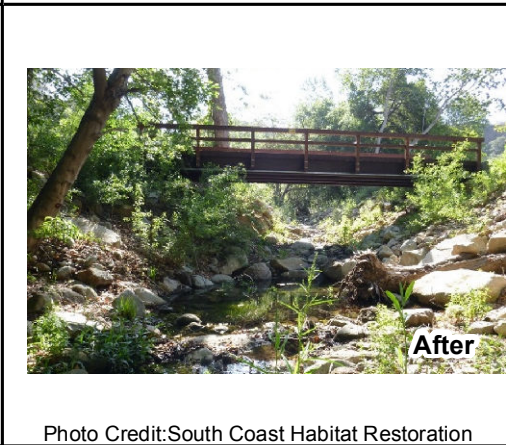
Site Status After Remediation: Remediated, fish response unconfirmed

Year Remediated: 2011
