**Site Name:** A-6 Road

**Stream Name:** Glenbrook Gulch

**PAD ID:** 730616

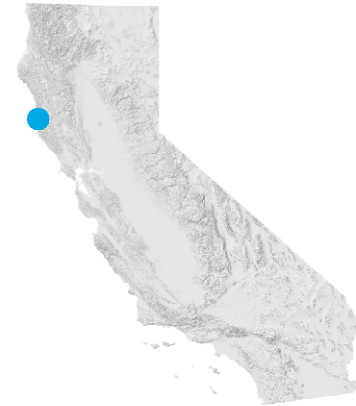
**Before**

**Barrier Description Prior to Remediation:** Total

**Notes:** Glenbrook Gulch Anadromous Fish Habitat Restoration Project. Per CDFW, this was a total barrier. After treatment, 1 redd and an abundance of juvenile coho were observed upstream in a 2013 spawner survey. Funded by CDFW FRGP. Before: "Unknown" passage status.

**Site Status After Remediation:** Not a barrier
