Site Name: removed culvert and rerouted channel

PAD ID: 737273

Tributary To: Dunn Creek

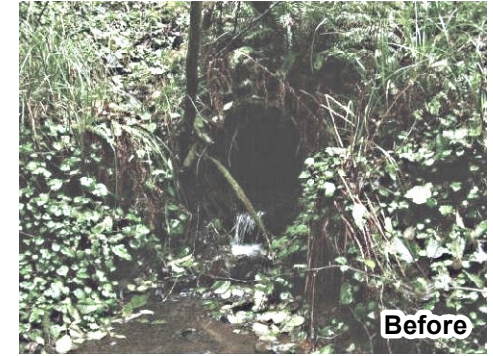
Barrier Description Prior to Remediation: Temporal & Partial

Notes: Removed in 2011; rerouted channel and created low-gradient backwater habitat. BEFORE: 3-foot culvert, barrier to adult and juvenile salmonids, 36 inch CMP Culvert. Was a 'temporal & partial' barrier.
