Site Name: Rooney Brothers Dam (RM 25)

Stream Name: Cosumnes River

PAD ID: 758044

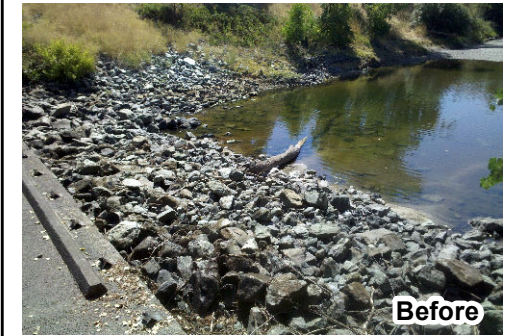
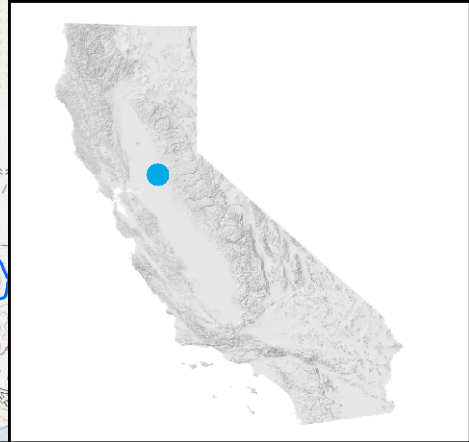
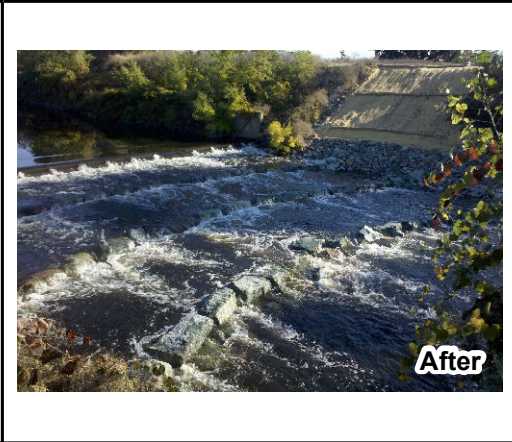
Barrier Description Prior to Remediation: Temporal

Notes: Remediation completed in 2010 with U.S. Fish and Wildlife Service Anadromous Fish Restoration Program funds; boulder weirs installed with resting pools in between. Post-barrier removal: Per January 2013 Fishery Foundation of California (FFC) Report, there has been a small amount of lateral scour adjacent to the lowermost weir on the south bank which may affect passage in the future. The FFC will continue to monitor this erosion over the next several years. Fish were observed readily passing the weirs at flows as low as 50 cfs and at no time during post project surveys were fish observed to be milling below the weirs. In the Fall of 2013, post-project monitoring by FFC documented unimpeded passage at flows as low as 30 cfs. Passage at flows below are still problematic but are expected to improve as the weir fills with sediment. BEFORE: small flashboard dam with a very steep rock approach leading up to the concrete footing that supports the flashboards. This was a temporal barrier prior to removal. Per FFC, it had a steep, four foot drop over large boulders on the downstream face of the dam. This configuration was responsible for a significant stranding event in 2002 and caused many salmon to spawn downstream of the structure in poor habitat. Temporary measures were taken in 2002 and 2003 to improve passage but those measures were only marginally successful.
