Santa Clara River Steelhead Trout: Assessment and Recovery Opportunities

December 2005

Prepared By:

Prepared For:

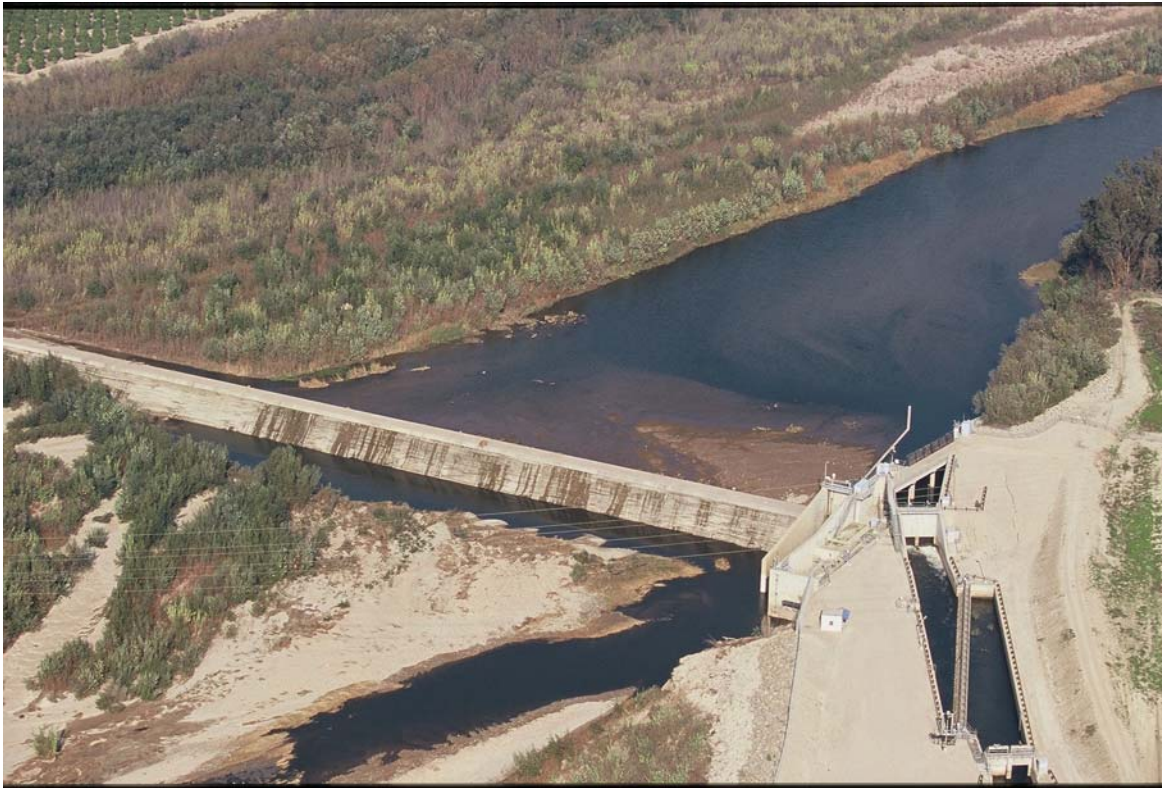
Description: The structure is owned and operated by Bureau of Reclamation and United Water Conservation District (UWCD). The current dam measures 1200 feet across and 20 feet tall from the crest to the downstream concrete apron. The dam extends an additional 50 feet down through the substrate and keys into bedrock. The current Vern Freeman Diversion Dam and associated Denil Fishway were built in 1990. Prior to the construction of this concrete dam, various temporary earthen diversion dams existed and occurred upstream from the current diversion dam location. These older dams diverted flows into an earthen channel built along the side of the river and water moved downstream to near the existing holding ponds by gravity. Murray McEachron of UWCD reported that the first company to divert water started operation in 1875. UWCD bought the operation in 1927 and at this time surface flows were generally only diverted during lower flows encountered in the summer and fall with a temporary earthen dam that blew out during the winter. In the 1940's winter flows started being diverted and a steel and piling diversion structure was built in 1968 to increase the ability to withstand the high winter flows and expand the diversion season. The flood of 1969 reportedly destroyed this new structure. From 1970 to 1990, UWCD reportedly operated an earthen dam that could survive mainstem flows up to 2000 cfs at which point the dam was blown out. This dam reportedly diverted all steelhead smolts into the diversion channel when operating and was also impassable to upstream migrating adult steelhead due to the excessive outlet drop. For twenty years upstream steelhead passage could only occur during high flow years that exceeded 2000 cfs and destroyed the dam.

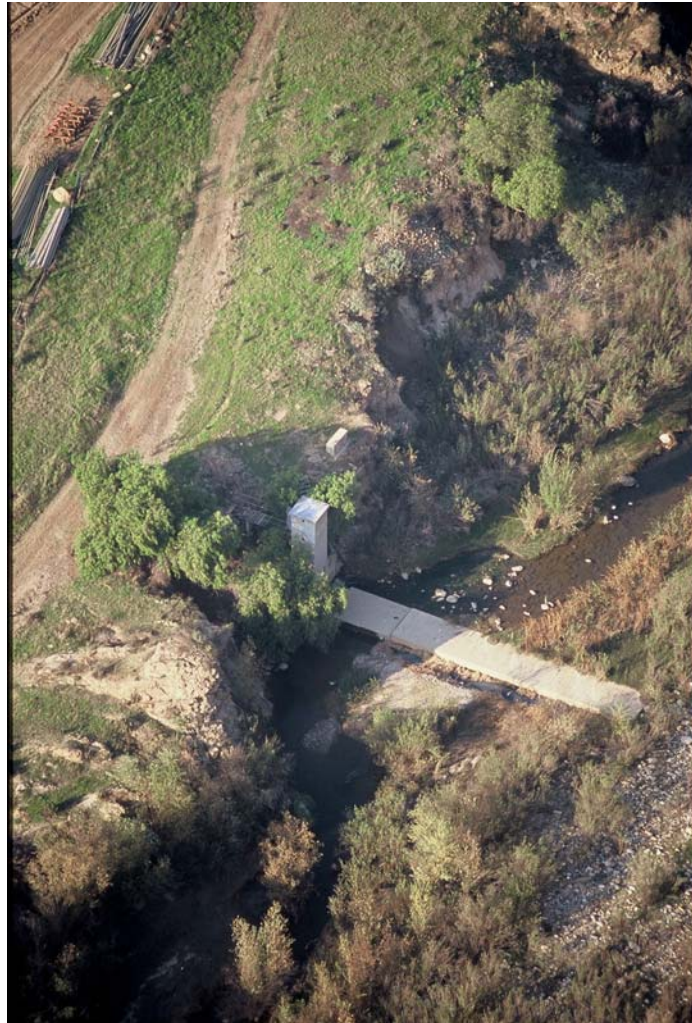
Description: Access to survey this structure was not obtained and limited observations were made from the air. This structure appears to be a gaging weir with a tall gaging-type structure occurring adjacent to the concrete weir on the river-right bank. Surface flows were observed to be focused across the weir on the far river-right side. Flows appeared to drop at least 2 feet 6 inches from the weir outlet to the surface of the downstream pool.

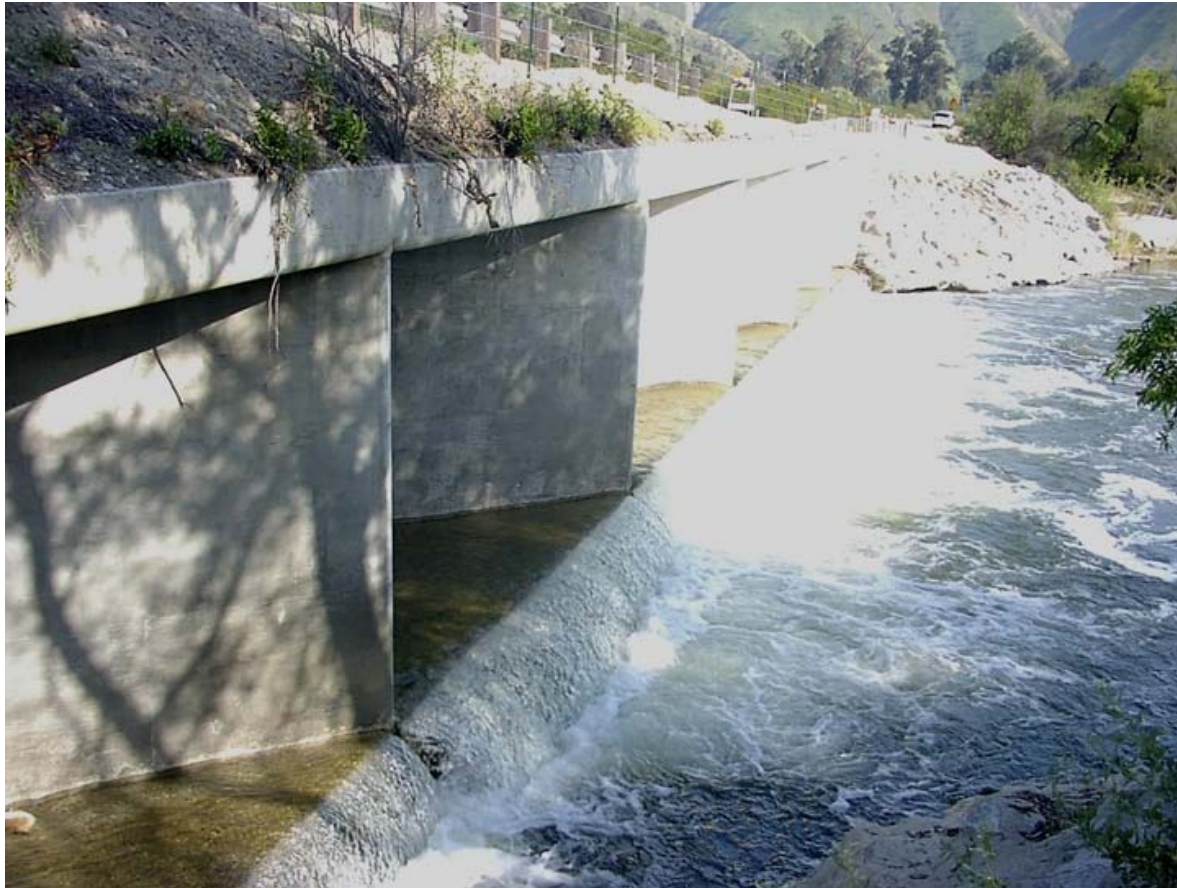
Description: Due to lack of access to adjacent private land, limited observations of this culvert were made. This 6-box concrete culvert appears to have a mild gradient and approximately 12-inch outlet drop during the fall of 2004. The structure appears to be in good condition.

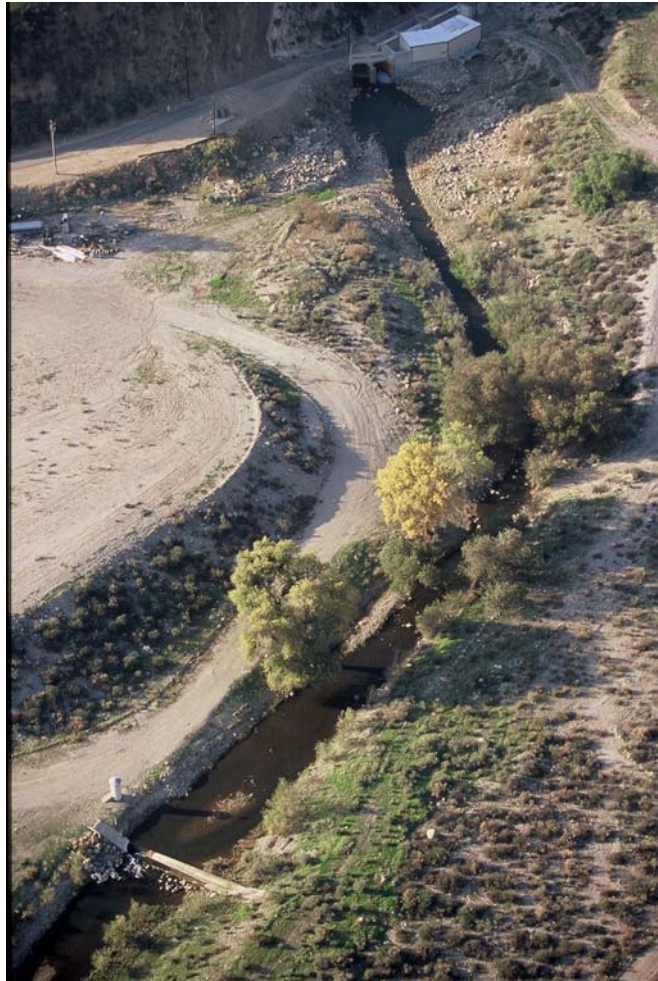
Weir/Dam (SC_PU_3) - Piru Creek

Description: Access to survey this structure was not obtained and limited observations were made from the air. This structure appears to be a concrete weir or possible obsolete diversion dam. An outlet pipe was observed on the downstream side. The structure is approximately 4 feet thick with 6 feet of boulder rip-rap protection forming a cascade-like apron on the downstream side. The total height of the structure from the downstream pool surface to the outlet lip of the dam is approximately 4 feet 6 inches.

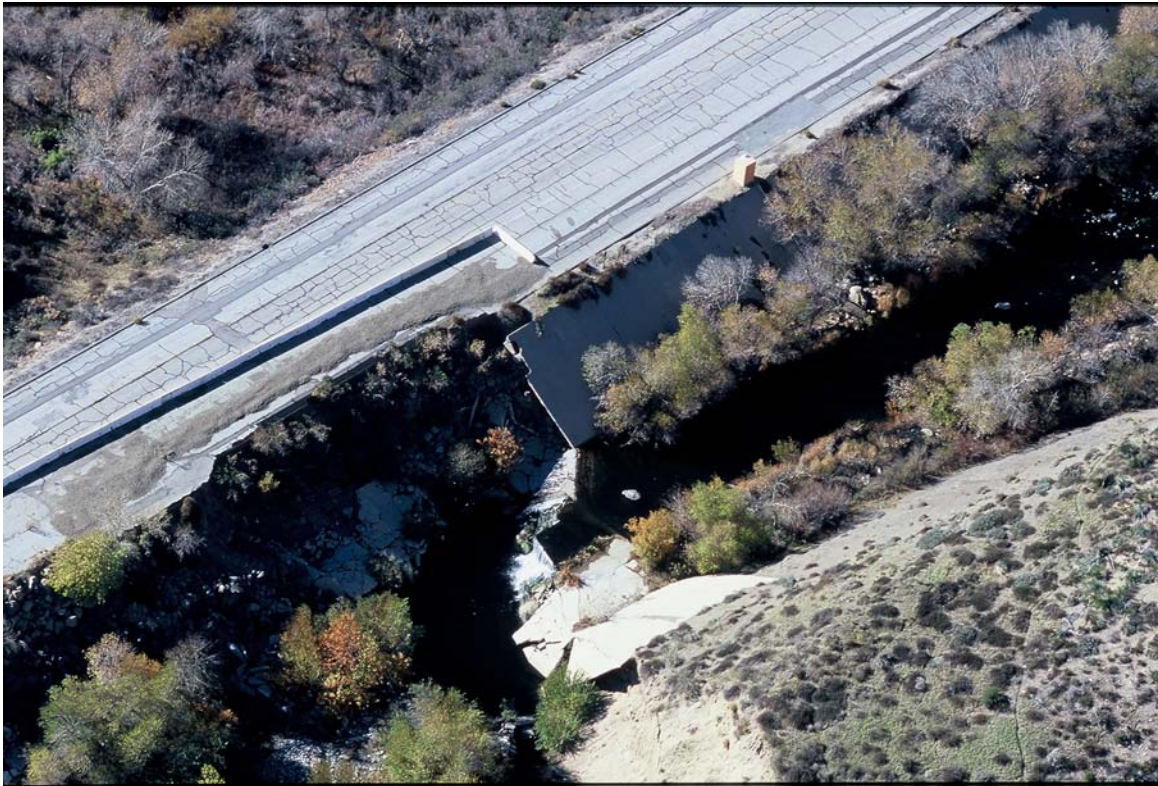
Description: Access to survey this structure was not obtained and limited observations were made from the air. This concrete channel appears to be several hundred feet long and is in poor condition with sediment deposits and riparian vegetation occurring within the channel. Concrete appears to be broken in several locations and an outlet drop of at least 5 feet has considerable downstream scour associated with it that has eroded adjacent banks and undercut the concrete channel.

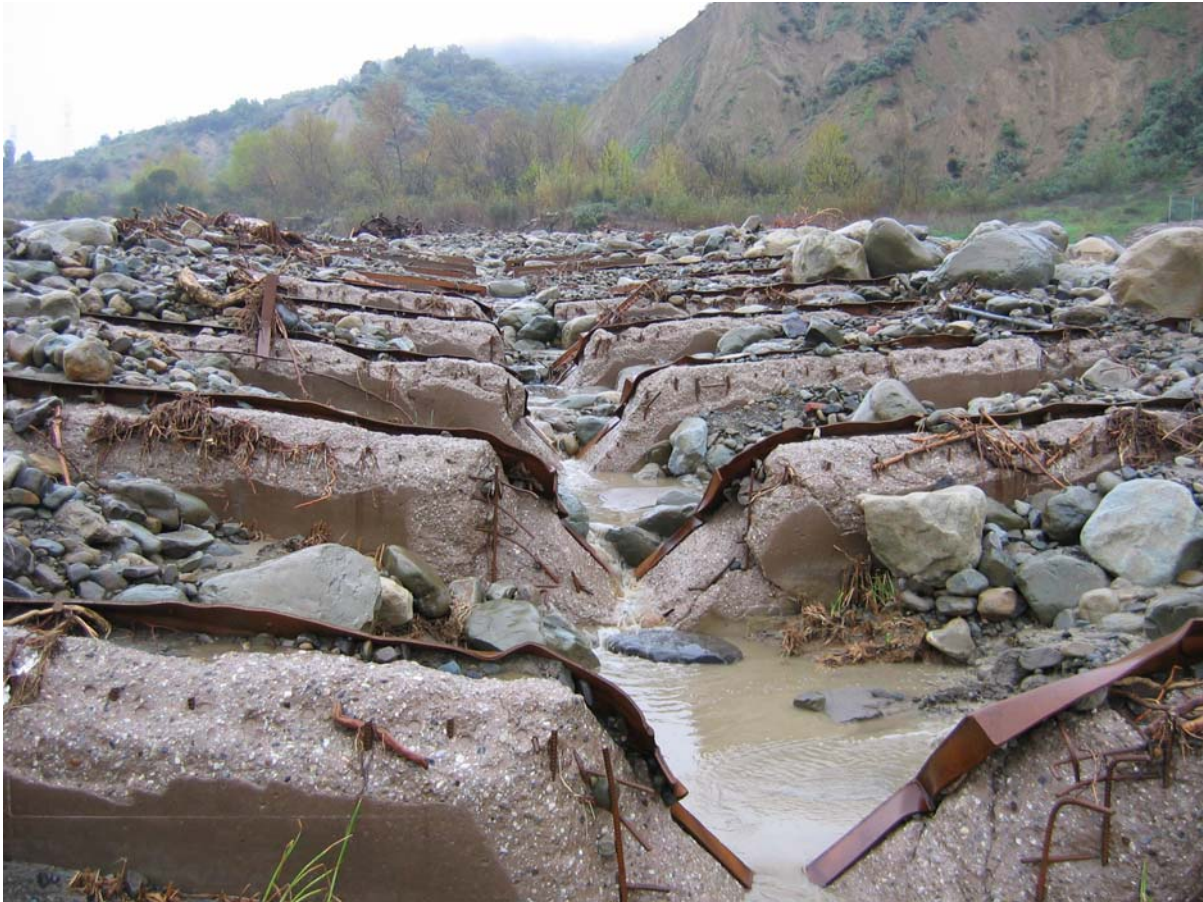
Fishway failure following January 2005 flows

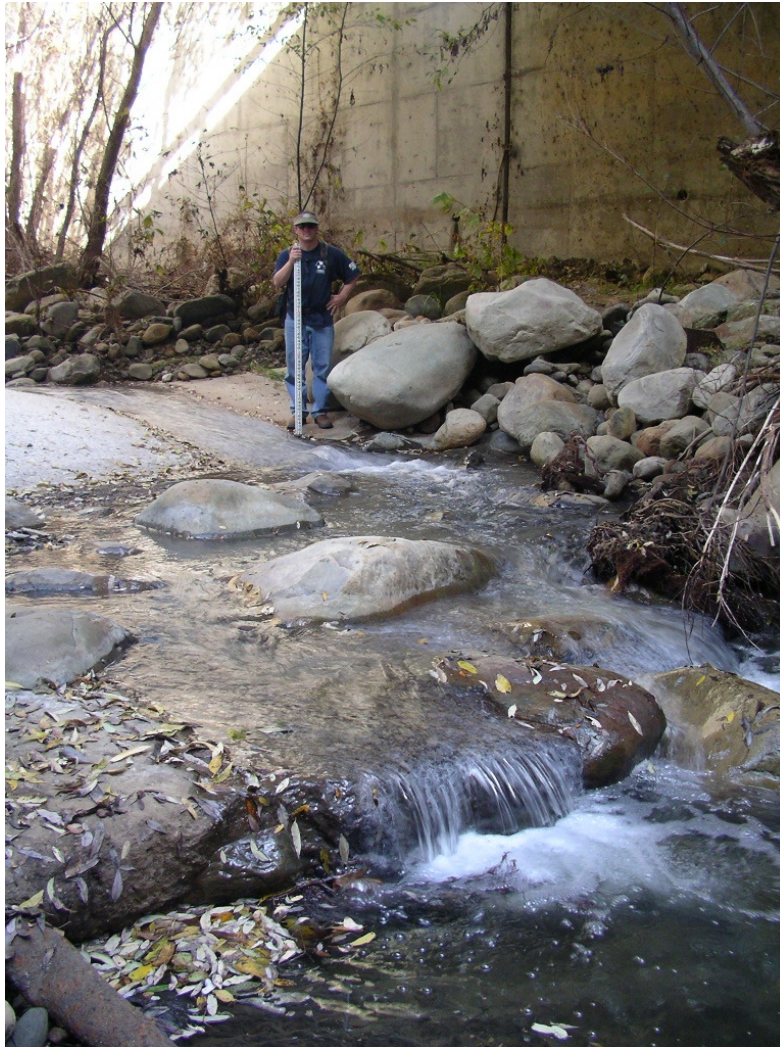
Description: This concrete grade control structure occurs under the Highway 150 Bridge and extends 25 feet 6 inches from the upstream lip to the sill of the downstream concrete and boulder apron. The upstream portion of concrete extends 13 feet with an elevation change of 1-foot 4 inches and a slope of 10%. The lower apron extends a maximum of 12 feet 6 inches and is relatively flat with numerous large embedded boulders. Flows drop 1-foot 2 inches off the apron into a pool with a maximum depth of 1-foot 2 inches. The structure ties into the vertical concrete bridge supports. Substrate occurs on top of the river-left side of the grade control structure.

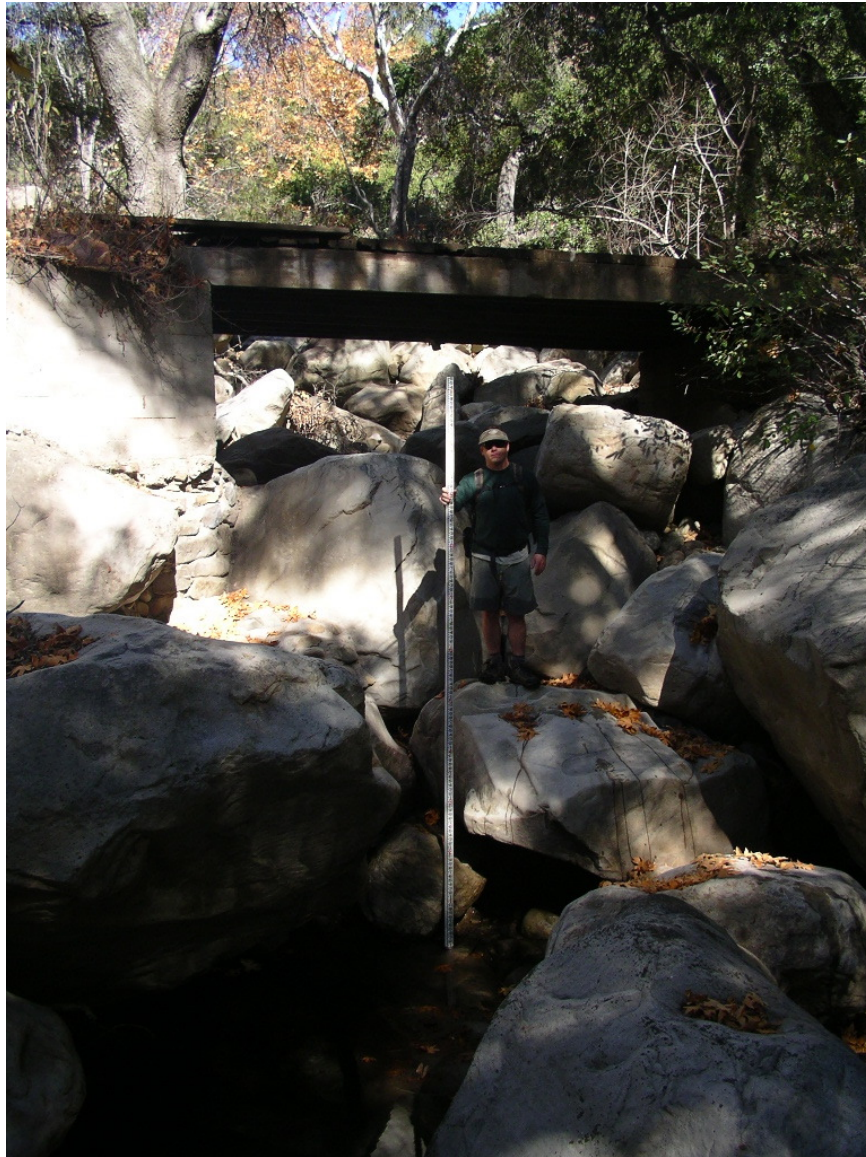
Description: This old, wood bridge spans 18 feet between concrete footings that are poured on large boulders within the stream channel. While the channel is natural underneath the bridge, the active channel width of the creek upstream and downstream is 24 to 28 feet across and the constricted bridge footings appear to have created a boulder blockage barrier. The concrete footings may be preventing large substrate mobility and exacerbating the steep boulder cascades occurring upstream and downstream of the bridge. Clearance under the bridge is only 5 feet 6 inches and the owner informed us that during the 1969 floods large boulders and flow by-passed the bridge on the river-right (pers. comm. B. Dron 2004). The original bridge was reportedly built in the 1930's. Surface flows also subside immediately upstream of the bridge for over 100 feet further indicating that substrate is being deposited upstream of the bridge. Downstream of the bridge a drop measuring 8 feet 8 inches occurs to a small 2-foot 1-inch deep pool. The bridge is partially burned from local fires and is in poor condition.

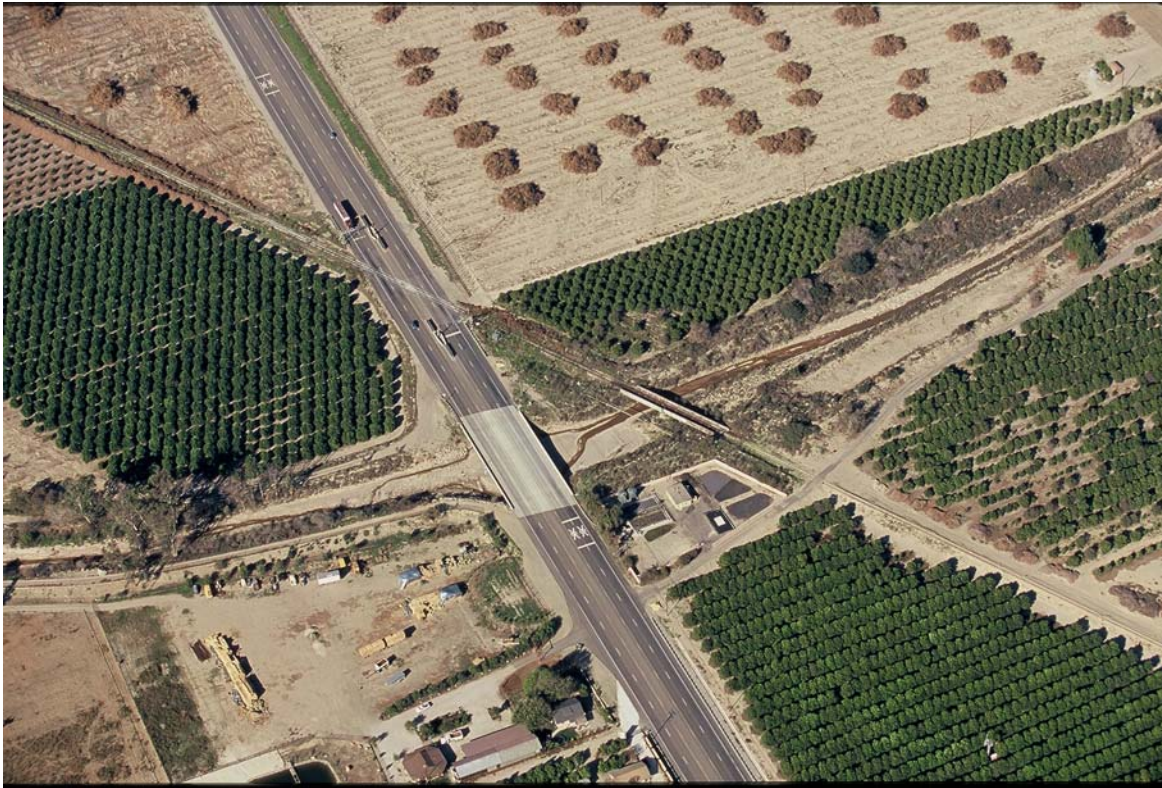
Description: Permission to access adjacent private lands to survey this crossing was not obtained and observations were limited from the bridge and air. The concrete apron occurs just upstream of the bridge and continues under the bridge. No drops were observed and the slope of the apron could not be determined.

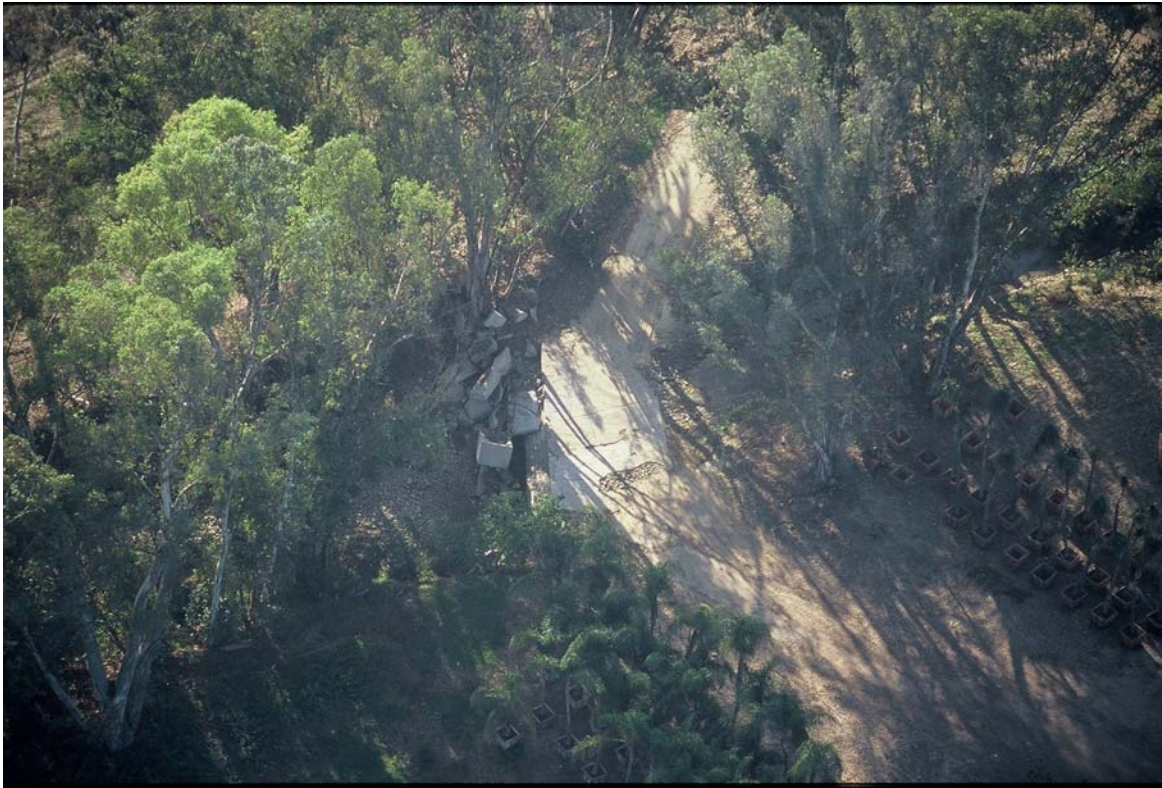
Description: Permission to survey this crossing was not obtained and observations were limited from the air. The concrete crossing occurs adjacent to a nursery just upstream from the confluence with Sespe Creek and the Santa Clara River flood plain. This private crossing appears to be in extremely poor condition with noticeable concrete failure and downstream scour and undercutting observed. An outlet drop of at least 5 feet occurs. The crossing appears to be approximately 12 feet wide and no culvert was observed from the air.

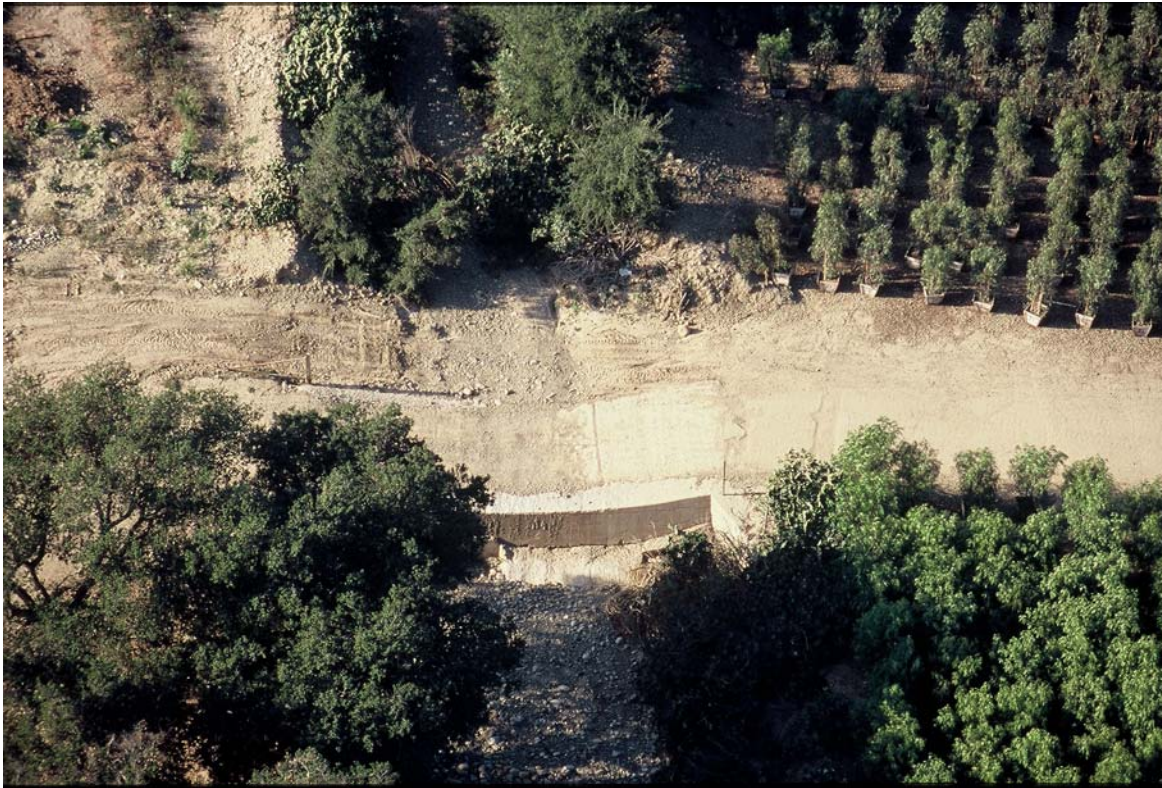
Description: Permission to survey this crossing was not obtained and observations were limited from the air. The crossing occurs just downstream from the railroad crossing culvert. This private crossing appears to be in poor condition. An outlet drop of at least 5 feet occurs. The crossing appears to be approximately 12 feet wide and no culvert was observed from the air.

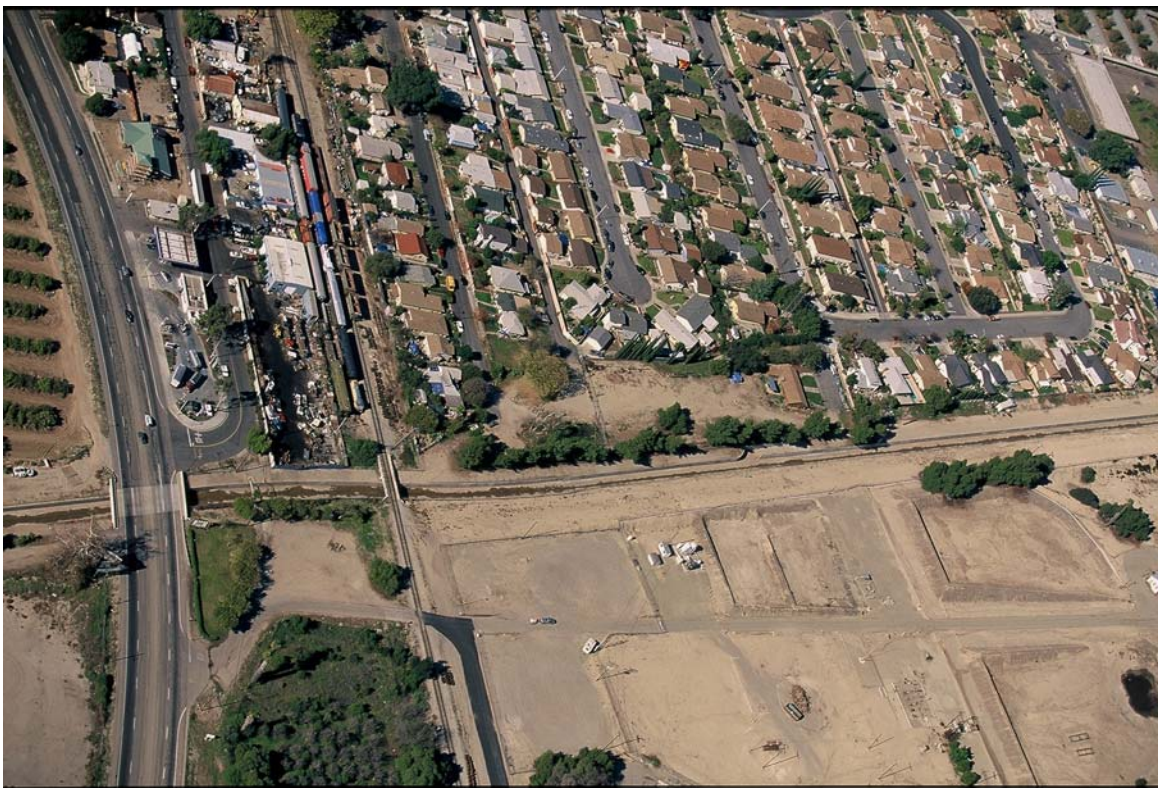
Description: Project budget and scope precluded ground surveying efforts on Pole Creek, but limited observations were made from the air. This concrete channel extends approximately 6,500 feet in length from the Santa Clara River upstream adjacent to the eastern end of Fillmore. The lower portion contains earthen levees, while the upper portion is a concrete box culvert with a steep inlet apron. The earthen and concrete channels appear to have mild gradients with deposited substrate present. The concrete inlet apron appears to be steeply sloped.

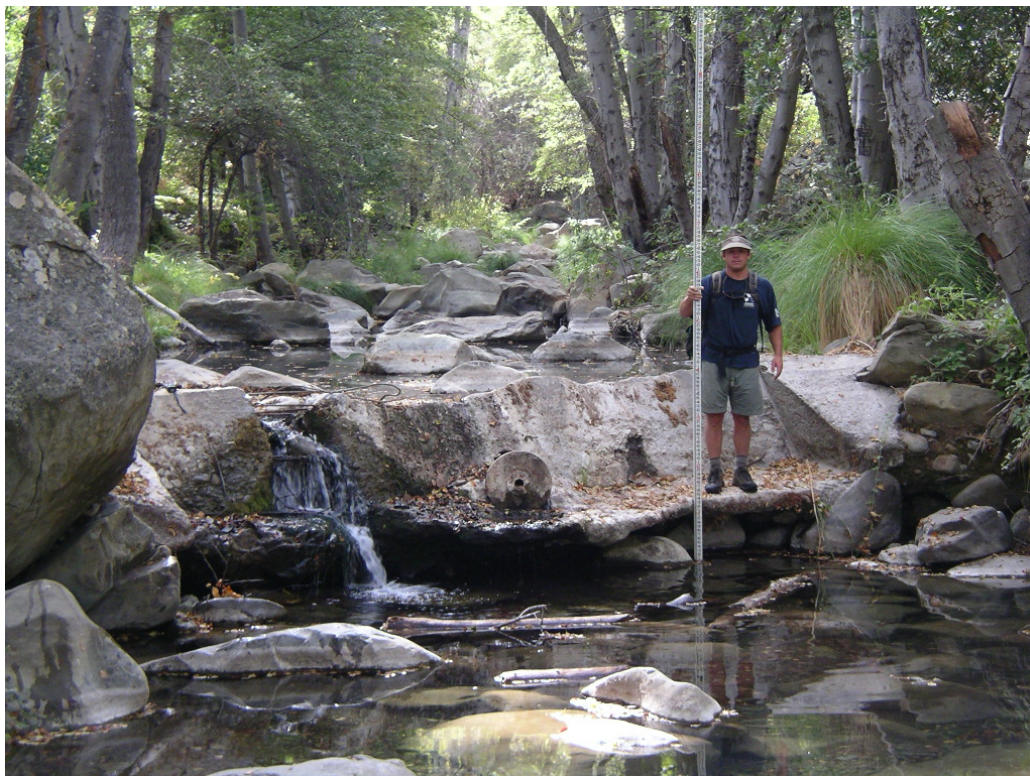
Description: This abandoned old diversion dam has an inscription in the concrete that appears seems to read “6/22/37 CO 2925”. It appears that this dam was built to divert water along the river-left banks downstream to Lower Lion Campsite almost 70 years ago. Remains of old metal pipes can be seen downstream. The dam measured 4 feet tall from the downstream tail-water control to the top of the dam. The dam measured 25 feet across the channel and 6 feet thick at its maximum point. The downstream pool measured 1-foot 9 inches at its maximum depth. A 12-inch diameter metal diversion pipefitting passes through the dam and is capped on the downstream side and buried with deposited substrate on the upstream side.

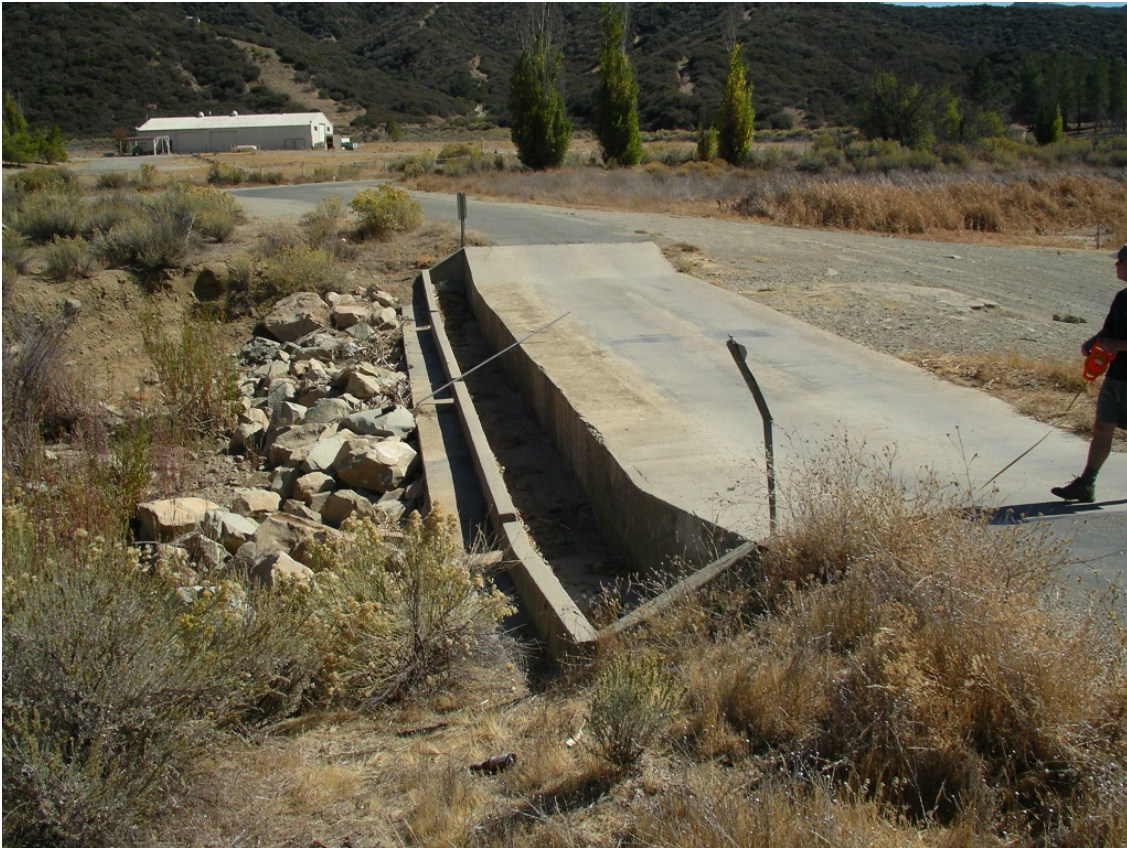
Description: This earthen dam has a concrete spillway that also serves as a road crossing. This spillway road measured 14 feet wide and 70 feet across. The total height of the dam measured 5 feet 3 inches from the spillway inlet to the downstream substrate. The slope on the spillway measured 2.3% and drops flows 2 feet 6 inches to a concrete shelf measuring 2 feet 7 inches out from the spillway. This shelf contains a 1-foot tall 6-inch wide concrete curb with 3 notches down to shelf level. Flows then drop 1-foot 9 inches to another concrete shelf and then spill onto a downstream boulder apron. This boulder apron measured 12 feet downstream from the concrete with an average slope of 40%.

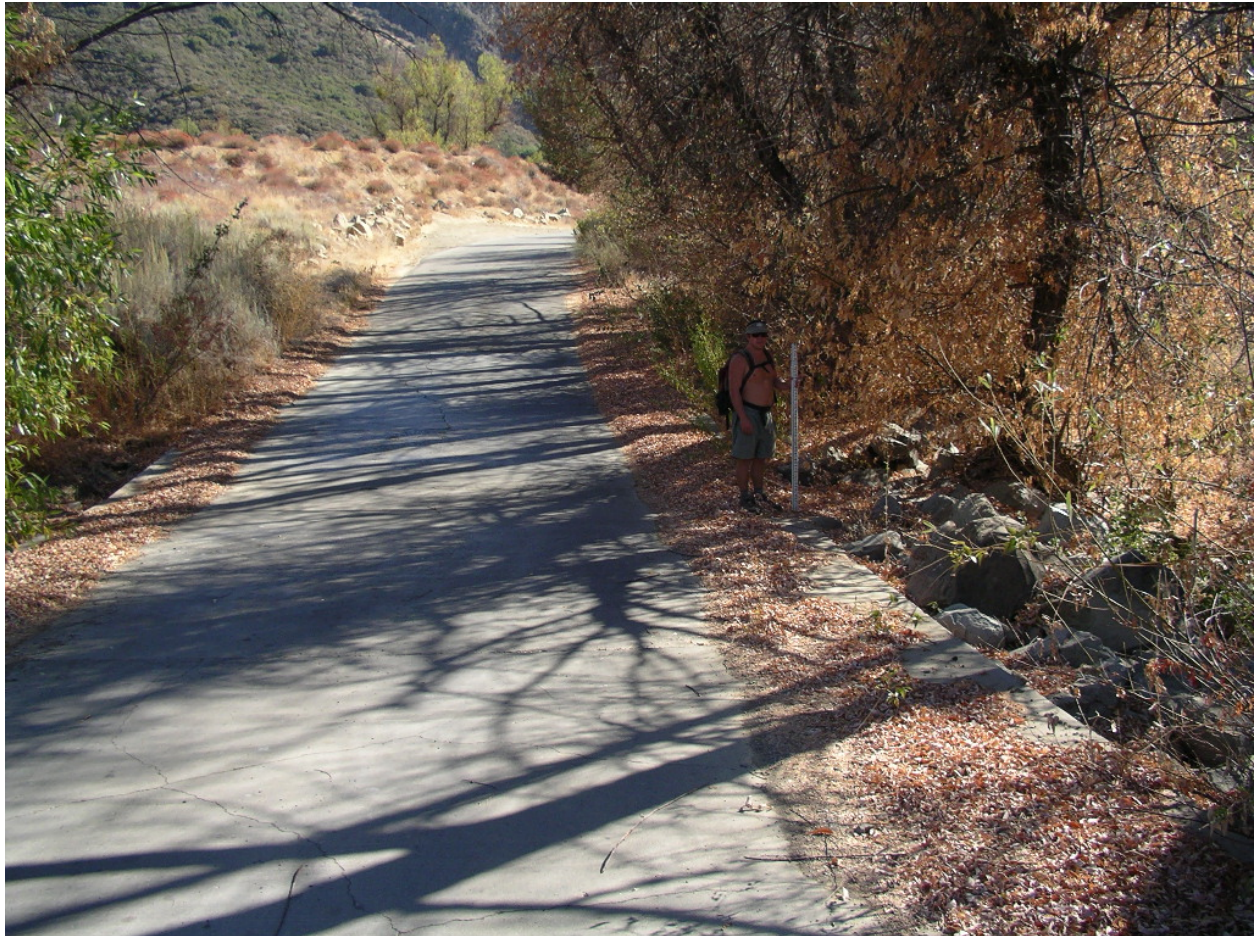
Description: The concrete crossing measured 67 feet 6 inches across the channel and 20 feet wide. The slope of the crossing is 1.5%. Surface flows are conveyed on top of the crossing and drop 3 feet onto the downstream substrate. Large boulders occur on a portion of the outlet and produce a 10-foot long apron with an average slope of 25%.

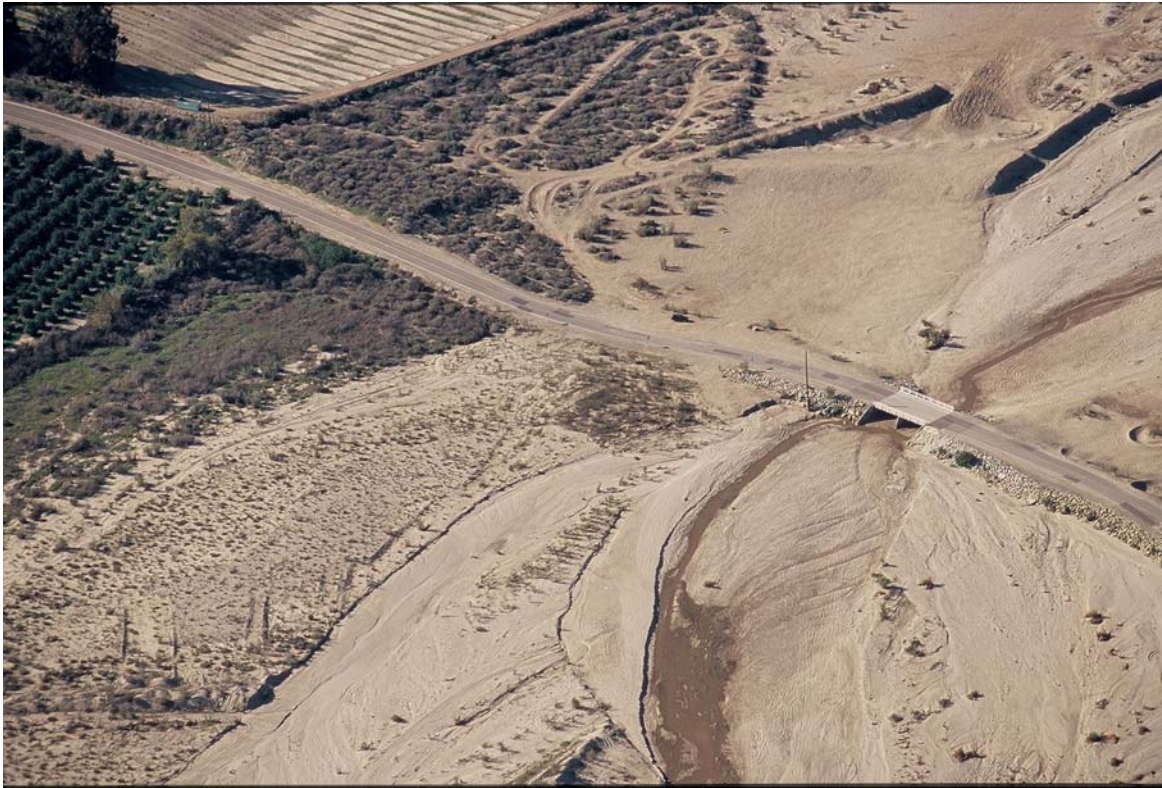
Description: This short-span bridge crossing occurs downstream from Piru Creek. Elevated dirt road fill occurs across much of the Santa Clara River channel on either side of the Torrey Road Bridge.

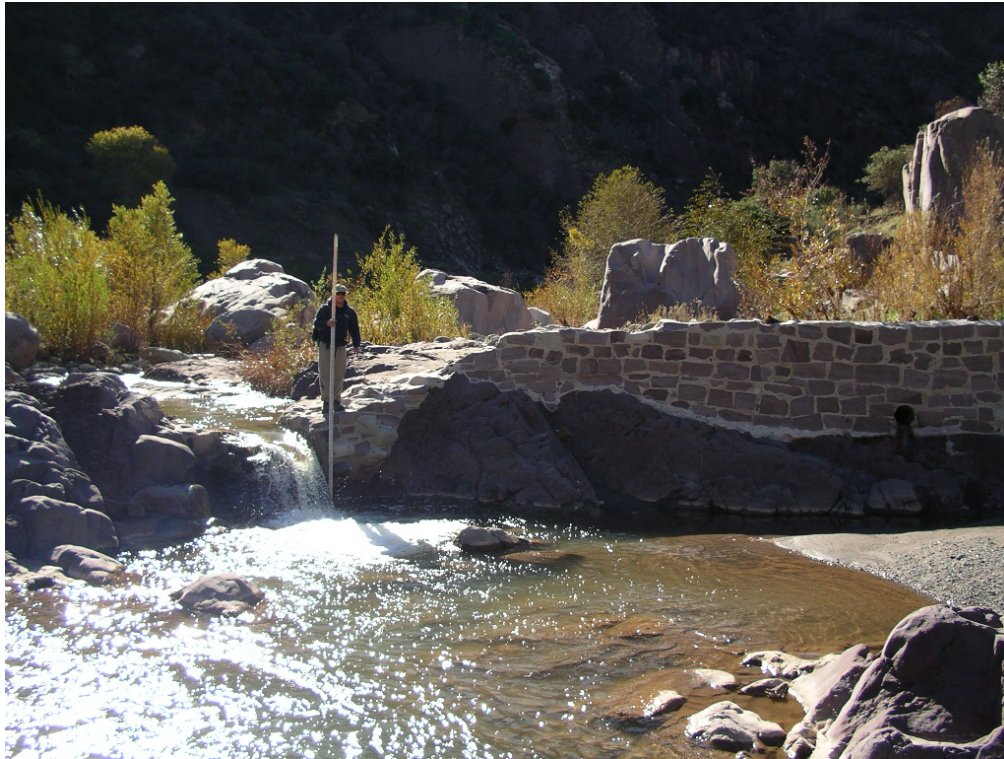
Description: James Van Trees, whose family has owned the lands adjacent to this dam for several generations, informed me that this historic, failed dam was built in the 1930's or 1940's by Los Angeles water figure William Mulholland (pers. comm. Van Trees 2004). The stone block and concrete diversion dam reportedly was destroyed in the 1969 flood and only remnants of the dam survived. The dam remains were reportedly buried by sediment for many years following 1969 and then were uncovered in recent decades. The original dam spanned approximately 200 feet across the stream channel and measured 5 feet thick and at least 10 feet in height above the substrate. Only 80 feet of the dam still remains on the river-left side and a small, stream-polished section occurs on top of a native boulder near the river-right side of the channel. Two 10-inch metal diversion pipes occur within each remaining part of the dam. Metal rebar anchors can also be observed protruding from some of the native boulders where the dam once stood.
