SECOND ANNUAL RESTORATION MONITORING REPORT (YEAR 2)

SOUZA II RESTORATION PROJECT
CONTRA COSTA COUNTY, CALIFORNIA

NOVEMBER 2011

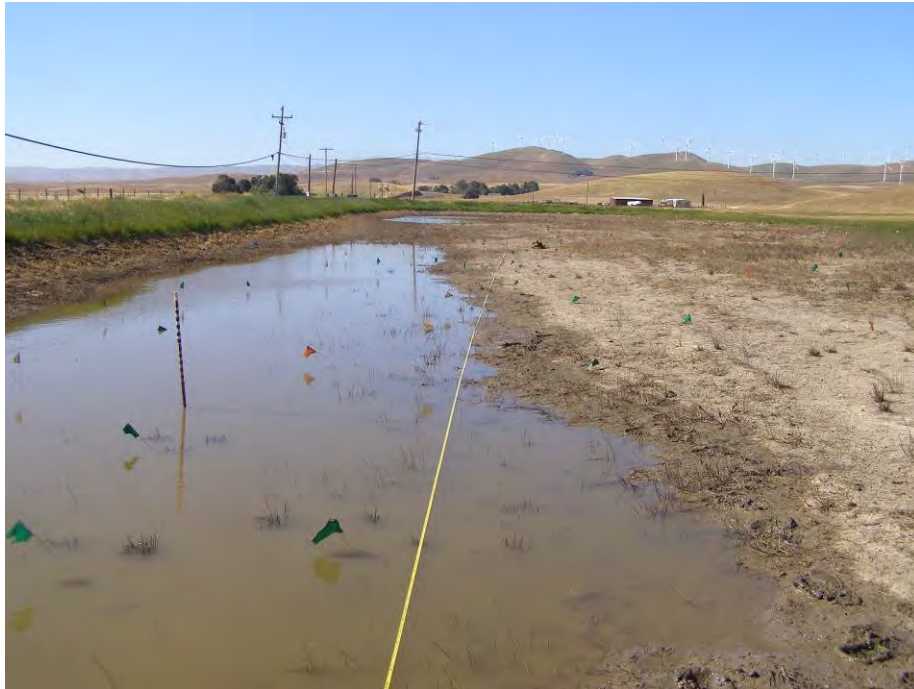
Photo 1. Transect 1. Facing south showing standing water. May 12, 2011.

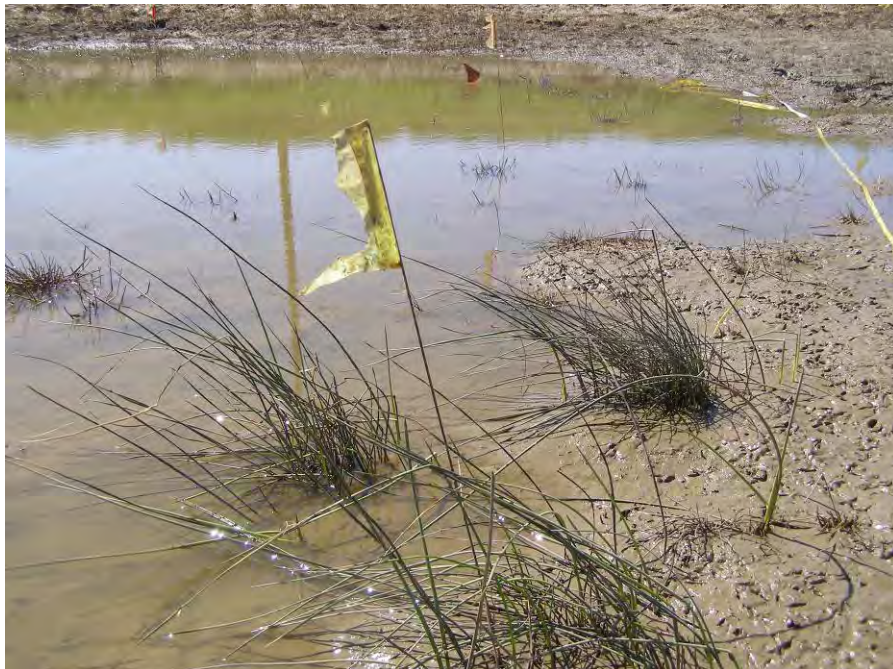
All of the species except spikerush, gumplant, and baltic rush, had under 10% survival. Spikerush had 12% survival and baltic rush had 20% survival. Spikerush and baltic rush were observed to be increasing in size and naturally recruiting and these would be good choices for replanting (Photo 4 in Appendix B).

Photo 4. Transect 3: Showing healthy Baltic rush (*Juncus balticus*). May 12, 2011.

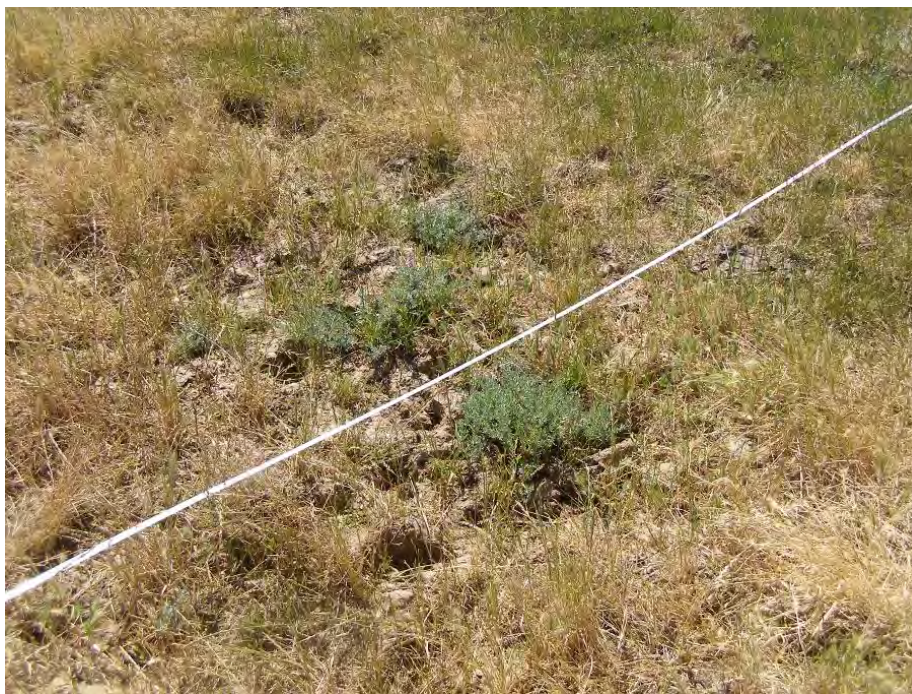
Photo 5. Transect 4. Showing healthy alkali heath (*Frankenia salina*). May 12, 2011.

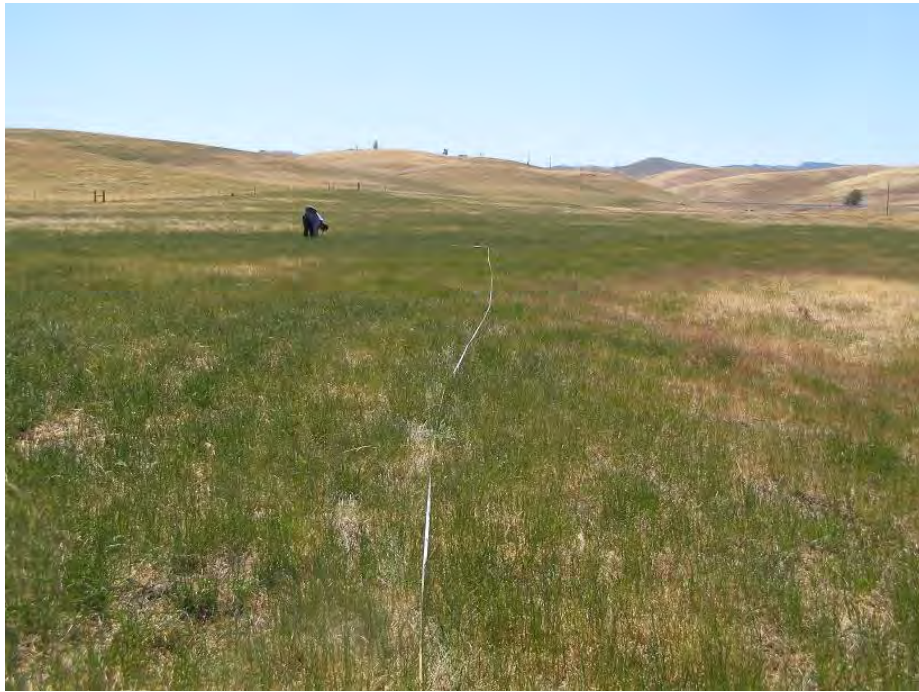
Photo 7. Transect 7. Showing high cover of Italian ryegrass*. May 12, 2011.

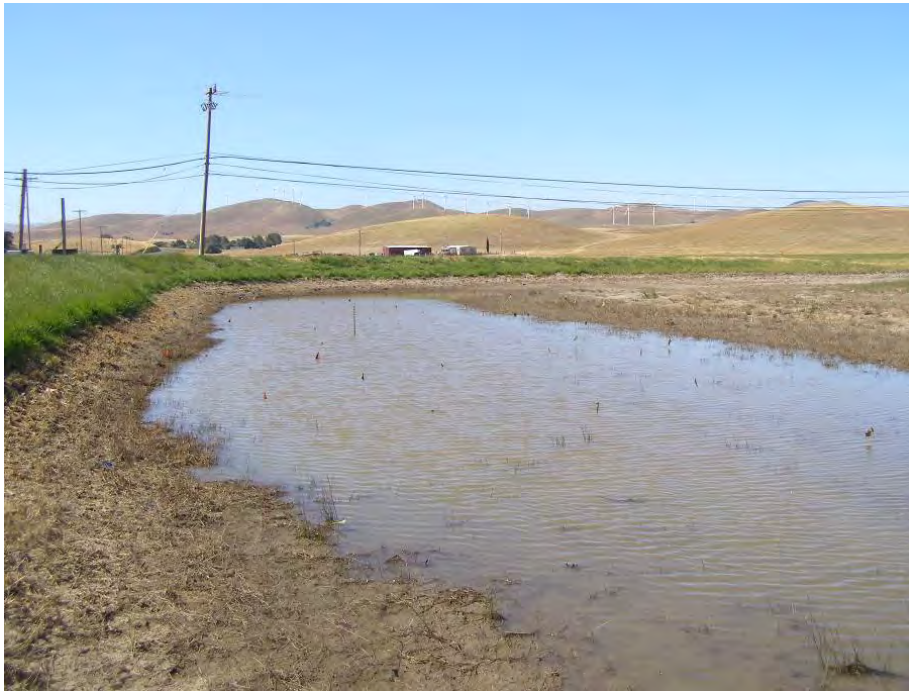
Photo 13. Showing depth gage 2 in the northern wetland and cattle trampling along the margin. May 12, 2011.

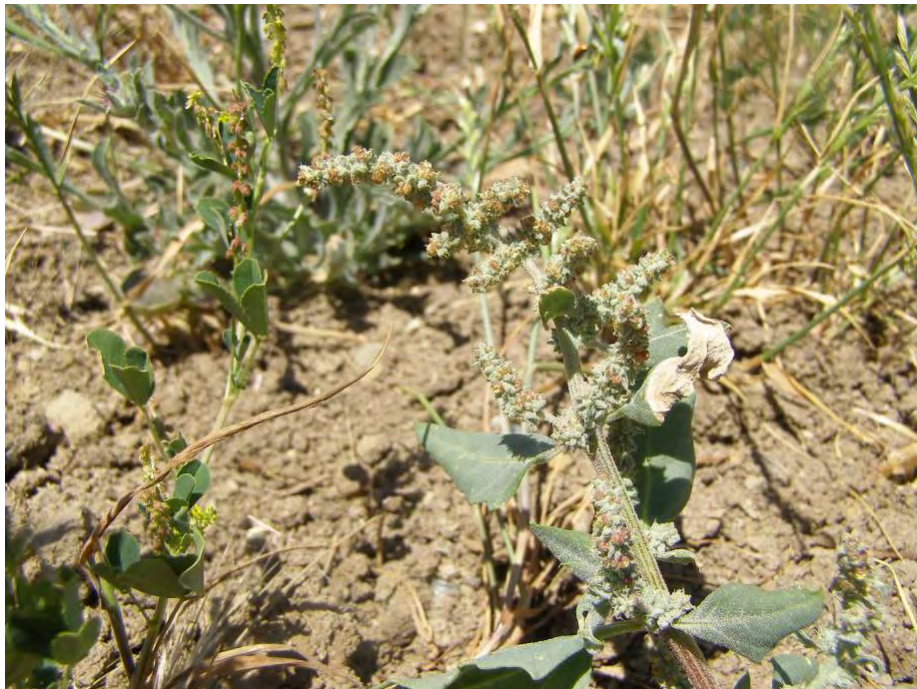
The Atriplex translocation sites were monitored on May 13, 2011. In the west transplant site, seven San Joaquin spearscale (*Atriplex joaquinana*) and two crownscale (*Atriplex coronata* var. *coronata*) were observed. In the east transplant site, 17 San Joaquin spearscale and 1 crownscale were observed. Many of the individuals were flowering and presumably producing seed (Photos 14 and 15 in Appendix B).

Photo 14. San Joaquin saltbush (*Atriplex joaquiniana*) seedling in the soil transplant site. May 12, 2011.

In the soil transplant sites, 24 San Joaquin spearscale and three crownscale were observed. These sites should be monitored in spring 2012 to determine if individuals of these annual species are persisting on site.

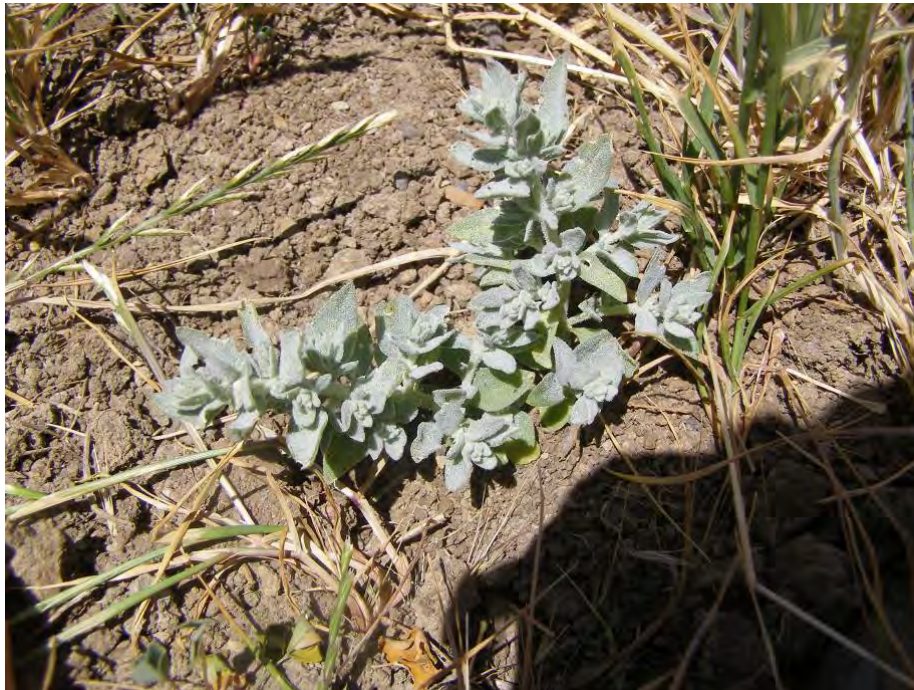
Photo 15. Crownscale (*Atriplex coronata* var *coronata*) seedling in the soil transplant site. May 12, 2011.

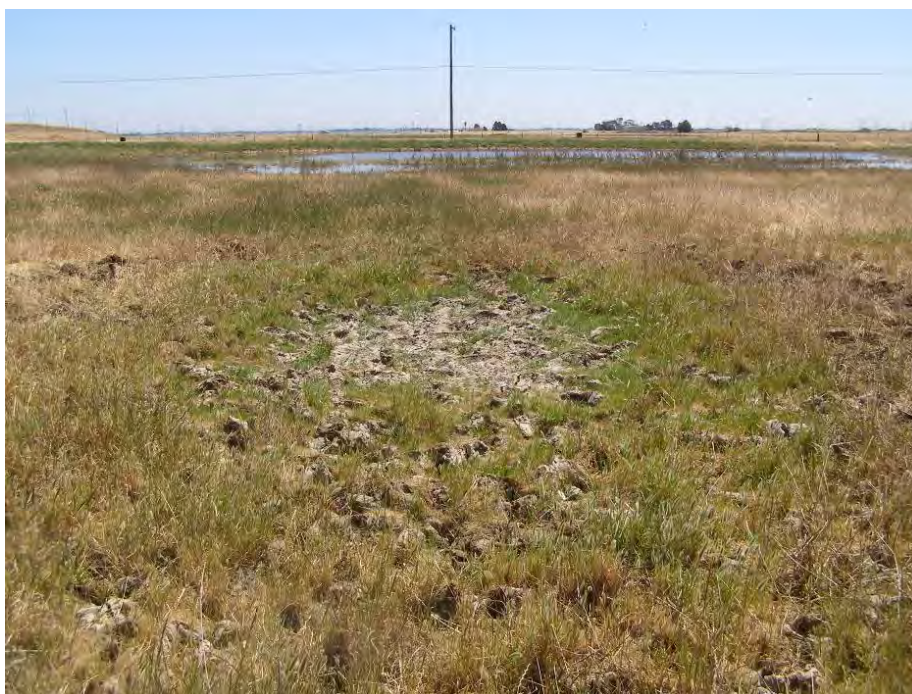
Photo 17. Alkaline soil and evidence of ponding water. The southern wetland is in the background.
May 12, 2011.

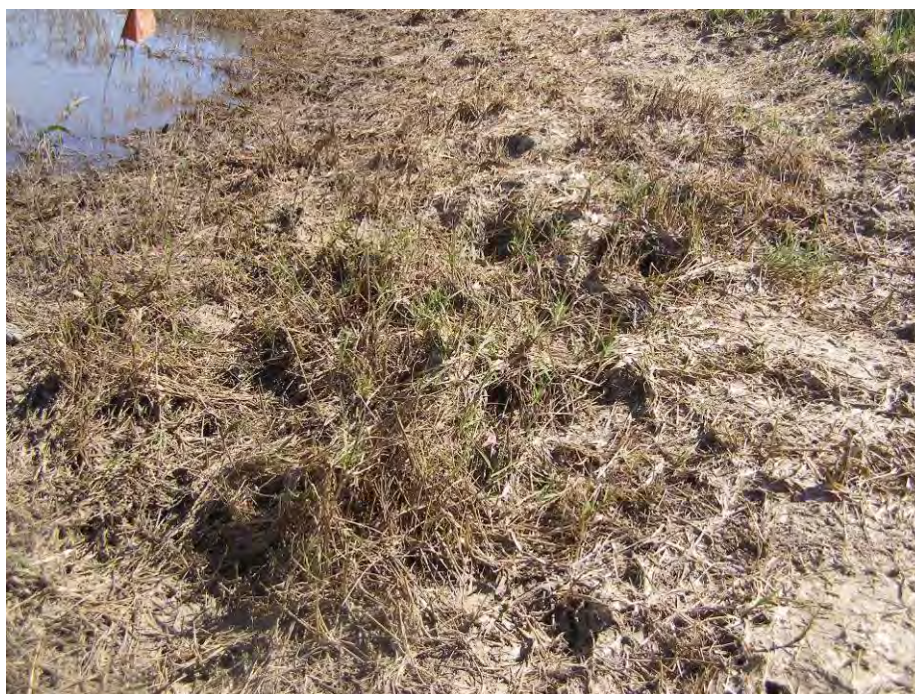
Photo 18. Salt grass (*Distichlis spicata*) on the margins of the northern wetland tolerated cattle trampling.
May 12, 2011.

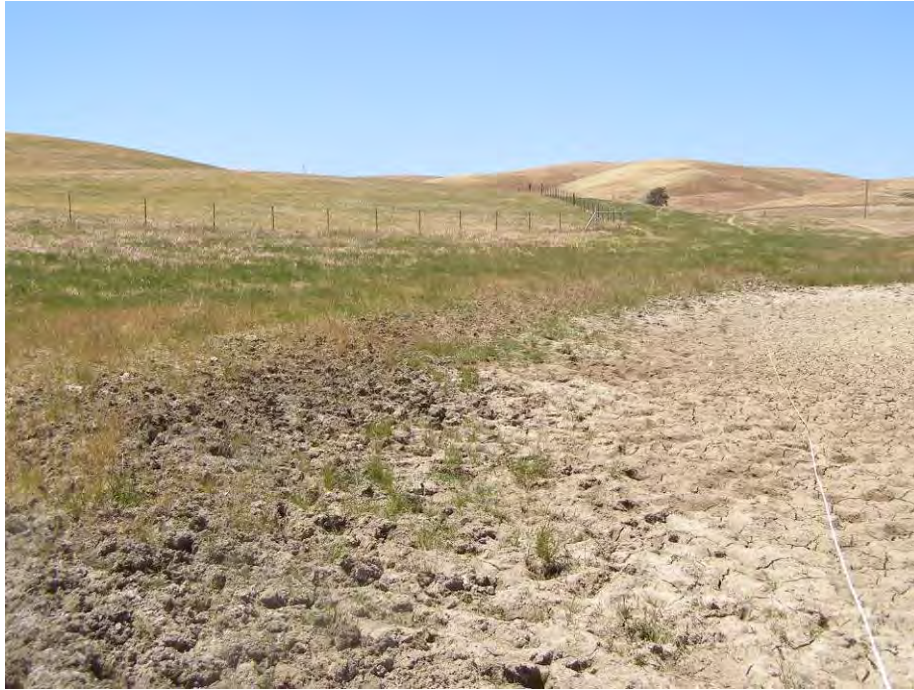
Photo 19. Cattle trampling on the edge of the pond. May 12, 2011.

Grazing in 2011 reduced the cover of Italian ryegrass* thatch and standing material on site with little damage to native plants and native wetlands. This is because the deep water in the wetlands kept the cattle out of the wetlands. Grazing should occur in 2012 at a similar time of year for a similar length of time. The timing of grazing will be adjusted based on the depth of water in the wetlands. The cattle-exclusion fencing should be extended to exclude the cattle from a larger portion of the tributary since they were causing some erosion to the creek banks particularly in the vicinity of the fence. Additional fencing could be used as necessary to keep cattle out of the wetlands.

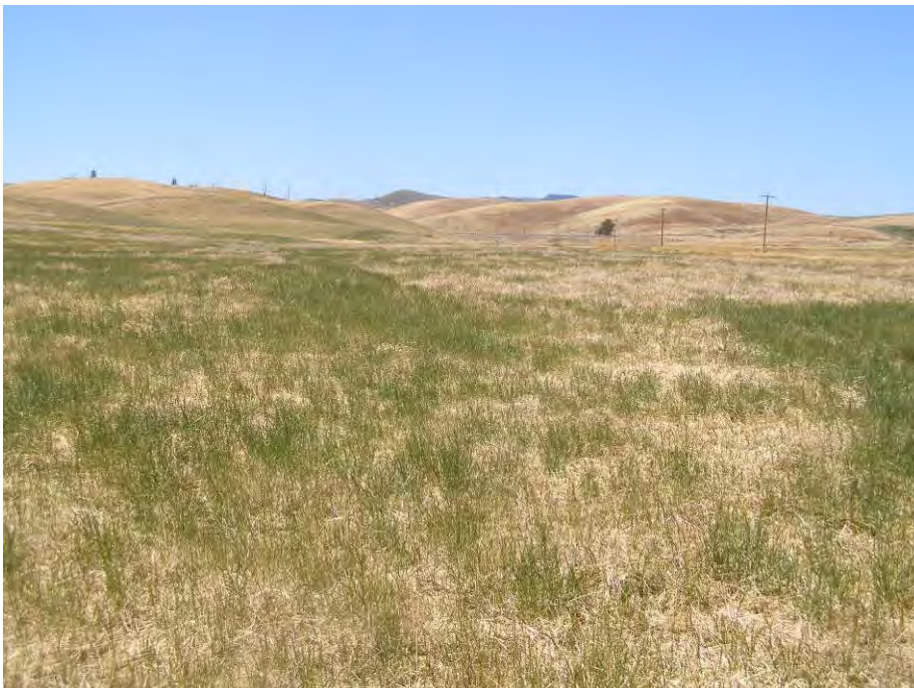
Photo 20. Italian ryegrass* had a second flush of growth after cattle were removed from the site. May 12, 2011.

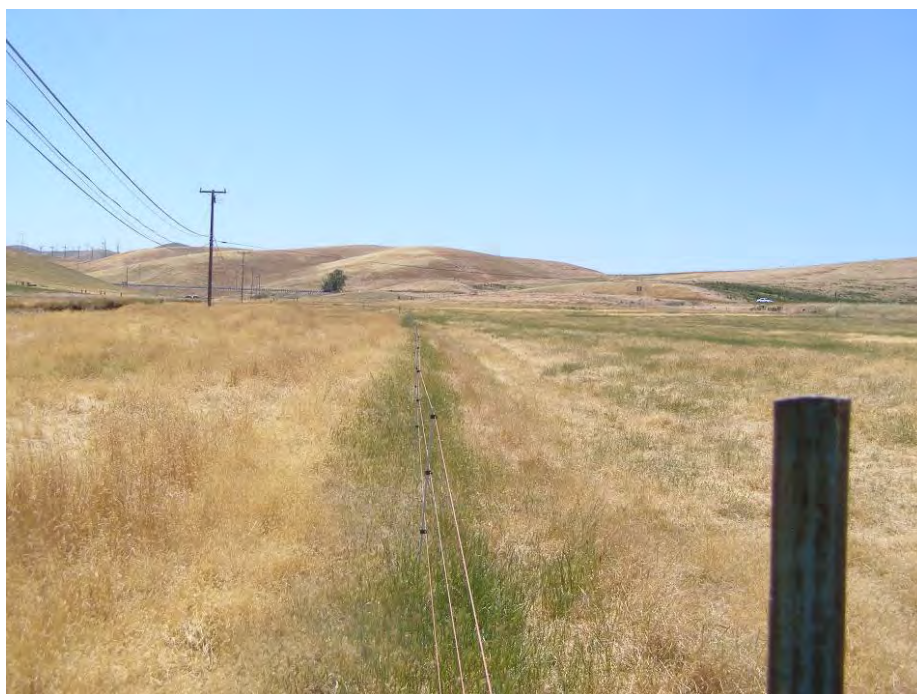
Photo 21. Comparing grazed grassland (right) to ungrazed grassland (left). The ungrazed grassland has higher above ground biomass. May 12, 2011.

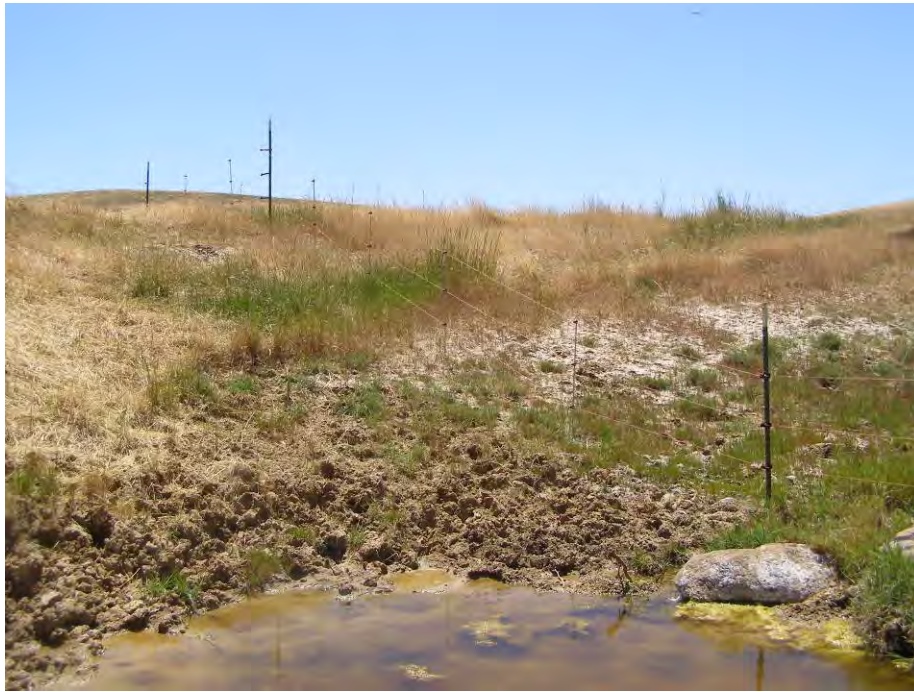
Photo 23. Tributary at the boundary of the cattle exclusion fence. Cattle trampled the banks of the tributary at this location. May 12, 2011.

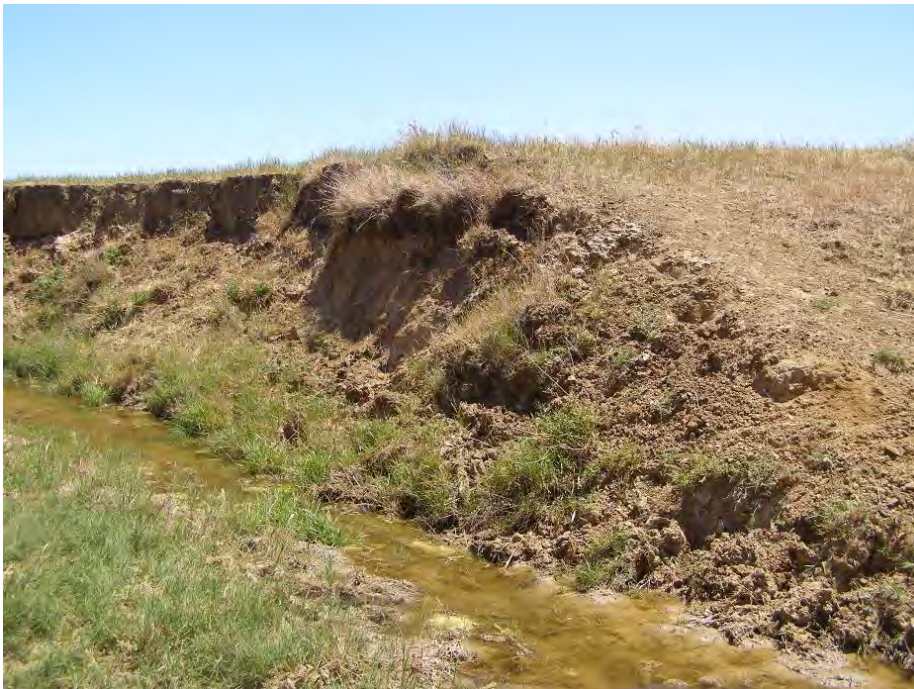
Photo 24. Erosion on the banks of the tributary caused by cattle. May 12, 2011.

In some areas where the bank was laid back, the banks are unvegetated and erosion is occurring. We recommend continued planting of saltgrass plugs to armor the banks. In winter 2010/2011, saltgrass was planted on select banks. In these areas, the saltgrass is doing well and erosion is decreased. In addition, straw wattles should be placed along the tops of the banks where work occurred to slow water flow across the banks and direct it to areas that are vegetated.

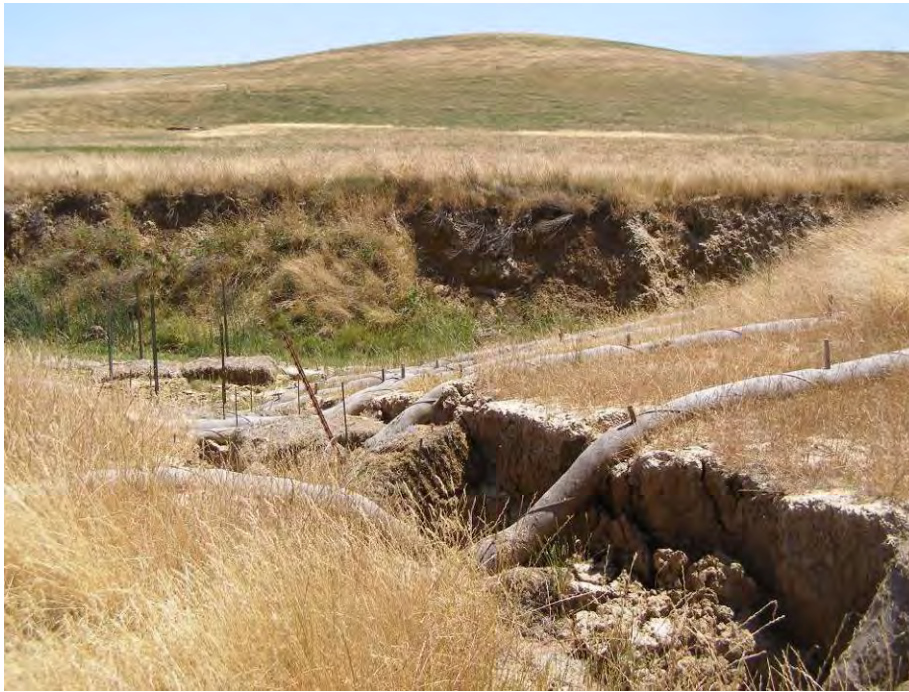
Photo 27. Head cut erosion. May 12, 2011.

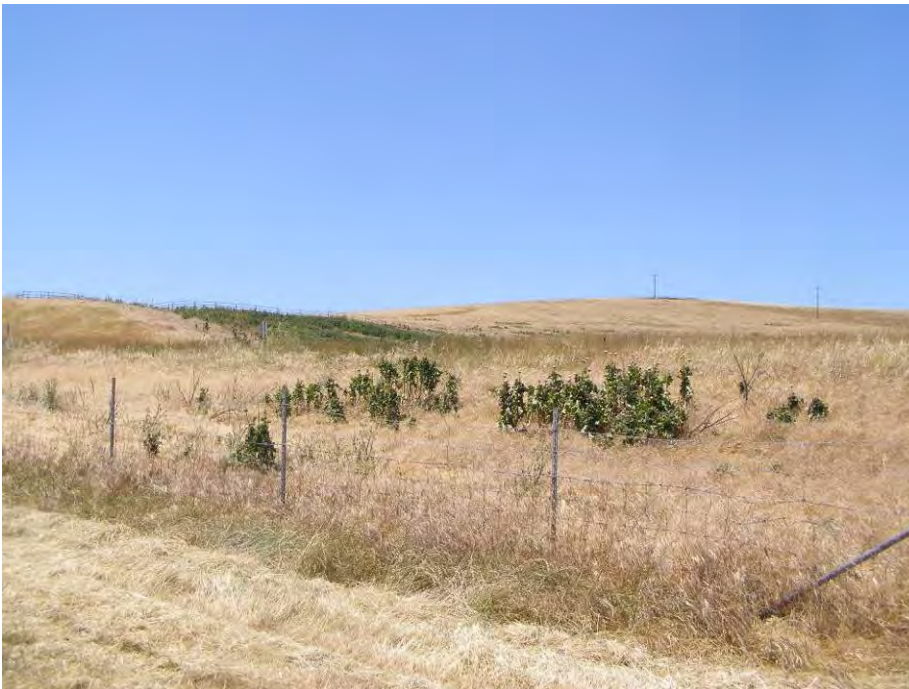
Photo 28. Milk thistle (*Silybum marianum*) growing on adjacent property.

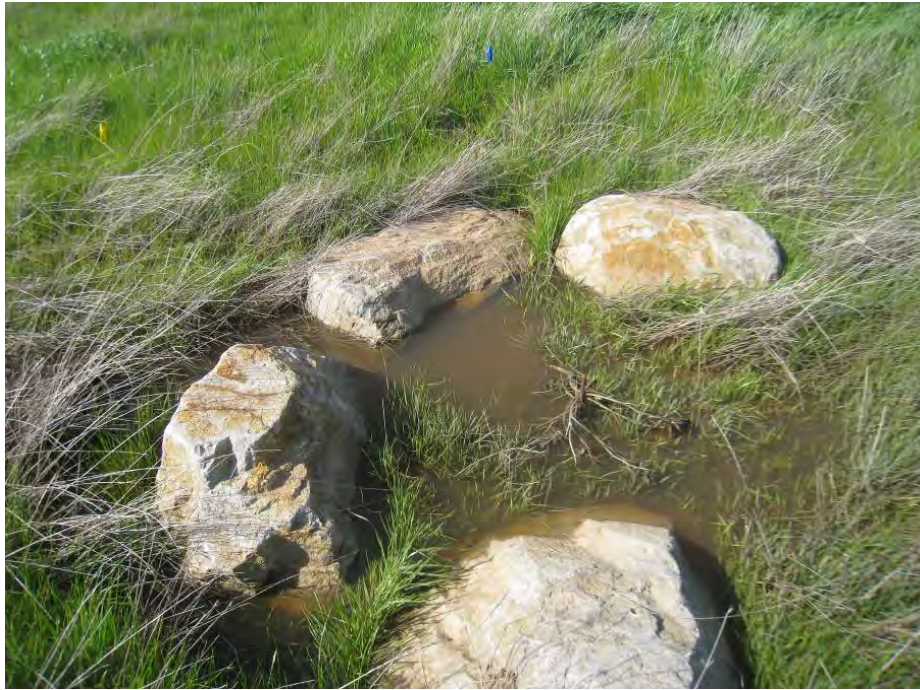
Photo 29. Ponding behind rock weirs. May 12, 2011.

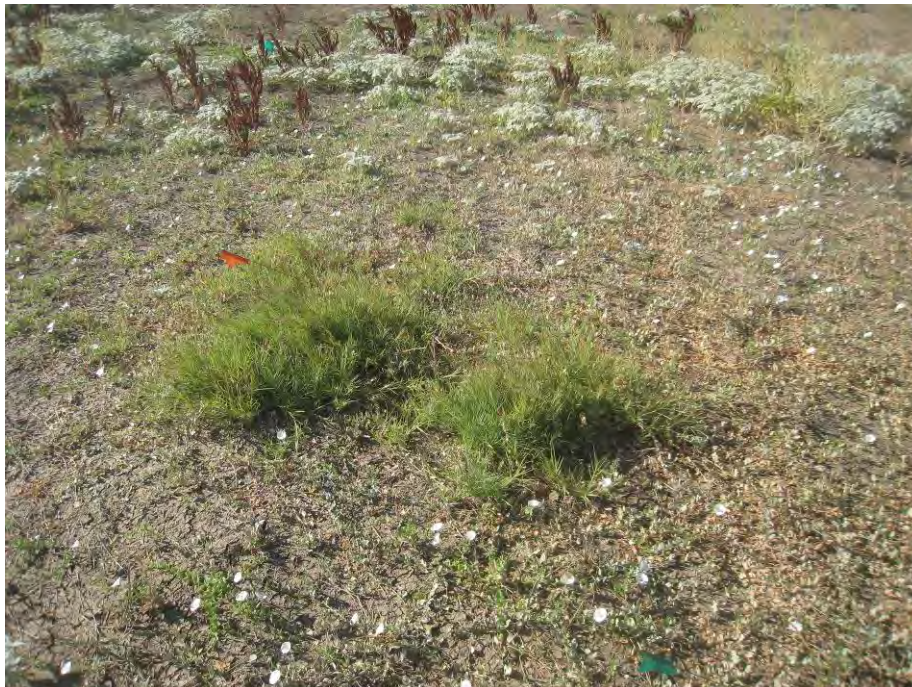
Photo 30. Annual weeds in the northern wetland. May 24, 2011.

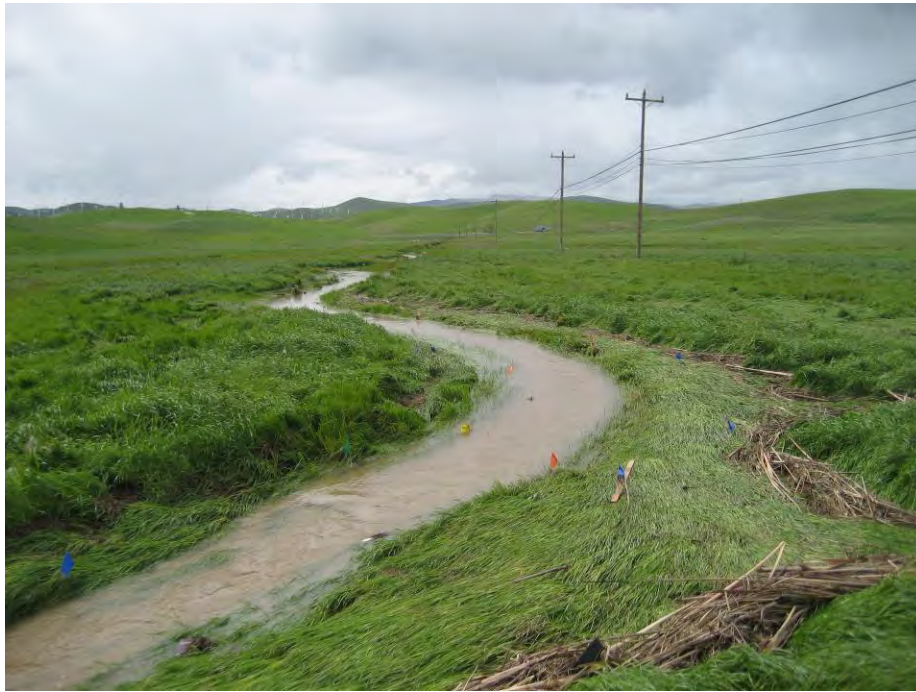
Photo 31. The tributary overtopping its banks after the major storm event. March 25, 2011.
Photo by John Kopchik.

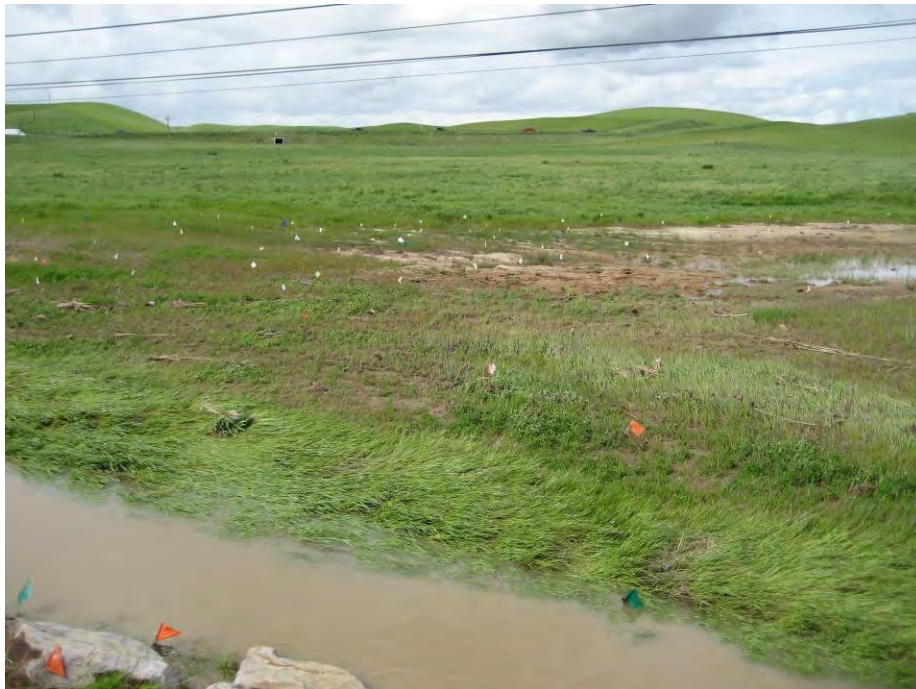
Photo 32. The tributary overtopping its banks and flowing into northern wetland complex at the engineered hydrologic connection. March 25, 2011. Photo by John Kopchik.

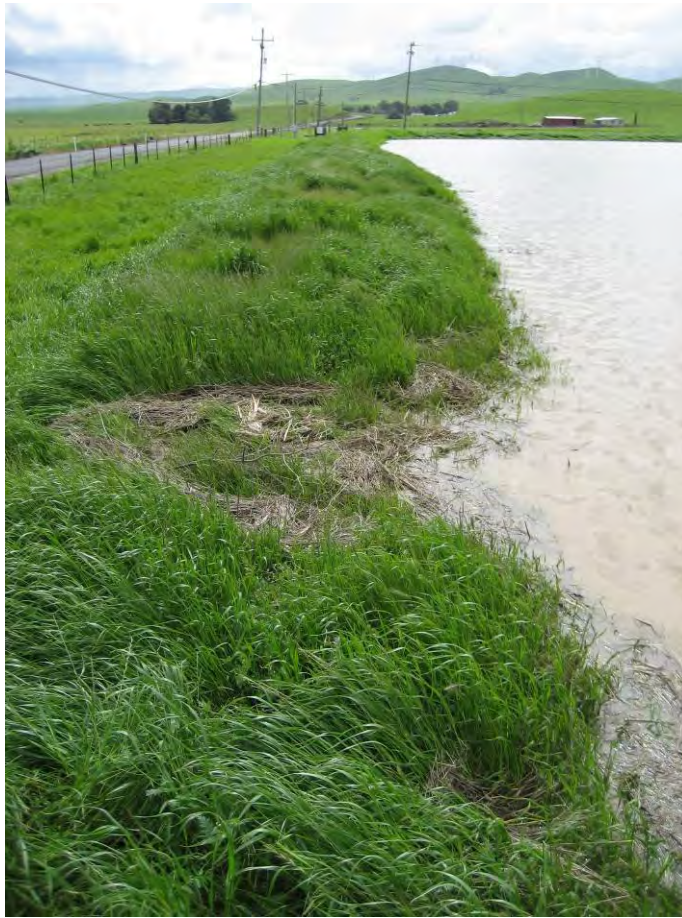
A major storm event occurred on March 24, 2011 with rainfall totals of 0.88 inches as reported by the Byron Airport weather station (Figure 4) which resulted in a high volume of water on site. The storm resulted in accumulated precipitation for the season of 12.77 inches (Figure 5). Large amounts of water came down the tributary resulting in it overflowing its banks (Photo 31 in Appendix B). Wetlands on site filled and overflowed their banks (Photo 33 in Appendix B).

Photo 33. The northern wetland spilling over its berm and flowing into roadside ditch. March 25, 2011.
Photo by John Kopchik.
