FINAL REPORT ◦ FEBRUARY 2014

Evaluation of Barriers to Pacific Lamprey Migration in the Eel River Basin

P R E P A R E D B Y

Stillwater Sciences
850 G Street, Suite K
Arcata, CA 95521

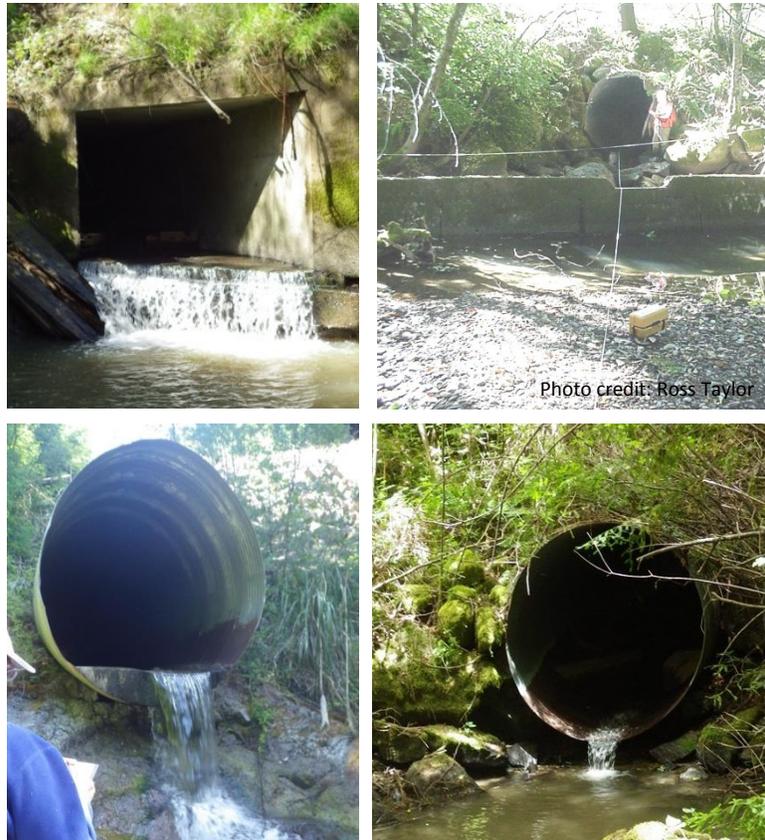
Figure 2-3. Examples of perched road crossings or tailwater control weirs found in the Eel River basin. Clockwise from upper left: Oil Creek (PAD ID 736789), Dinner Creek (PAD ID 723276), Stitz Creek (PAD ID 715449), Strawberry Creek (PAD ID 715429)

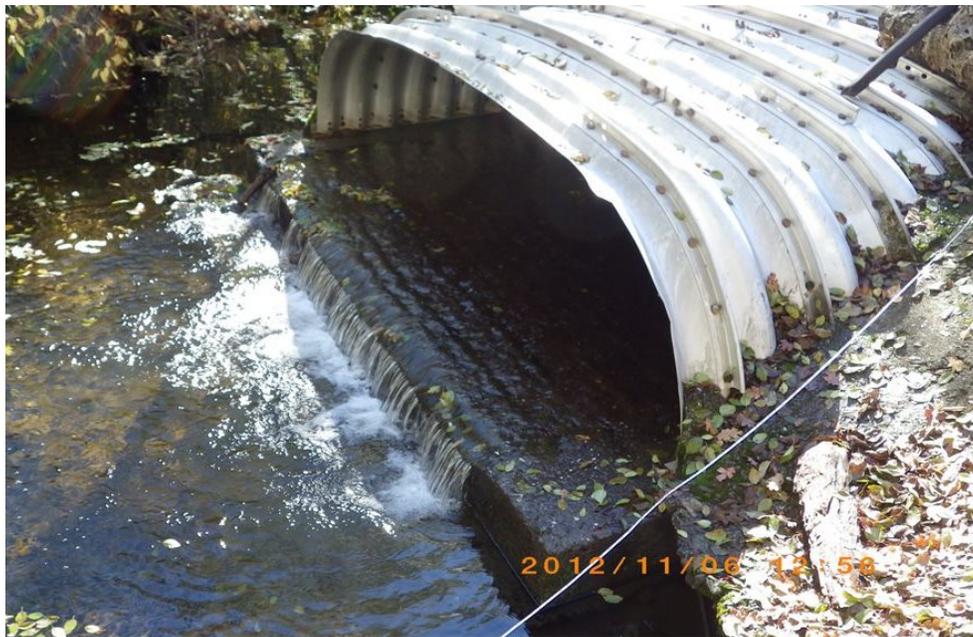
Figure 2-4. Example of culvert outlet apron with a vertical step at a crossing of Butte Creek (PAD 715481).

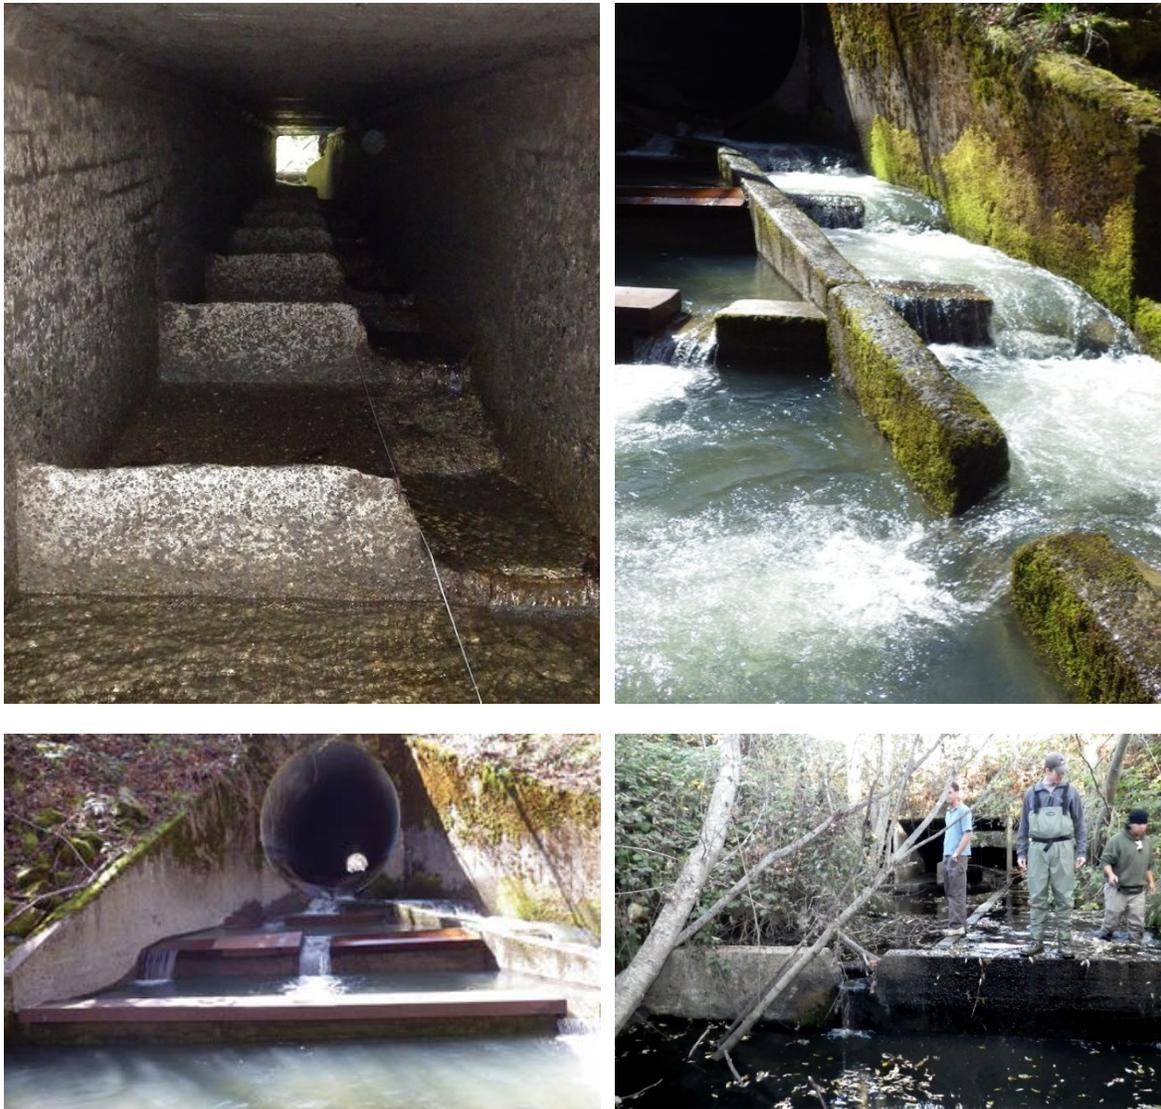
Figure 2-5. Examples of internal structures and modifications at road crossings in the Eel River basin. Internal baffles (top left; Fish Creek, PAD 707157), step-pool fishways at outlet (top right and bottom left; Elk Creek, PAD 707107), and tailwater control weir (bottom right; Rohner Creek at 12th St. in Fortuna, CA).

Since culvert internal structures and retrofits are typically designed specifically to improve salmonid passage and often disregard lamprey-specific requirements (e.g., CalTrans 2007), many may hinder lamprey migration, particularly if they contain sharp angles or require leaps. Laboratory and field experiments indicate that, when water velocities are high, Pacific lamprey have difficulty passing features that have squared corners such as vertical steps or vertical slot weirs in fish ladders (Moser et al. 2002, Daigle et al. 2005, Keefer et al. 2010). Such sharp angles prevent lampreys from maintaining attachment as they move around a corner (Moser et al. 2002, Moser and Mesa 2009). These same studies demonstrated that Pacific lampreys have significantly higher passage success through fishways with rounded, instead of squared, corners on bulkheads.

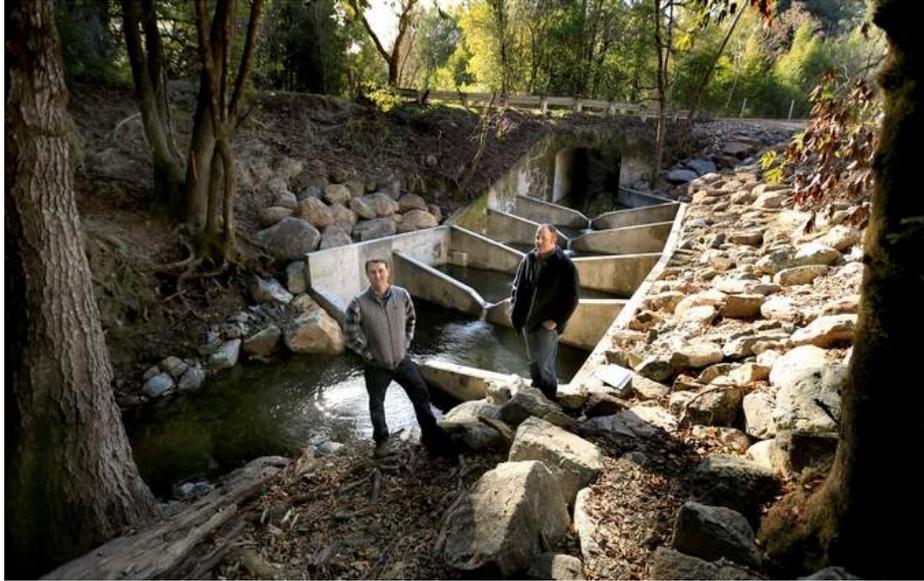
Figure 5-1. Example pool-weir fish ladder designed to improve salmon passage, but not well designed for Pacific lamprey passage. Source: <http://www.pressdemocrat.com/article/20140109/articles/140109595>

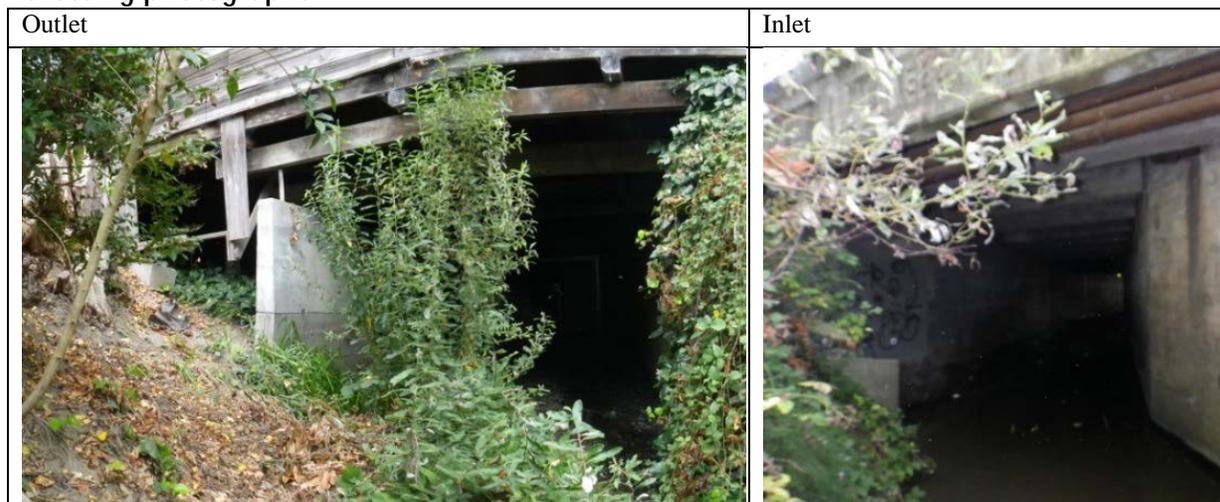
PAD ID	Stream name	Tributary to	Sub-basin	Survey date	Road name	Latitude (N)	Longitude (W)
715459	Strong's Creek	Eel River	Lower Eel	10/11/2012	S. Fortuna Blvd.	40.58004	-124.14706

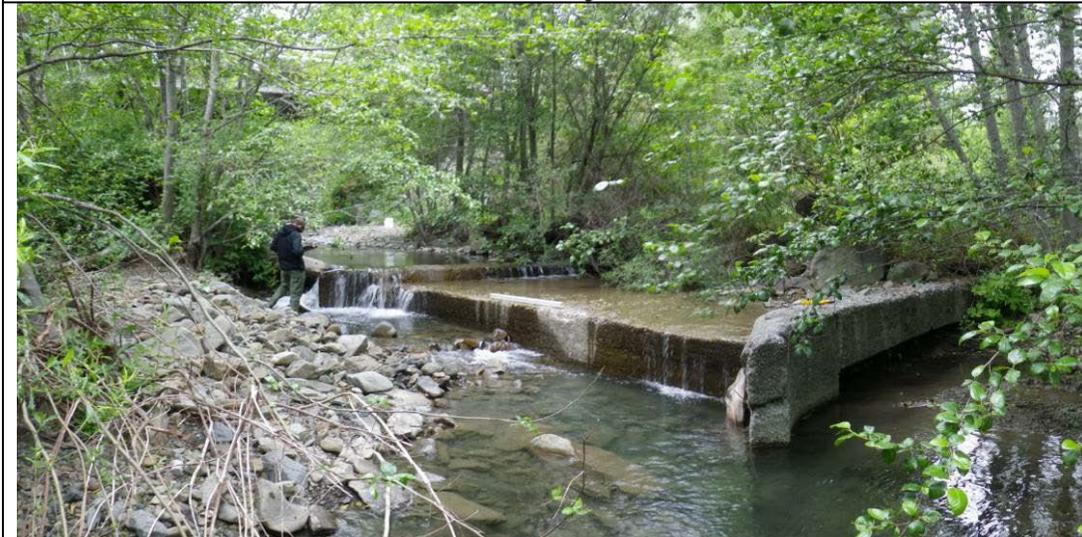
Concrete structure downstream of Mattole Road Bridge (PAD ID 736752).

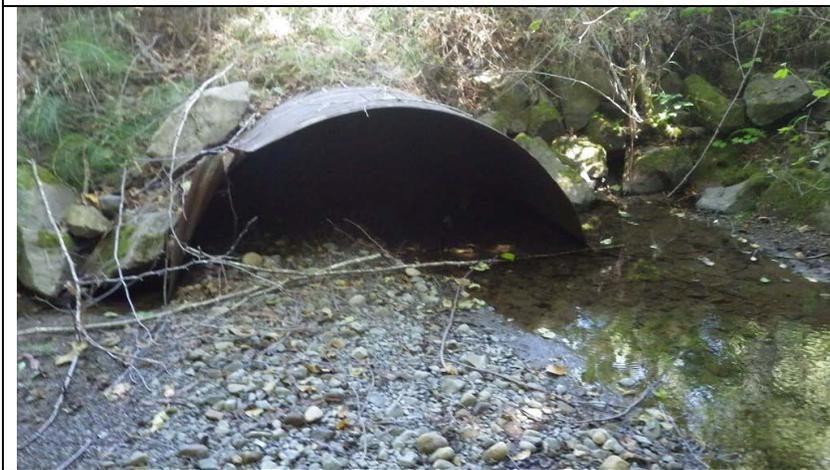
Inlet (outlet not accessible)
