STREAM INVENTORY REPORT

North Fork Gualala River (Upper Watershed)

A stream inventory was conducted beginning August 28 and ending November 4, 2003 on North Fork Gualala River. The survey began on the mainstem near an unnamed left bank tributary, upstream of Stewart Creek. The survey extended upstream 14,832 feet.

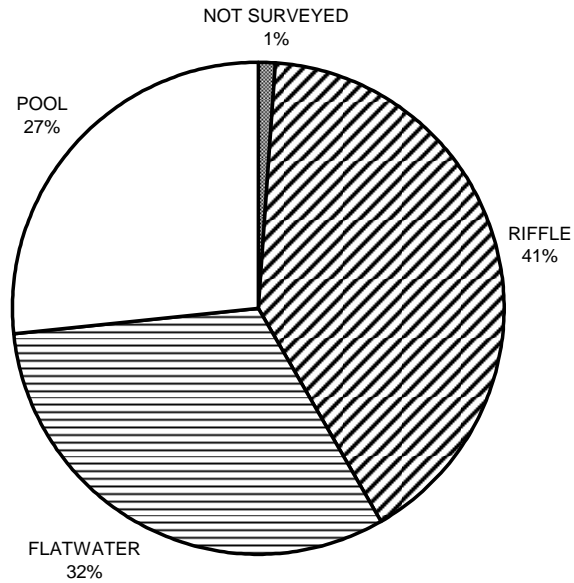
GRAPH 1

Table 1 summarizes the Level II riffle, flatwater, and pool habitat types. Based on frequency of occurrence there were 41% riffle units, 32% flatwater units, and 27% pool units (Graph 1). Based on total length of Level II habitat types there were 44% riffle units, 35% flatwater units, and 20% pool units (Graph 2).

Riffle habitat types comprised 41% of the total length of this survey, flatwater 32%, and pools 27%. The pools are relatively deep, with 25 of the 35 (71%) measured pools having a maximum depth greater than 3 feet. In general, pool enhancement projects are considered when primary pools comprise less than 40% of the length of total stream habitat.

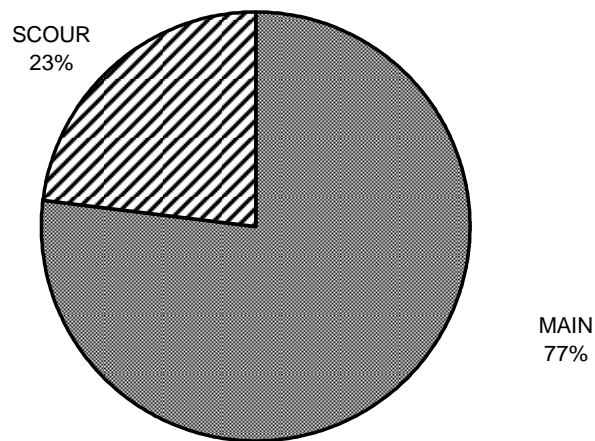
GRAPH 4

A total of 35 pools were identified (Table 3). Main-channel pools were the most frequently encountered, at 77%, and comprised 77% of the total length of all pools (Graph 4).

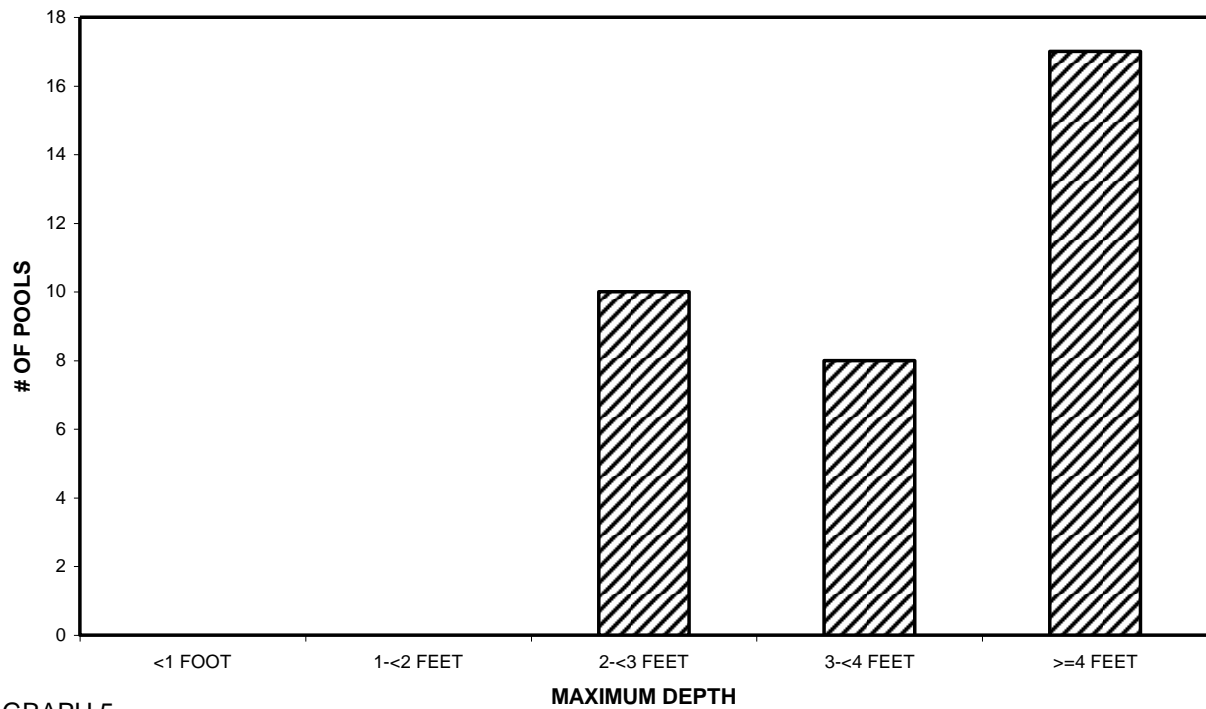
GRAPH 5

Table 4 is a summary of maximum pool depths by pool habitat types. Pool quality for salmonids increases with depth. Twenty-five of the 35 measured pools (71%) had a depth of three feet or greater (Graph 5).

- 4) Where feasible, design and engineer pool enhancement structures to increase the number of pools. This must be done where the banks are stable or in conjunction with stream bank armor to prevent erosion.

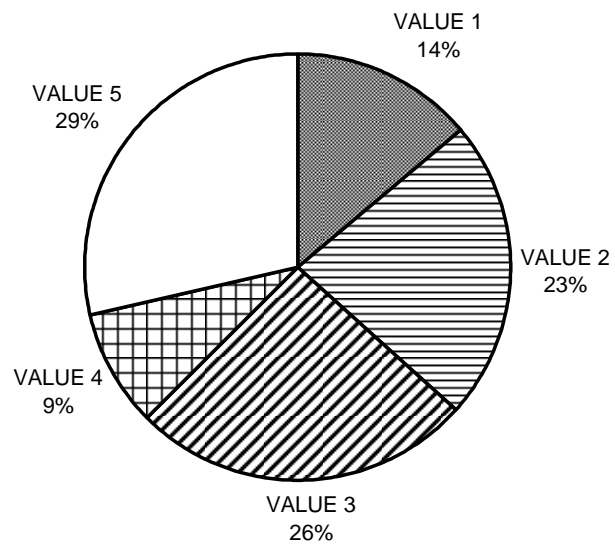
GRAPH 6

The depth of cobble embeddedness was estimated at pool tail-outs. Of the 35 pool tail-outs measured, 5 had a value of 1 (14%); 8 had a value of 2 (23%); 9 had a value of 3 (26%); 3 had a value of 4 (9%); and 10 had a value of 5 (29%) (Graph 6). On this scale, a value of 1 indicates the highest quality of spawning substrate.

Thirteen of the 35 pool tail-outs measured had embeddedness ratings of 1 or 2. Twelve of the pool tail-outs had embeddedness ratings of 3 or 4. Ten of the pool tail-outs had a rating of 5, which is considered not suitable for spawning. Cobble embeddedness measured to be 25% or less, a rating of 1, is considered to indicate good quality spawning substrate for salmon and steelhead. Sediment sources in North Fork Gualala River should be mapped and rated according to their potential sediment yields, and control measures should be taken.

- 3) Active and potential sediment sources need to be identified, mapped, and treated according to their potential for sediment yield to the stream and its tributaries.

- 6) Inventory and map sources of stream bank erosion and prioritize them according to present and potential sediment yield. Identified sites should then be treated to reduce the amount of fine sediments entering the stream.

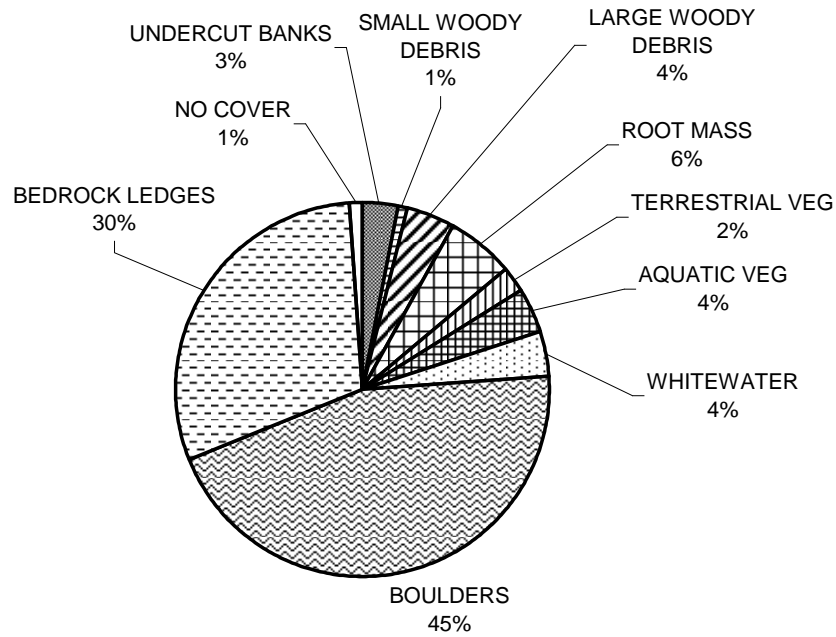
GRAPH 7

Table 5 summarizes mean percent cover by habitat type. Boulders are the dominant cover types in North Fork Gualala River. Graph 7 describes the pool cover in North Fork Gualala River. Boulders are the dominant pool cover types followed by bedrock ledges.

The mean shelter for flatwater was 15. The mean shelter rating for pools was 26. A pool shelter rating of approximately 100 is desirable. The amount of cover that now exists is being provided primarily by boulders in all habitat types. Additionally, bedrock ledges contribute a small amount. Log and root wad cover structures in the pool and flatwater habitats would enhance both summer and winter salmonid habitat. Log cover structure provides rearing fry with protection

- 5) Increase woody cover in the pools and flatwater habitat units. Most of the existing cover is from boulders. Adding high quality complexity with log and root wad cover is desirable.

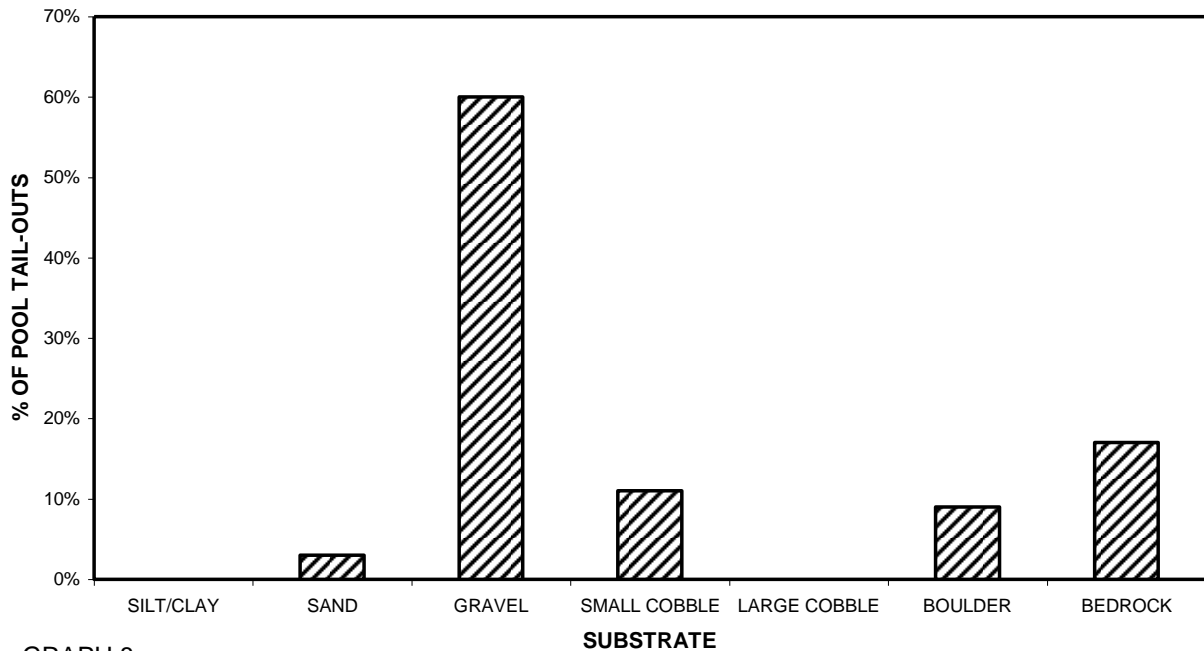
GRAPH 8

Table 6 summarizes the dominant substrate by habitat type. Graph 8 depicts the dominant substrate observed in pool tail-outs. Gravel was the dominant substrate observed in 60% of pool tail-outs while bedrock was the next most frequently observed substrate type, at 17%.

Twenty-five of the 35 pool tail-outs measured had gravel or small cobble as the dominant substrate. This is generally considered good for spawning salmonids.

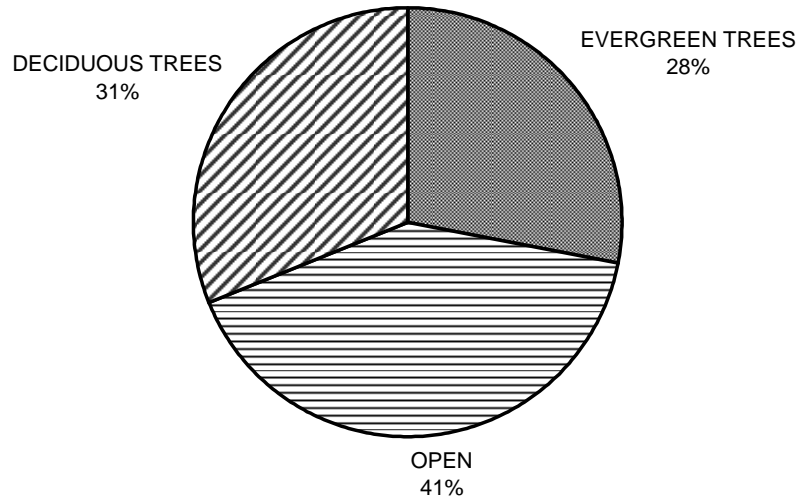
GRAPH 9

The mean percentages of evergreen and deciduous trees were 28% and 31%, respectively with 41% of the canopy open. Graph 9 describes the mean percent canopy in North Fork Gualala River.

The mean percent canopy density for the stream was 59%. Reach 1 had a canopy density of 57% while Reach 2 had a canopy density of 63%. In general, revegetation projects are considered when canopy density is less than 80%.

- 7) Increase the canopy on North Fork Gualala River by planting willow, alder, redwood, and Douglas fir along the stream where shade canopy is not at acceptable levels. The reaches above this survey section should be inventoried and treated as well, since the water flowing here is affected from upstream. In many cases, planting will need to be coordinated to follow bank stabilization or upslope erosion control projects.

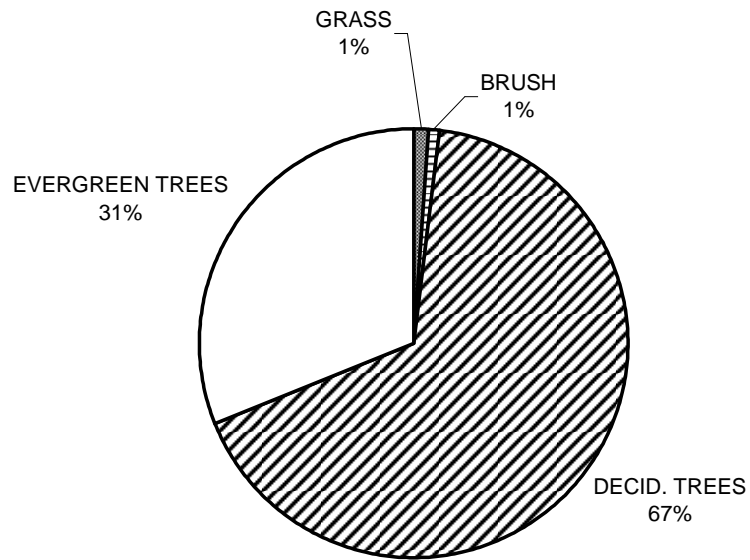
GRAPH 11

For the stream reach surveyed, the mean percent right bank vegetated was 49%. The mean percent left bank vegetated was 51%. The dominant elements composing the structure of the stream banks consisted of 45% bedrock, 24% cobble/gravel, 18% boulder, and 13% sand/silt/clay (Graph 10). Deciduous trees were the dominant vegetation type observed in 67% of the units surveyed. Additionally, 31% of the units surveyed had coniferous trees as the dominant vegetation type, 1% brush, and 1% grass as the dominant vegetation (Graph 11).

The percentage of right and left bank covered with vegetation was low at 49% and 51%, respectively. In areas of stream bank erosion or where bank vegetation is not at acceptable levels, planting endemic trees species, in conjunction with bank stabilization, is recommended.
