Stream Name: Carpinteria Creek

Year Remediated: 2013 Site Type: Road crossing

PAD ID: 706233

Barrier Remediated

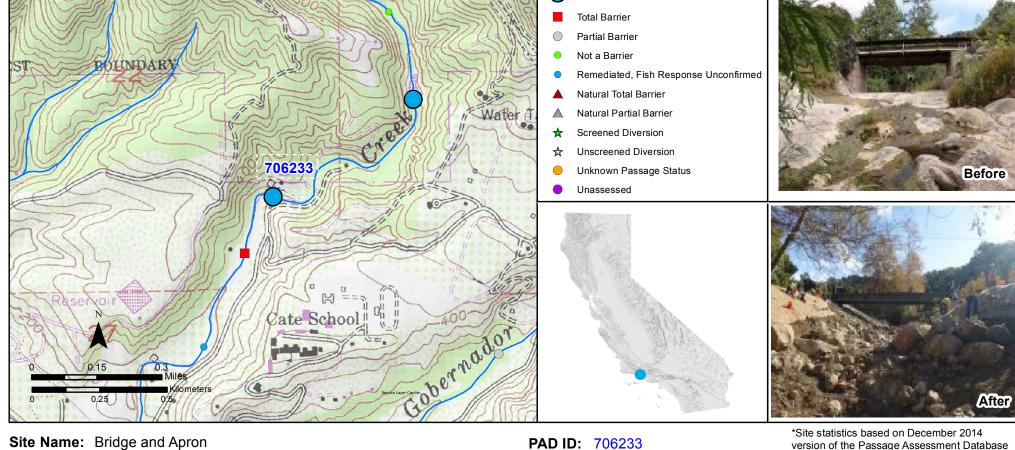
Barrier Description Prior to Remediation: Total

Notes: At the end of December 2013, the bridge was replaced by a new steel free-span bridge, 90 feet of concreted stream channel and banks removed, and banks restored. SCHR is currently working with the last remaining major barrier located downstream of the Pinkham crossing and hopes to have full access restored for steelhead trout within the Carpinteria Creek Watershed in the next few years. Before: Total barrier per DFG Restoration Manual assessed by South Coast Habitat Restoration. In 2008, three ~26" female steelhead migrated up the watershed and were stuck below an impassable barrier. As a result of the section of concrete nearly 90 feet long that lacks natural channel roughness the crossing is a velocity barrier to adult and juvenile steelhead trout and is considered to be a high priority for removal. Plans for the debris basin are currently being finalized and once complete, there will be over 1.09 miles of habitat available as a result of the two projects. The barrier was identified as "RED" as assessed through the DFG Green-Gray-Red Passage Evaluation by Questa Engineering and South Coast
