Site Name: Debris Basin Dam

Stream Name: Carpinteria Creek

PAD ID: 706491

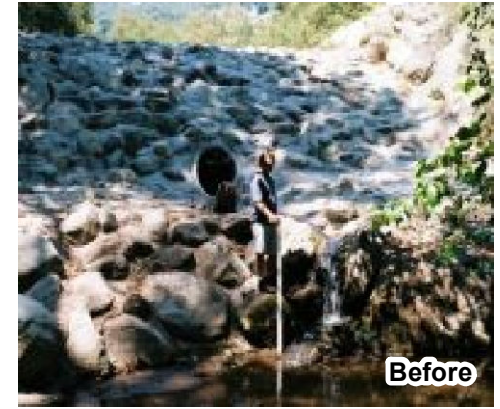
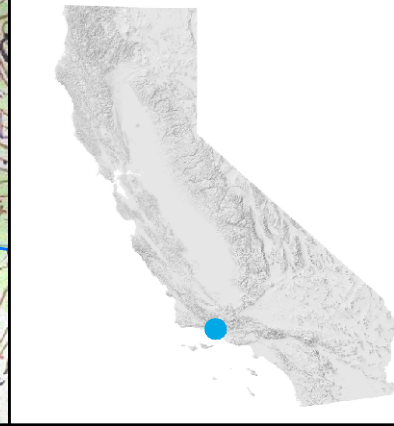
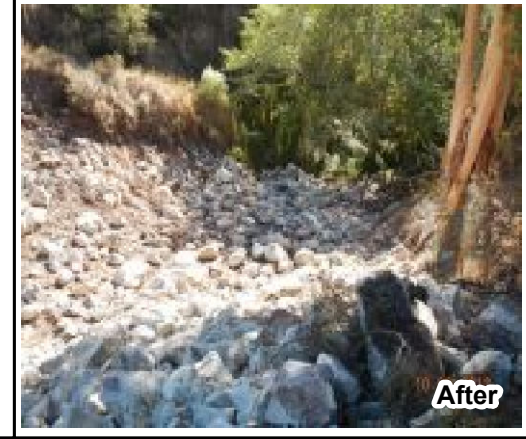
Barrier Description Prior to Remediation: Total

Notes: Dam was removed over a three year period because of the amount of sediment above the dam. More information available at: <ftp://pwftp.countyofsb.org/Water/FTP/ENVIRONMENTAL/Lillingston%20Debris%20Basin%20Removal/> Before: Total barrier per professional judgement by Stoecker Environmental Consulting. During migration flows, the downstream pool depth will increase and a jump onto the apron and passage among the large embedded boulder apron would be possible with a high degree of difficulty for an adult steelhead. The long, smooth culvert through the debris dam is impassable to upstream migrating steelhead due to the shallow water depth during low flows and the excessive water velocities during moderate and high flows. Debris has also completely clogged the entire inlet to the culvert.
