**Site Name:** Concrete Channelization

**Stream Name:** San Jose Creek

**Structure Owner:** Santa Barbara County Flood Control District

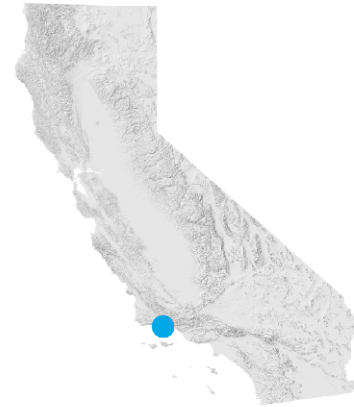
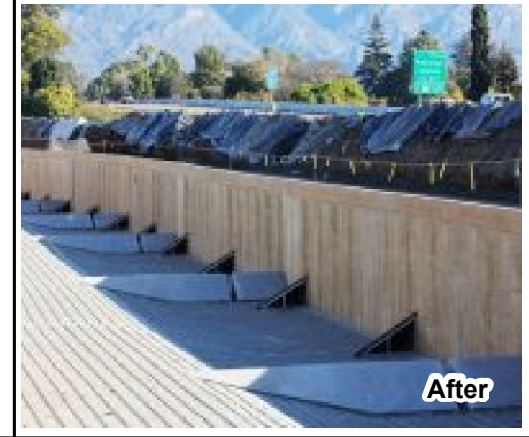
**Notes:** In 2013, a low flow fish passage channel (weirs and pools) was installed on the east side of the flood control channel and is deeper and narrower than the rest of the channel. The low flow fish passage channel uses weirs to slow the release of water. The weirs in San Jose Creek will insure the water will be deep enough for the fish to swim. The fish passage channel continues to the north side of the Hollister Avenue Bridge where it conforms to the natural creek bottom approximately 80 feet north of the bridge. This is part of the San Jose Creek Flood Control and Fish Passage Project. The existing concrete channel has been demolished and replaced with a wider channel with an articulated concrete revetment (blanket of concrete blocks cabled together with polycarbonate rope) anchored to the walls of the channel, and will mimic a natural creek bottom. Total length of structure: 0.78 miles. Before remediation: Total barrier per professional judgement by Stoecker Environmental Consulting. The excessive length of the channel, with no significant resting areas, accelerated stream velocities, and/or shallow water conditions,
