**Site Name:** West Dry Creek Road

**Stream Name:** Grape Creek

**PAD ID:** 712169

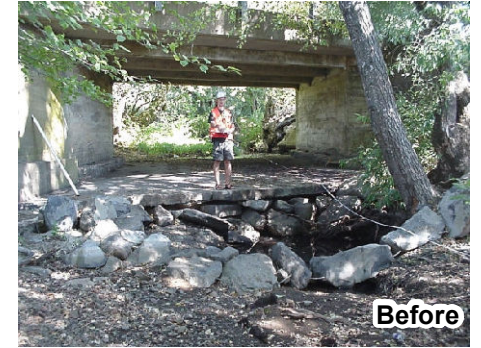
**Barrier Description Prior to Remediation:** Partial

**Notes:** Concrete box culvert. Fish way with four concrete v-notch weirs and pools constructed on October 22, 2012 to improve fish passage. The University of California Cooperative Extension/California Sea Grant conducted a spawner survey upstream of the site in 2012-13 (the first winter following remediation) and they did find spawning coho salmon. The Water Agency has also found wild juvenile coho and steelhead upstream of the site in summer 2013 during snorkel surveys. The fish passage improvement project expanded the greatly expanded the range of flows that fish could pass. Before: Partial barrier per FishXing by Ross Taylor and Associates. FishXing determined this crossing was 28% passable for adults and 0% passable for juvenile salmon and steelhead. barrier to juvenile salmonids, adult passage ok. 30' long x 21' wide concrete apron spanning the channel to help protect the bridge abutments from scour and undermining, and wing walls on both u/s and d/s ends. Box culvert passable only over a narrow range of flows.
