**Site Name:** Rhine Driveway (previously Hamman Driveway)

**Stream Name:** South Fork Ryan Creek

**PAD ID:** [712813](#)

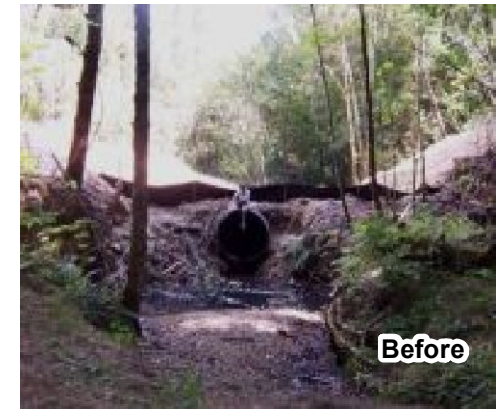
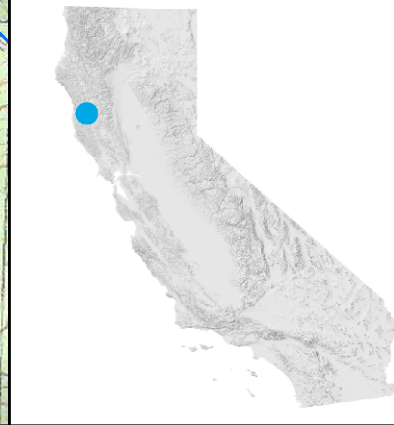
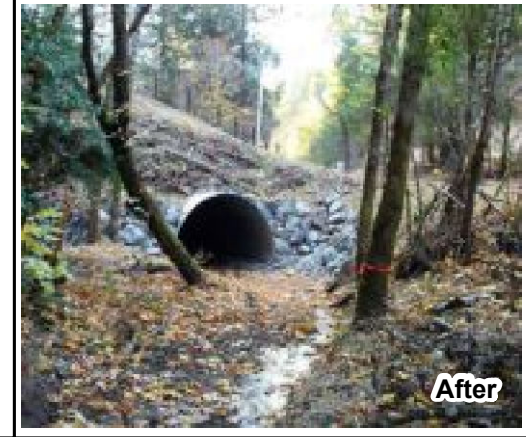
**Notes:** On 8/19/2013, Wiyot tribe assessed fish passage for adult pacific lamprey, and determined that this site is a not a barrier. Current site slated to be replaced with open-bottom arch culvert with natural streambed. Perched and undersized corrugated metal pipe was in process of being replaced during 8/19/13 site visit. A follow-up site visit to verify new crossing does not present passage problems for lampreys would be valuable. Prior to lamprey assessment: 5' Corrugate metal culvert was replaced with a 14' multi-place arch culvert and the channel was restored. The second pipe is offset 40' from the main crossing pipe and has a return flow channel to the main stem. It was disconnected as part of this fish passage project. After d/s barrier removal, coho were found up to Rhine Driveway in 2012 and in 2014 spawner surveys will be conducted by RTA on behalf of 5 counties upstream of this driveway. Before Treatment: Partial barrier per professional judgment by CDFW. Two 5 ft diameter corrugated metal pipes (CMP) under a 25 foot embankment depth, slope is approximately 20%
