Site Name: Hwy 150 Bridge (52-105) with Grade Control Structure

Stream Name: Santa Paula Creek

Structure Owner: California Department of Transportation

Year Remediated: 2012

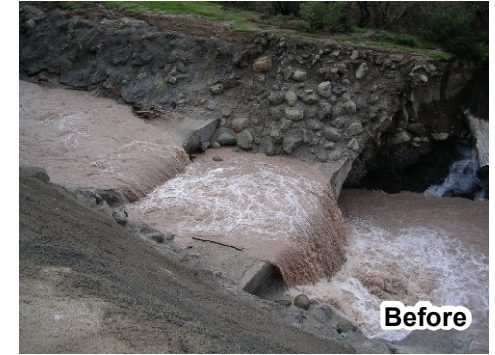
Barrier Description Prior to Remediation: Total

Notes: Per USGS flow gauge d/s, the lowest cfs was 0.5 this summer (below historical average). The fish passage project at this site was designed to pass all life stages and through all flows, but the flow is currently going subsurface - need a good rainy season. In November, finished installation of 15 rock weir step pools to make stream bed level. The waterfall/drop structure was a barrier to steelhead. No steelhead were observed at or above site on Santa Paula Creek because of a dry 2013 year. Before: Total barrier per DFG Restoration Manual by Stoecker Environmental Consulting. Even prior to changes caused by the 2005 stream flows, this series of grade controls represented a severe migration barrier to upstream migrating steelhead. The pre-2005 conditions failed to meet DFG and NOAA passage criteria at all flows for strongest swimming species presumed present due to excessive outlet drops on 4 of 7 curbs and excessive slope on one curb. Following the devastation caused by the 2005 flows the series of grade controls continues to fail DFG and NOAA passage requirements for the same reasons mentioned above minus one curb that was eliminated.
