Site Name: Caprini Low-flow Road Crossing

Stream Name: Mormon Slough

PAD ID: 735110

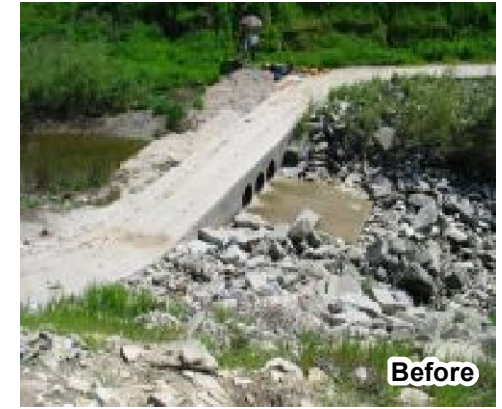
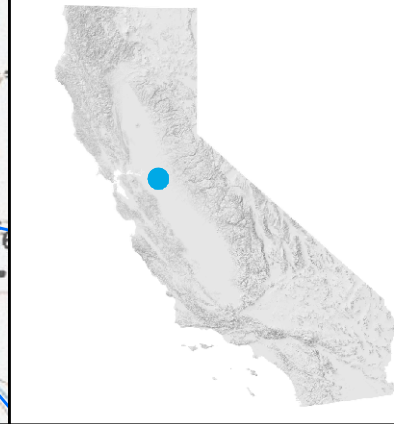
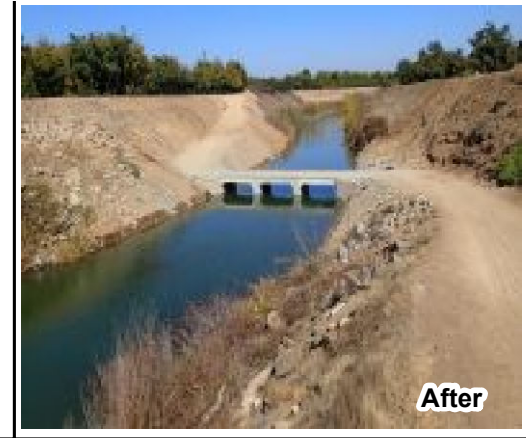
Barrier Description Prior to Remediation: Temporal

Notes: In October 2013, the low flow crossing with three circular culverts was completely removed and replaced with another road crossing with box culverts. Concrete apron on the downstream and upstream side of the crossing was removed and concrete riprap around crossing was also removed. Video of barrier removal: <http://youtu.be/6XKvWI4JT5Q>. Before: Temporal barrier per field survey conducted by CDFW. All three culverts have similar geometric properties – corrugated metal pipe, 36 inch diameter, about 10 feet long, and set at about a 3% slope. A concrete apron is attached to the upstream and downstream faces of the crossing. The upstream apron extends about 15 feet upstream of the structure,
