Site Name: Haul Road Culvert

Stream Name: Newman Gulch

Tributary To: Noyo River

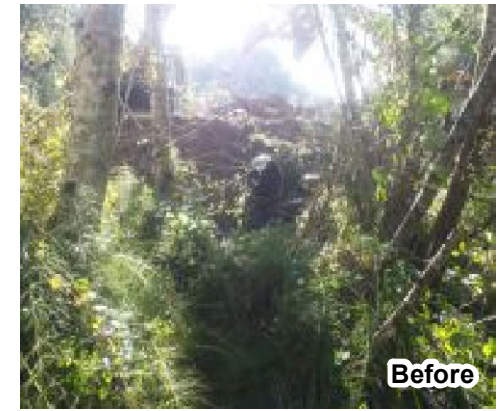
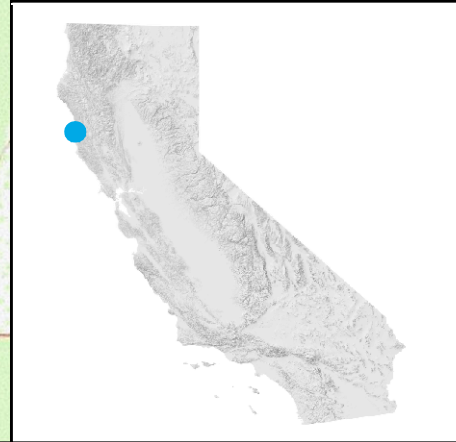
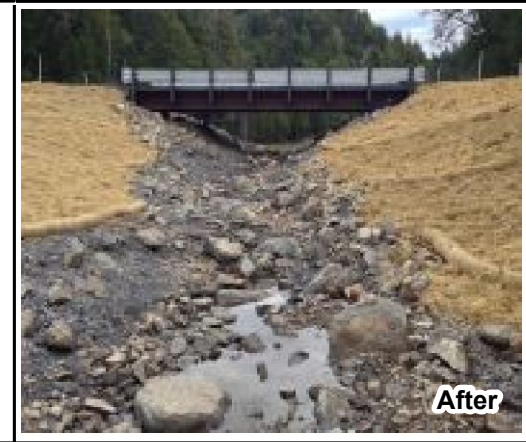
Notes: Replaced failing and undersized 4-foot (diameter) culvert, ~50 ft long with a 45-foot pre-fabricated steel bridge. Before: Total barrier per FishXing Software assessed by Winzler and Kelly Consulting Engineers. Complete barrier to all life stages of salmonids and will not pass a 50-year event causing high risk for catastrophic failure.
