**Site Name:** Hammer Diversion Dam (removed)

**Stream Name:** South Fork Cottonwood Creek

**PAD ID:** 758588

**Barrier Remediation By:** U.S. Fish and Wildlife Service

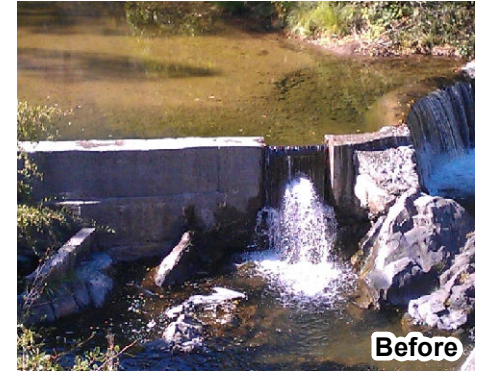
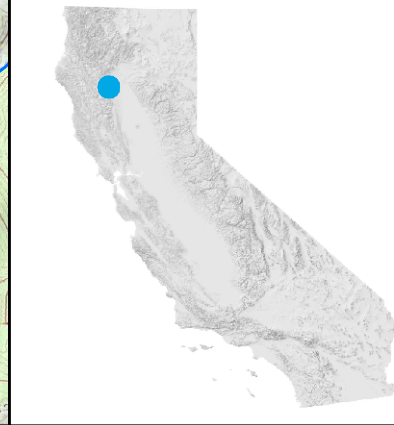
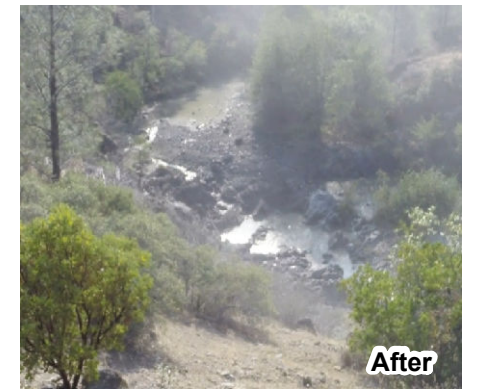
**Barrier Description Prior to Remediation:** Temporal & Partial

**Notes:** Dam removed by being blown up on October 14, 2014: <http://www.youtube.com/watch?v=m87WfWycecQ>. This was a AFRP project just downstream of Mendocino National Forest. Before: Temporal & Partial barrier per professional judgement by USFWS. Dam built to provide domestic water and hydropower to remote homesite. Fishway not functioning.
