SELBY CREEK – SILVERADO TRAIL CULVERT FISH PASSAGE ASSESSMENT

NAPA COUNTY, CALIFORNIA

NAPA COUNTY RESOURCE CONSERVATION DISTRICT
1303 JEFFERSON ST. SUITE 500B NAPA, CALIFORNIA 94559
WWW.NAPARCD.ORG

OCTOBER, 2006

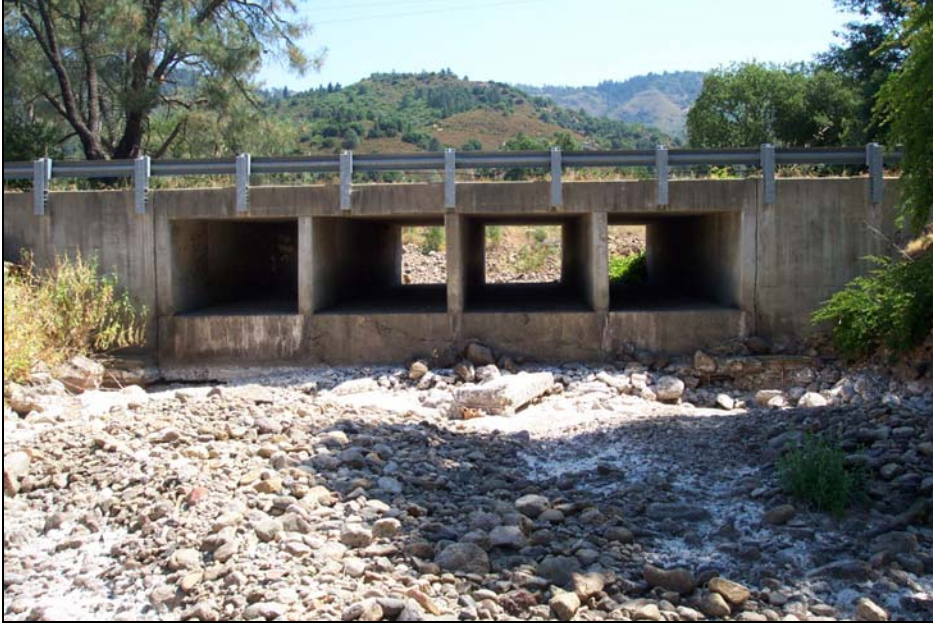
Silverado Trail culvert facing upstream (5-17-2006)

The main obstacles for fish passage are lack of water depth within the culvert and high velocities from the steep slope (3.7%). The culvert is relatively wide, which promotes sheet flow (shallow, fast moving water) during most low to moderate flows. Under all conditions, the culvert is a complete barrier to juvenile upstream movement due to high velocities and the excessively high jump into the culvert outlet (Table 1).

The Silverado Trail culvert outlet is perched above the downstream pool, requiring a substantial leap into the culvert. Leap heights range from approximately 3.1 feet at the low passage flow (3 cfs) to about 2.1 feet at the high passage flow (258 cfs). These leap heights are well within documented adult steelhead leaping abilities of six feet or greater. However, the downstream jump pool is not deep enough to allow for efficient leaping. If a perched outlet is unavoidable, the downstream jump pool depth should be at least 1.25 times the leap height to create favorable hydraulic conditions for leaping. NOAA Fisheries and DFG guidelines recommend that all culverts be installed slightly below grade to eliminate leaping at the outlet. Repeated leap attempts cause exhaustion, injury, and even mortality to migrating fish.

The Silverado Trail culvert represents a major obstacle for steelhead migration, and likely has a significant impact on fish movement to high quality upstream habitat. The culvert should be either replaced or modified to reduce water velocities, concentrate flows into a deeper low-flow lane, and eliminate the leap at the outlet. Since the culvert appears to be undersized, it is not advisable to improve passage by installing roughness elements (e.g. boulders, baffles, concrete berms, etc.) inside the culvert to decrease velocities and create resting areas.

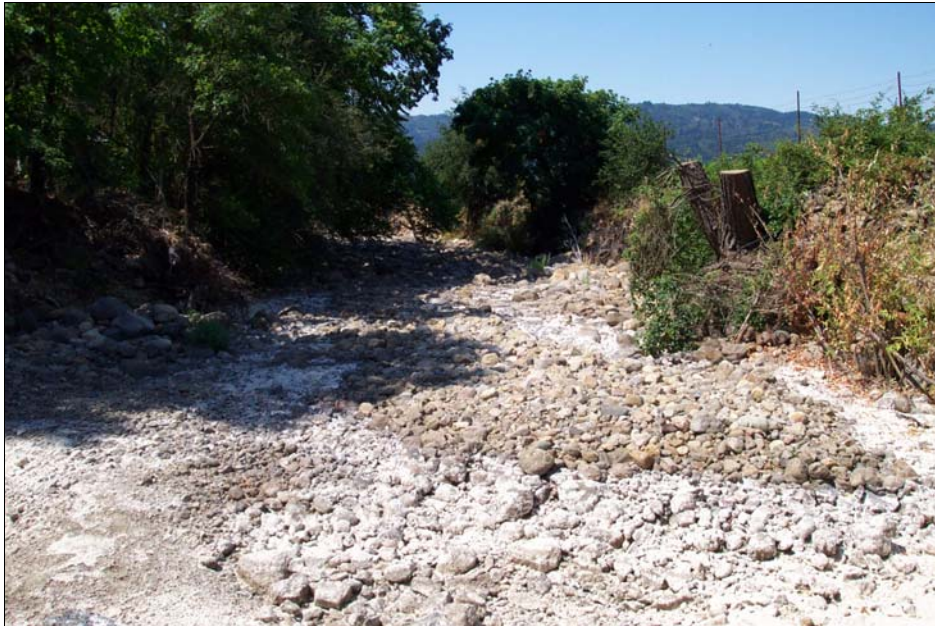
Selby Creek downstream of Silverado Trail facing downstream (5-17-2006)

The channel downstream of the Silverado Trail culvert shows evidence of incision, and is characterized by steep, unstable banks. The culvert is currently providing grade control to the channel, preventing incision from traveling upstream into Dutch Henry and Biter Creeks. Restoration efforts in this downstream reach could include elements that sequentially raise the bed elevation over several hundred feet of channel. This may include a series of constructed step pools or other instream structures that promote bed aggradation. If the culvert remained in place and an improved approach route was created, the culvert itself would still remain a significant barrier, requiring modification to reduce velocities and increase depth. This may be partially accomplished by creating a notched lane in the concrete that concentrates flow through the culvert. This lane would likely only be effective at lower flows when velocities are lowest.

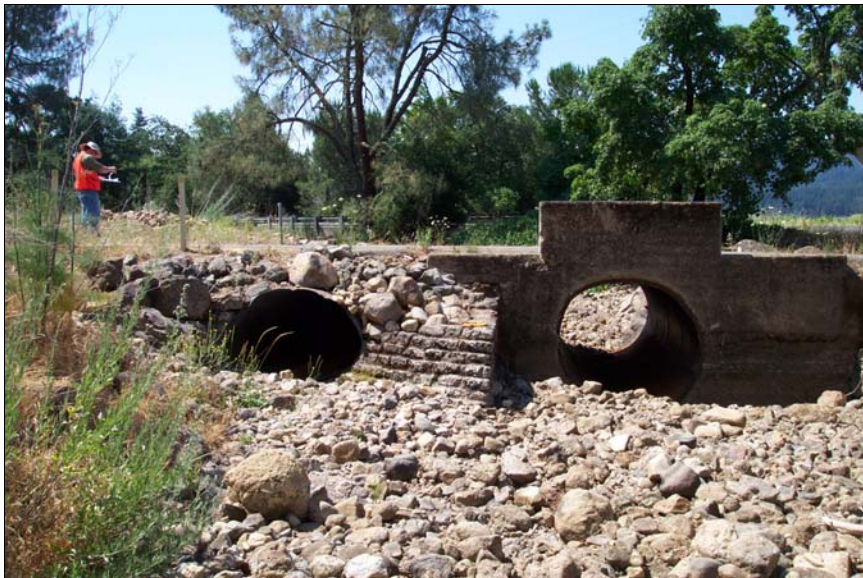
Dutch Henry Culvert inlet facing downstream (5-17-2006)

Based on field observations and Fish X-ing analysis, this culvert does not represent a significant obstacle to steelhead migration. The culvert was given a “GREEN” value based on DFG criteria, which indicates that conditions are adequate for passage of all salmonid life stages.

The main culvert is installed slightly below streambed level, maintains sufficiently low velocities during a wide range of flows, and is relatively short. The passage window analyzed was 3–70 cfs with Fish X-ing. The results of this analysis suggest that the culvert is passable during all but the lowest passage flows (< 5 cfs) for adults and passable during all passage flows for juveniles. Shallow conditions with water depths less than 0.5 feet in the culvert exist during low flows, which may slightly hinder fish passage. However, such shallow water depths are also expected in the natural channel above and below the culvert during such flows.

The culvert on Dutch Henry Creek does not warrant further action to improve fish passage. The current two-pipe configuration allows full passage during all expected steelhead migration flows and the structures appear to be in good physical condition.
