Evaluating the Pollution Potential of the M/V FERNSTREAM

M/V FERNSTREAM Task Force

Assessing the *M/V FERNSTREAM*

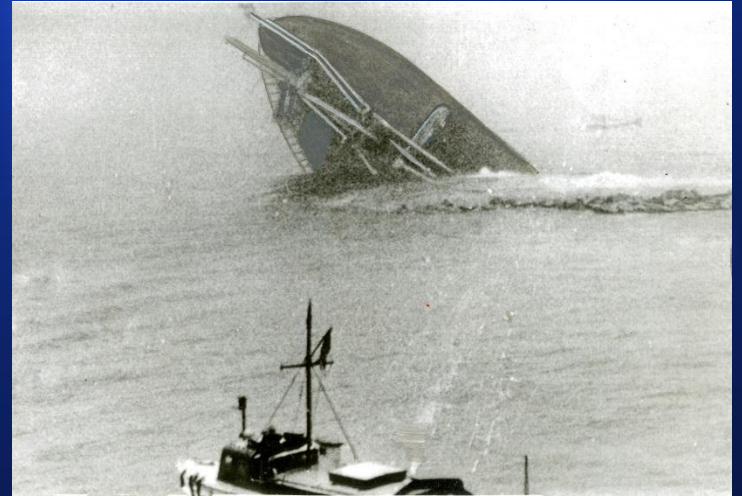
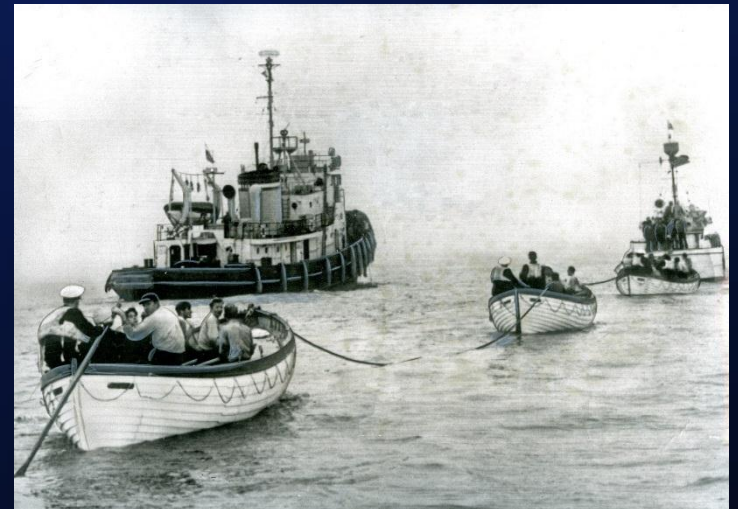
- Visibility - ½ mile
- Collision with *SS Hawaiian Rancher*
- Only minor injuries
- Sank within 37 minutes, <1 NM from the Lime Point Lighthouse (north end of the Golden Gate Bridge)
- No significant spill(s) reported

- Estimated 12,500bbls marine diesel
- Tank layout unknown
- Exact location not verified

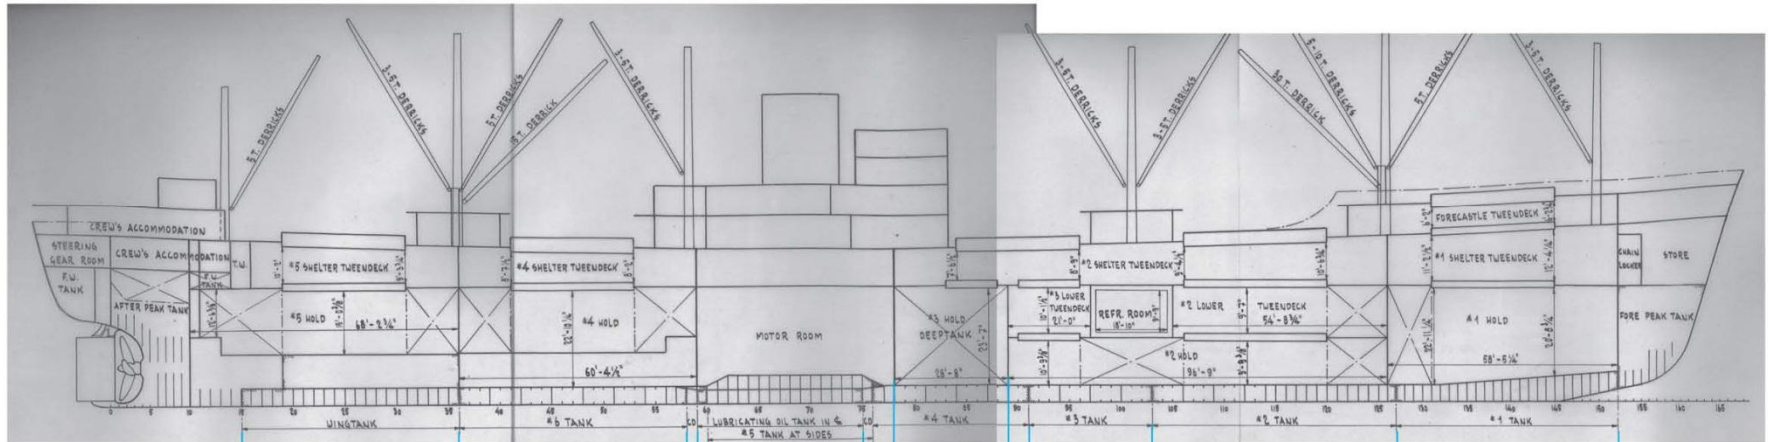
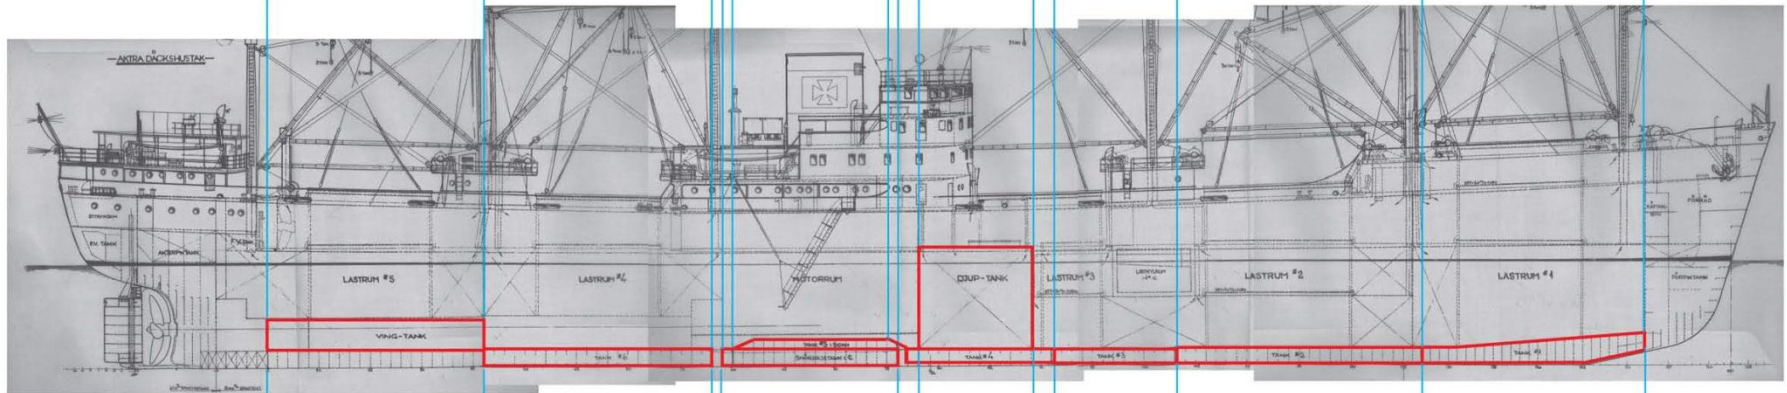
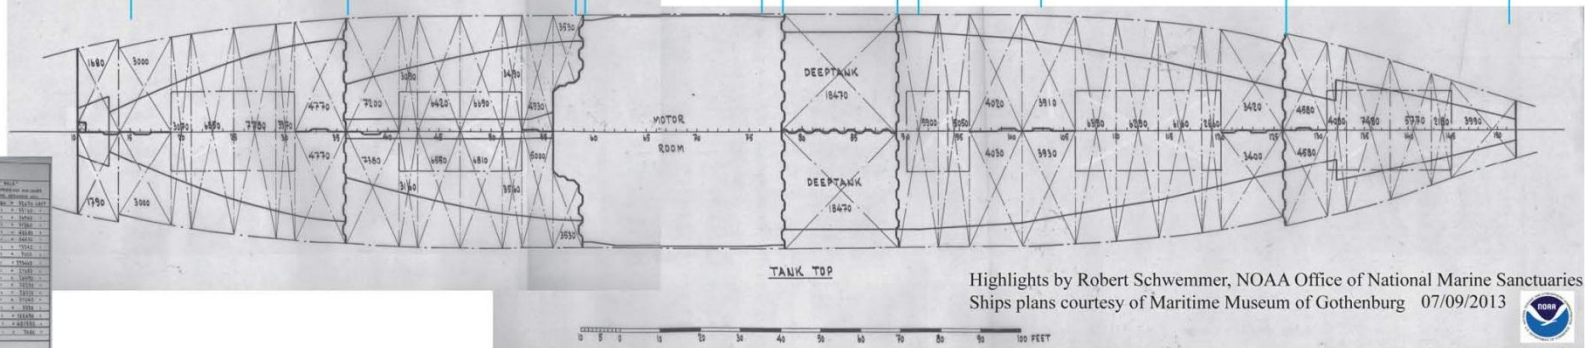
FERNSTREAM Plans & Tank Layout

Highlights by Robert Schwemmer, NOAA Office of National Marine Sanctuaries
Ships plans courtesy of Maritime Museum of Gothenburg 07/09/2013

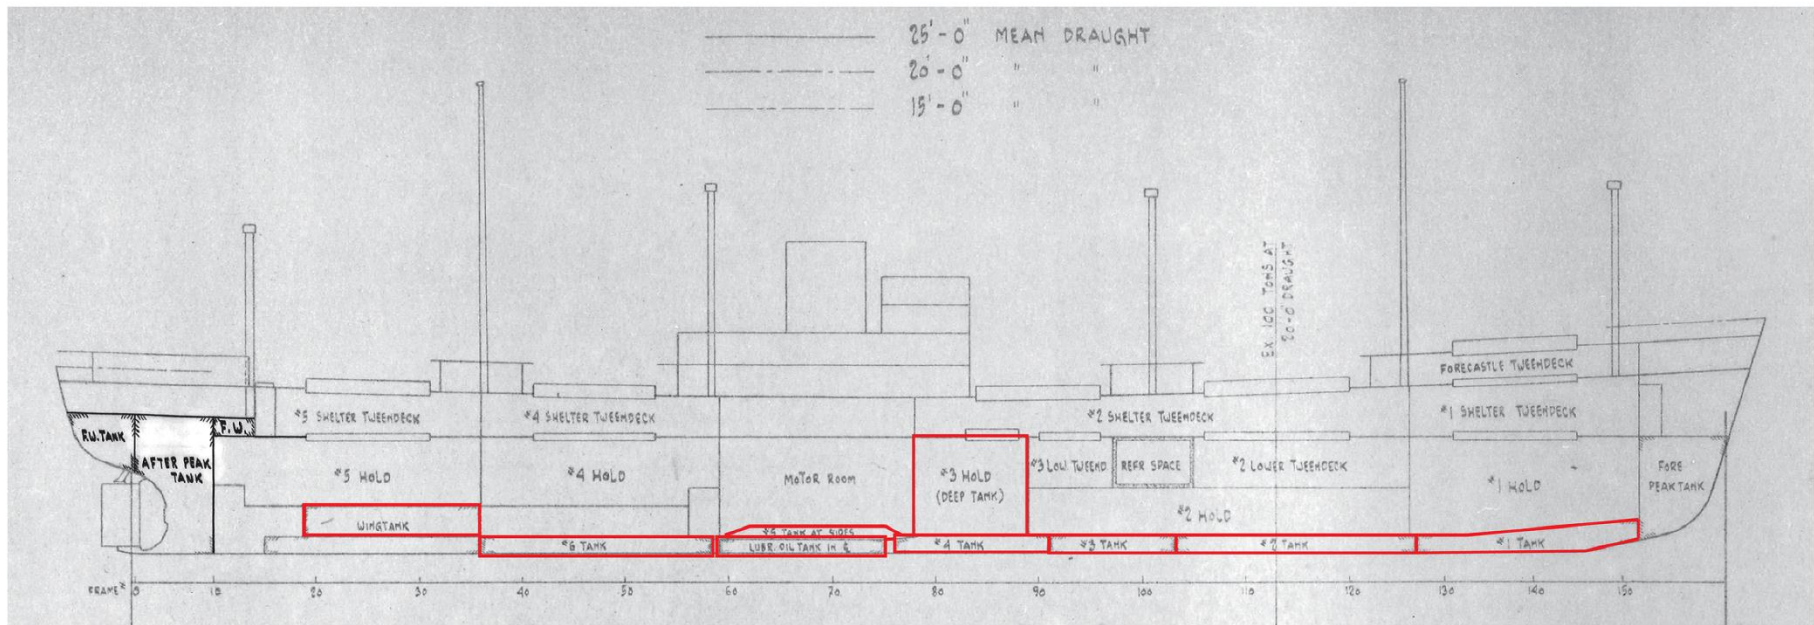
FERNSTREAM Plans & Tank Layout

- 4 3/8"	+ 1'-4 1/4"	264.2	261.8	#6	36 - 58/60	243.4	#6 Tank	261.8	243.4	1,761	73,962	
+ 3'-3 3/8"	+ 1'-4 3/4"	1210.8	1200.0	DEEP TANK	78 - 89	1112.6	Deep Tank	1,200.0	1,112.6	8,051	338,121

- 1'-3"	+ 2'-4 3/8"	322.2	324.3	WING TANK	13/4 - 36	301.4	Wing Tank	324.3	301.4	2,181	91,602	
- 3'-3 3/4"	+ 6"	53.2	52.7	DRINKING WATER TANK	10 - 14		Drinking Water Tank	52.7	N/A

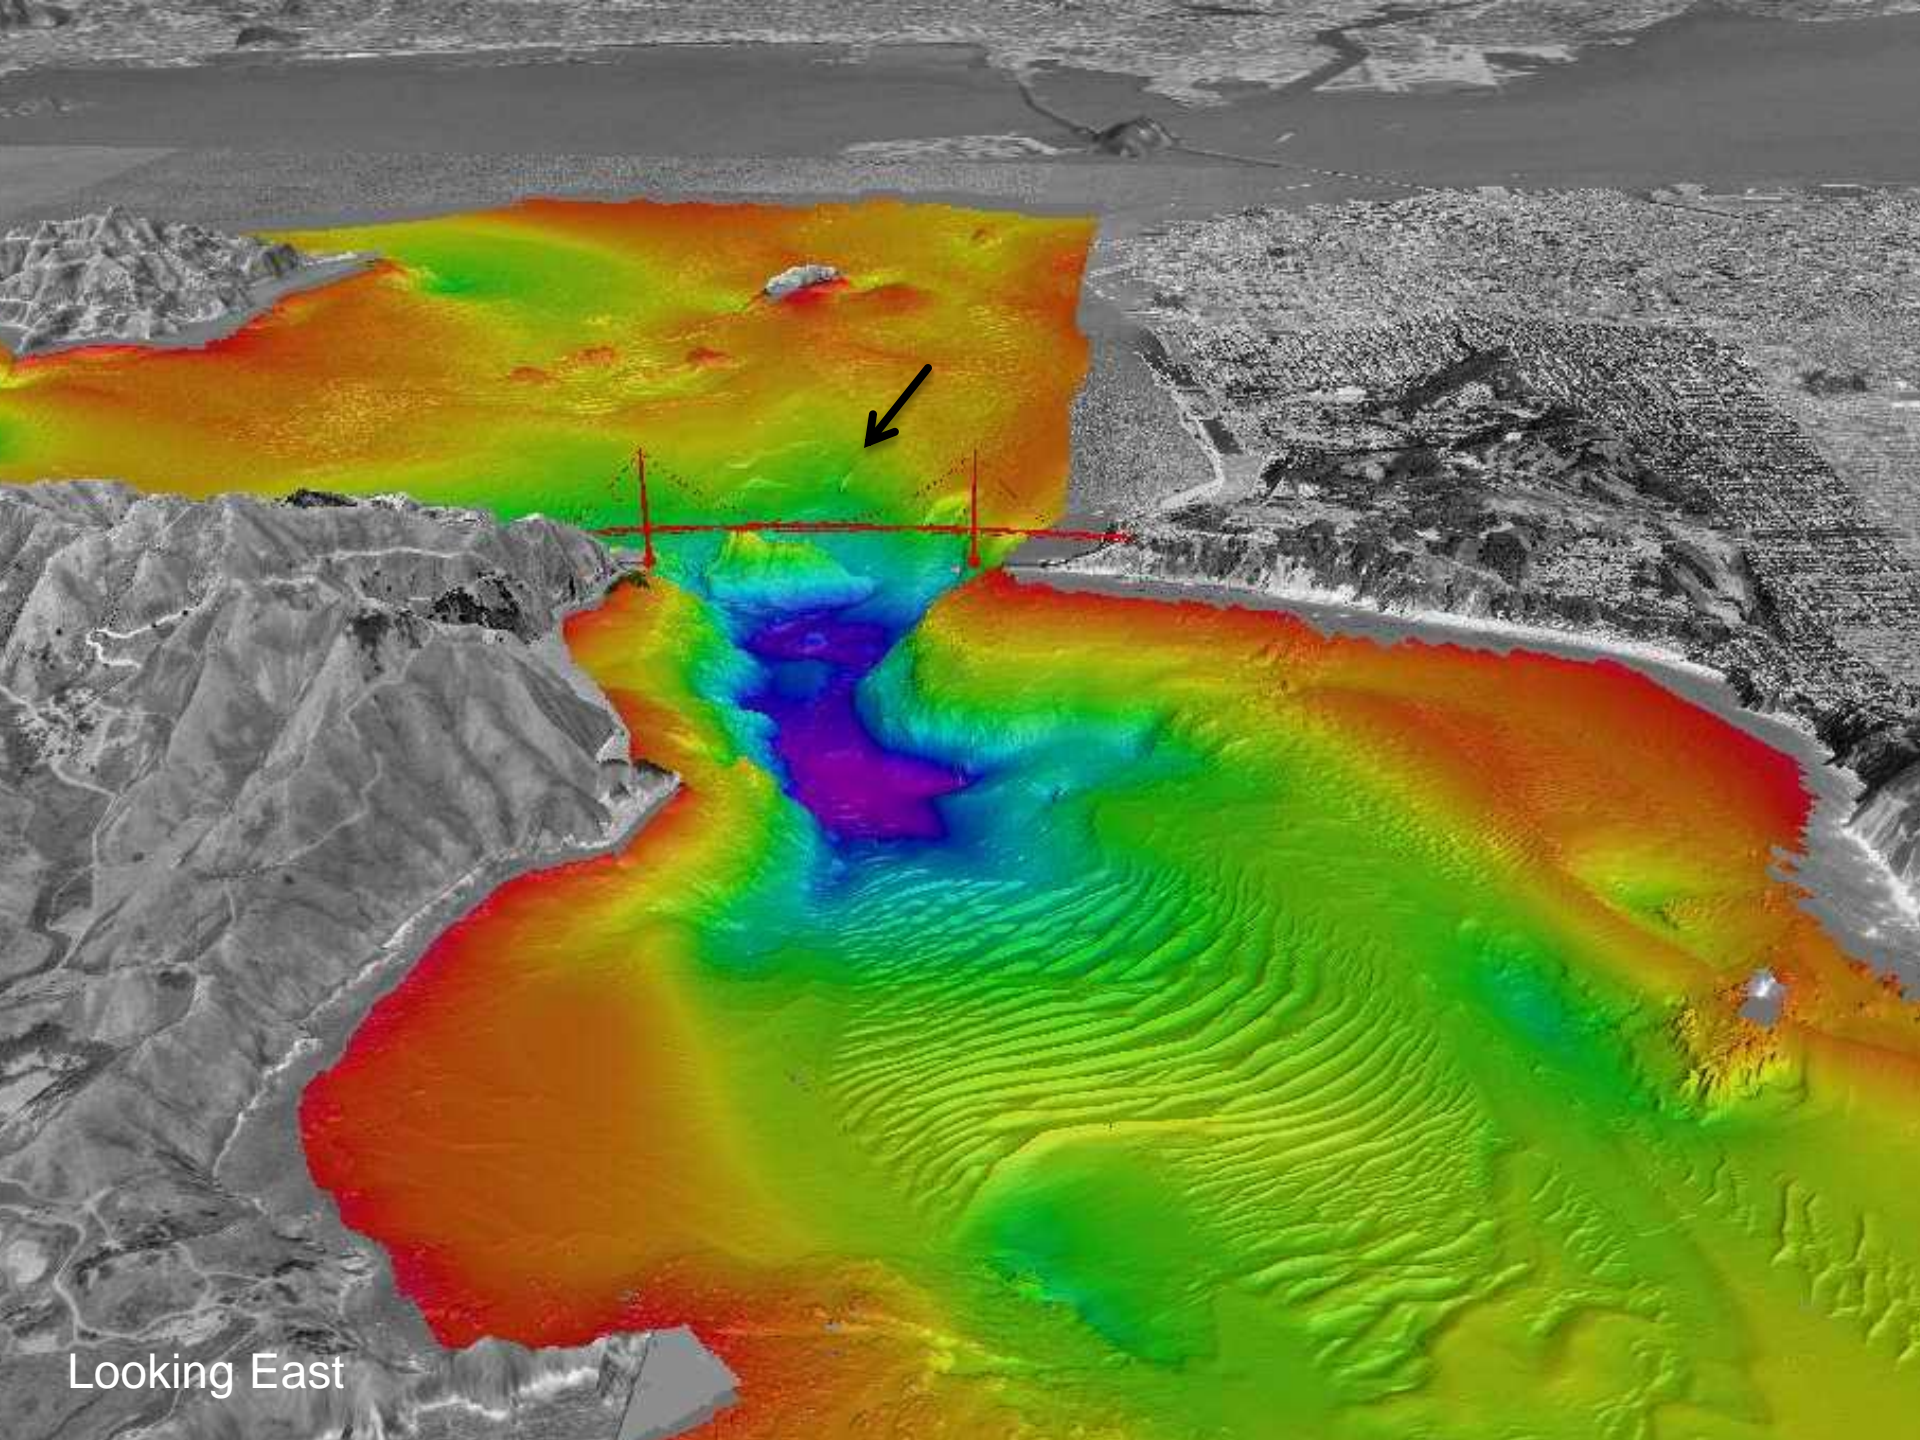
Chartlet
1 of 7

WRECK LOCATION: 37-49-11.96N, 122-27-32.56W | LENGTH: 415 FEET | BEAM: 100 FEET | HEIGHT ABOVE BOTTOM: 22 FEET | SHOALEST DEPTH: 123 FEET

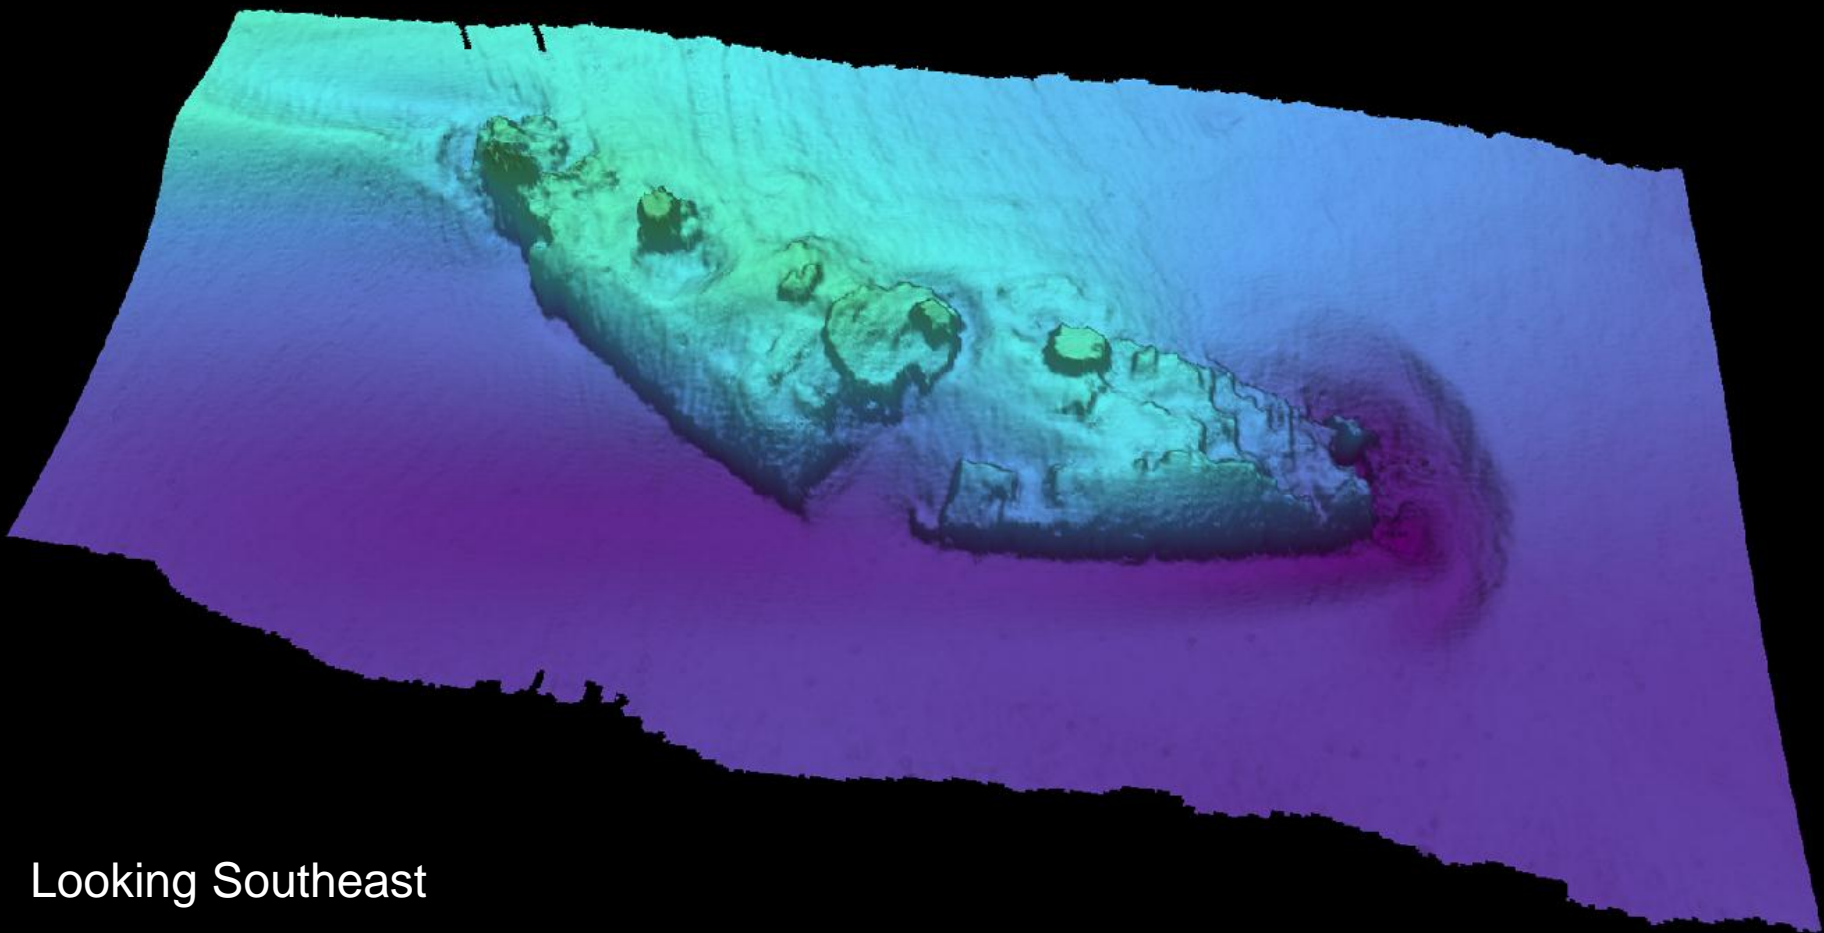
Chartlet
2 of 7

WRECK LOCATION: 37-49-11.96N, 122-27-32.56W | LENGTH: 415 FEET | BEAM: 100 FEET | HEIGHT ABOVE BOTTOM: 22 FEET | SHOALEST DEPTH: 123 FEET

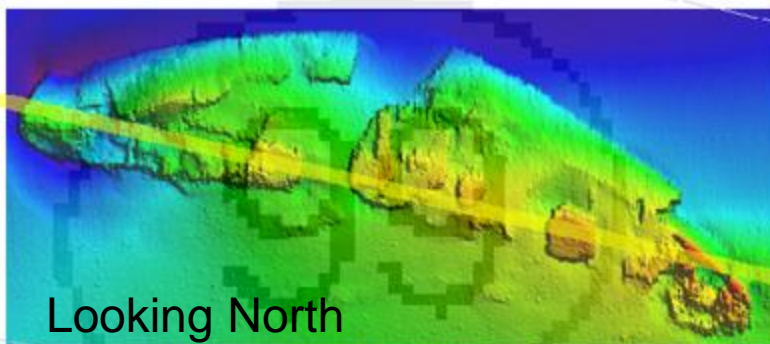
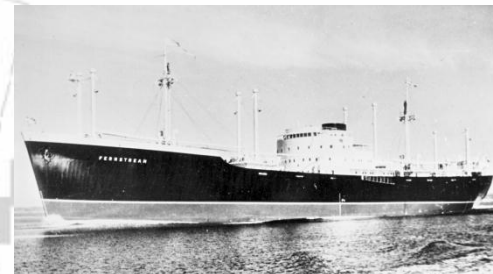
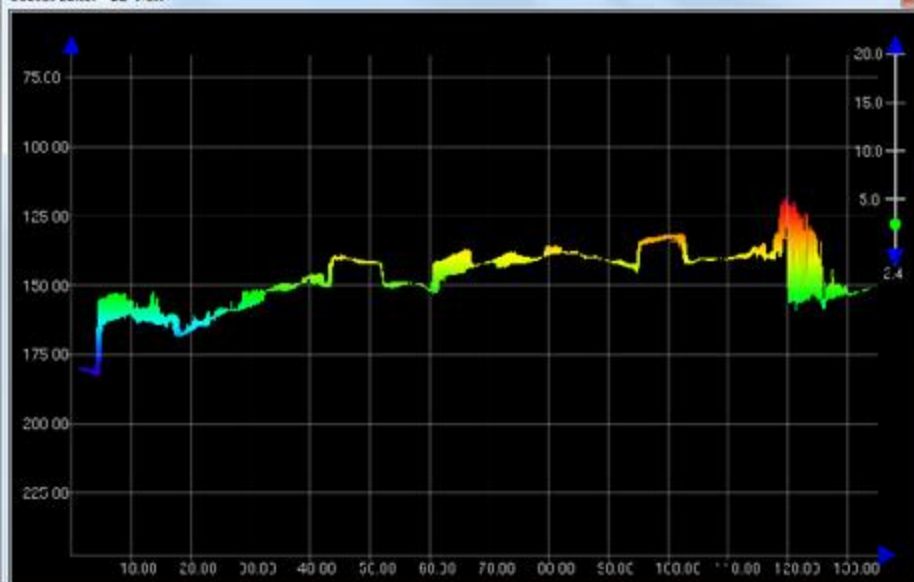
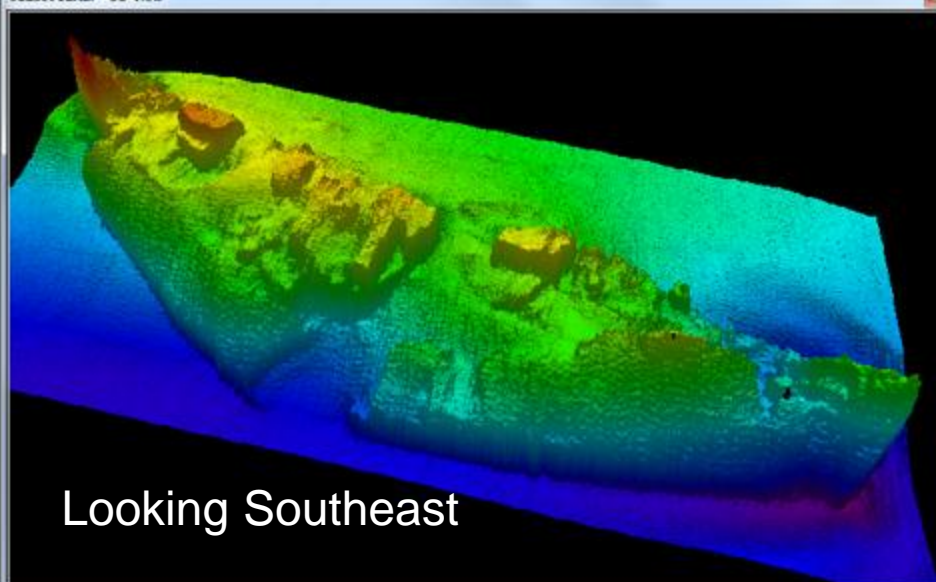
Chartlet
1 of 8

WRECK LOCATION: 37-49-11.96N, 122-27-32.56W | LENGTH: 415 FEET | BEAM: 100 FEET | HEIGHT ABOVE BOTTOM: 46 FEET | SHOALEST DEPTH: 116 FEET

FOSC determined the M/V FERNSTREAM no longer poses a substantial oil threat; though small, inaccessible amounts of residual oils may remain

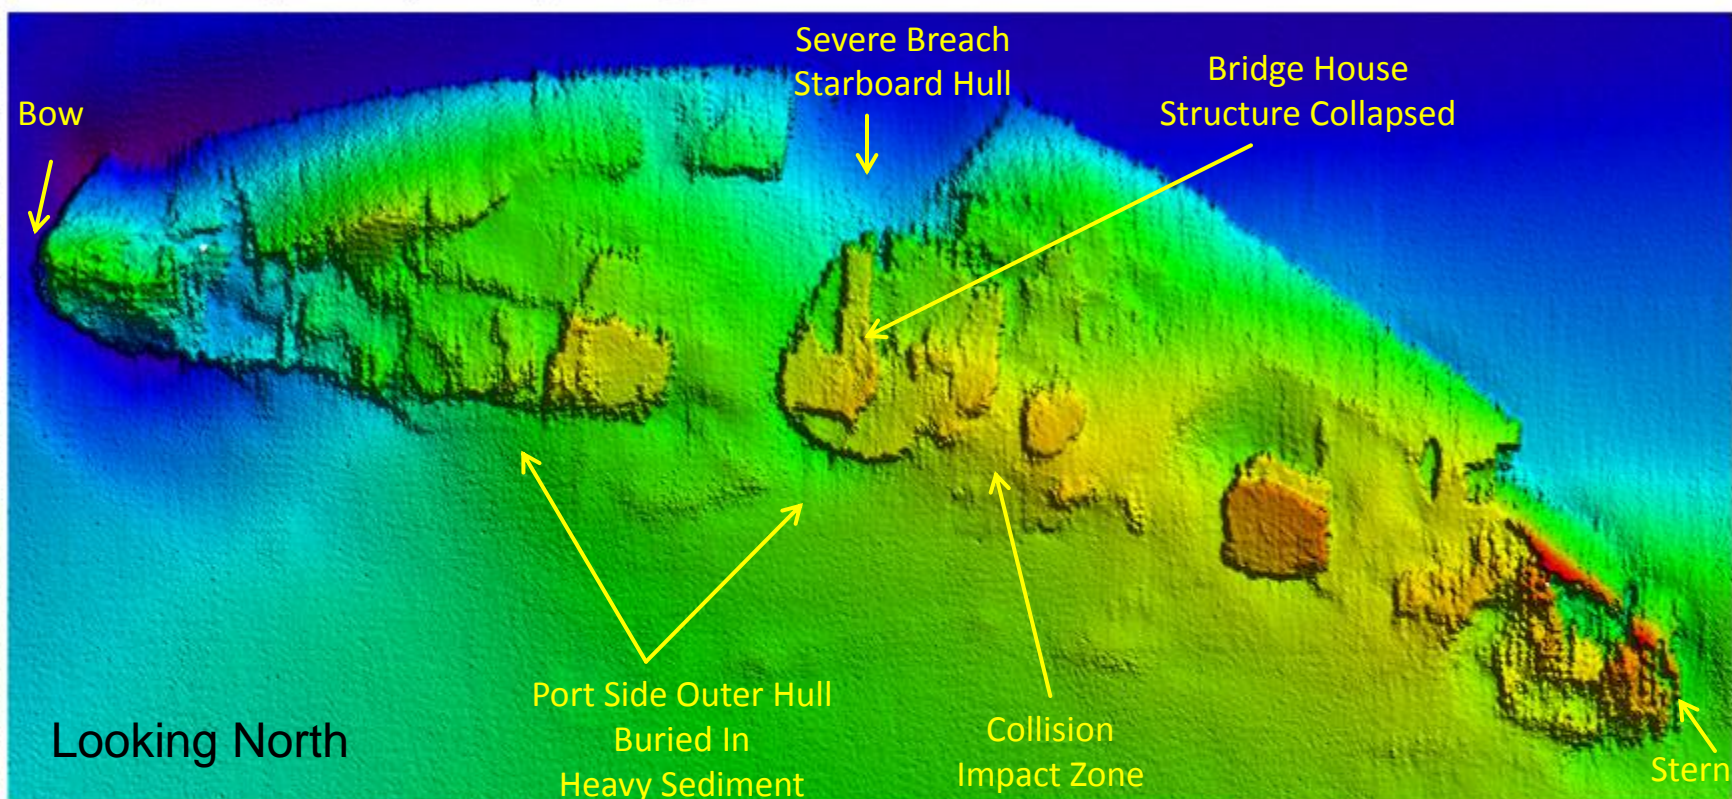
Chartlet
8 of 8

WRECK LOCATION: 37-49-11.96N, 122-27-32.56W | LENGTH: 415 FEET | BEAM: 100 FEET | HEIGHT ABOVE BOTTOM: 46 FEET | SHOALEST DEPTH: 114 FEET

Monitor RULET vessels in San Francisco AOR as part of regular Maritime Domain Awareness Patrols
