## CALIFORNIA DEPARTMENT OF FISH AND WILDLIFE

### STREAM INVENTORY REPORT

#### Laguna Creek

A stream inventory was conducted on July 28, 2015 on Laguna Creek. The survey began at the confluence with Big River and extended upstream 1.8 miles.

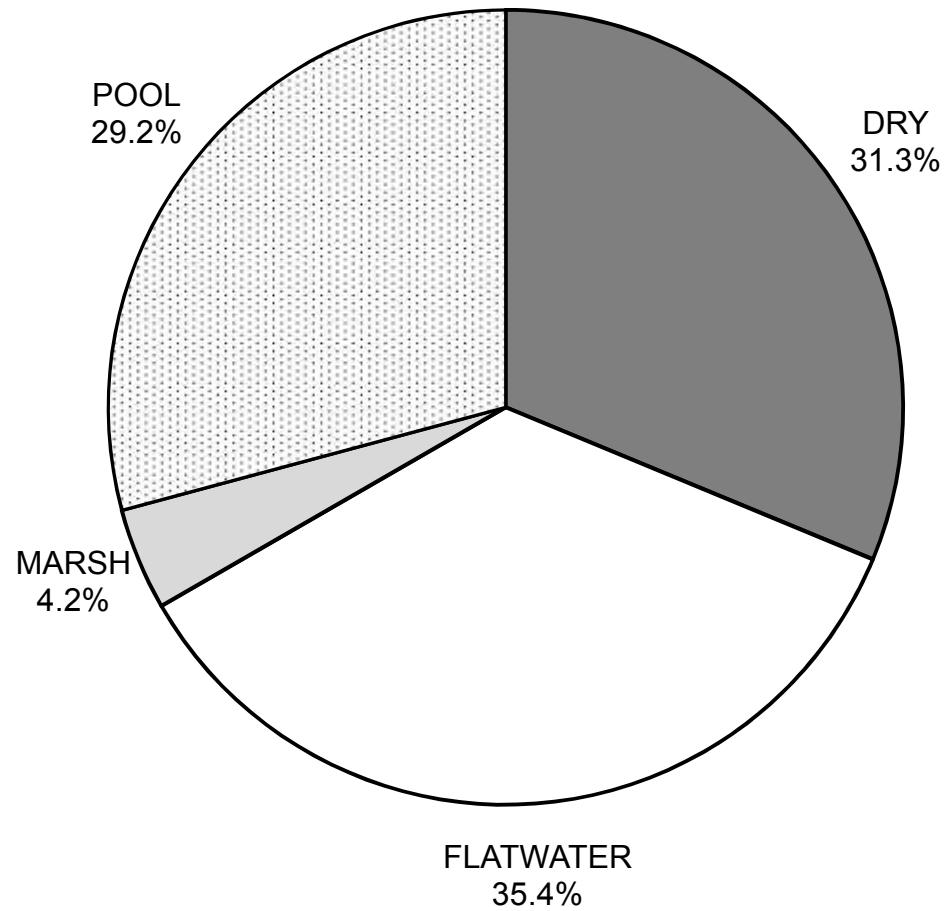
GRAPH 1

Table 1 summarizes the Level II riffle, flatwater, and pool habitat types. Based on frequency of occurrence there were 35% flatwater units, 31% dry units, 29% pool units, and 4% marsh units (Graph 1). Based on total length of Level II habitat types there were 57% marsh units, 19% dry units, 13% pool units, and 12% flatwater units (Graph 2).

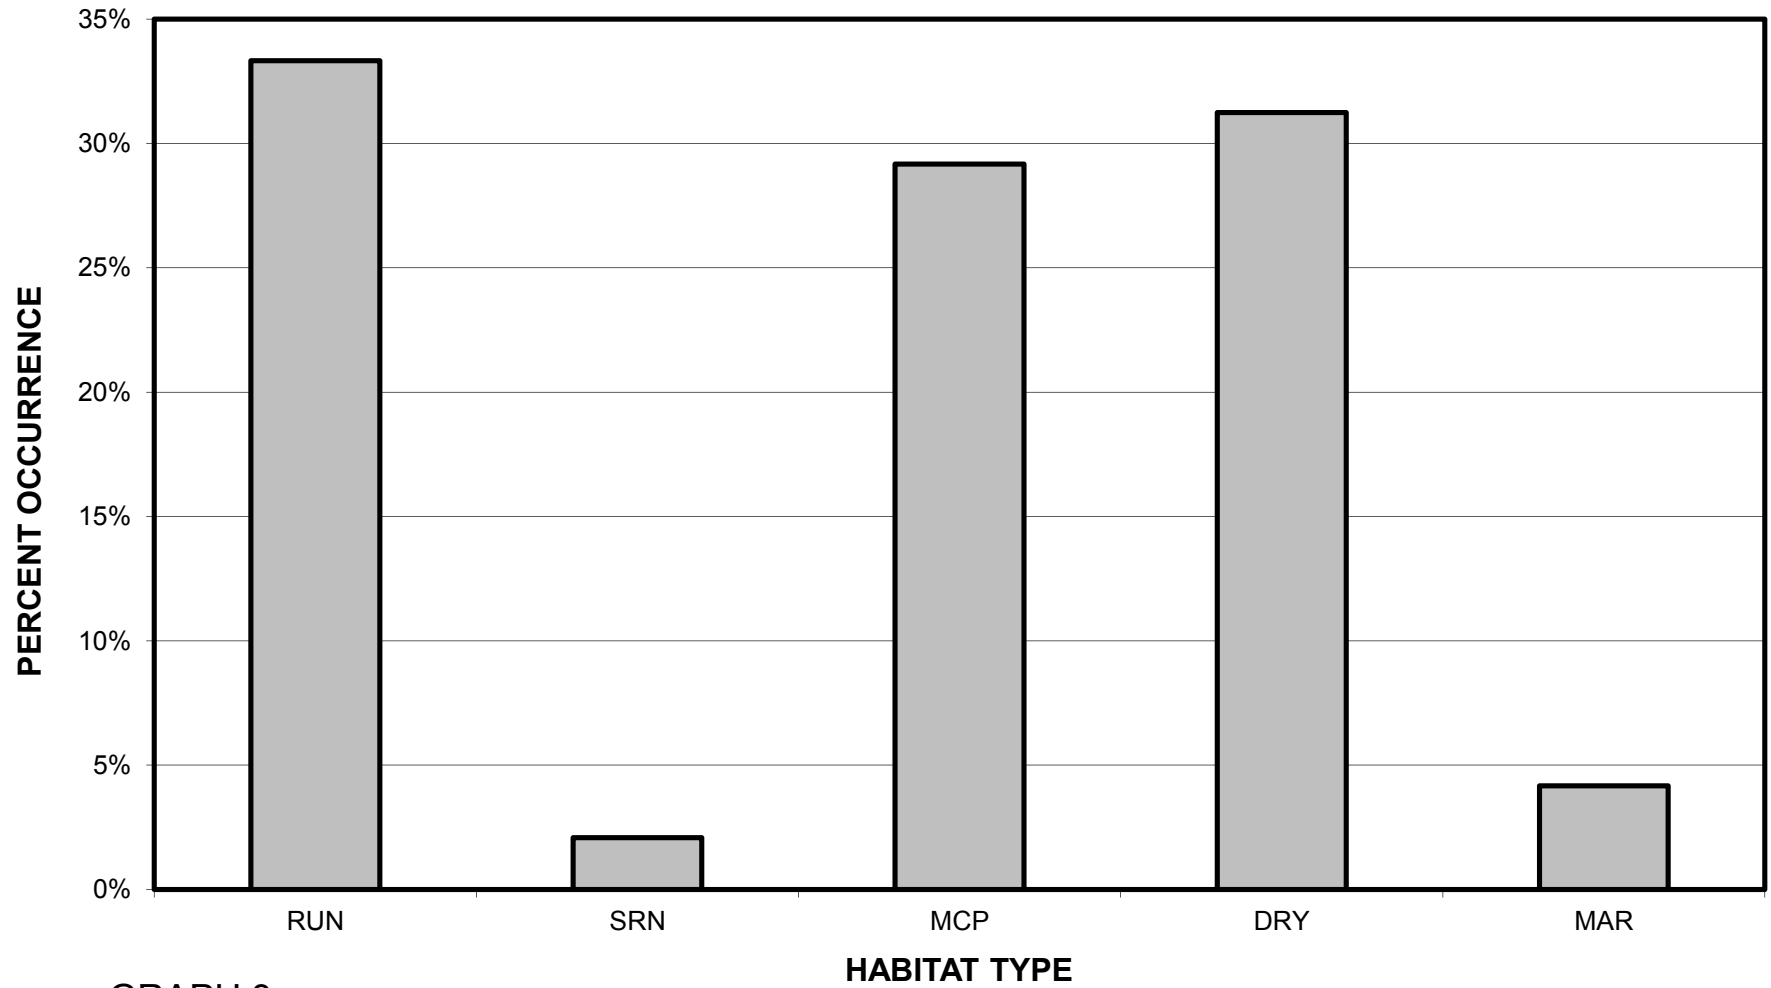
GRAPH 3

Four Level IV habitat types were identified (Table 2). The most frequent habitat types by percent occurrence were run units, 33%; dry units, 31%; and mid-channel pool units, 29% (Graph 3). Based on percent total length, marsh units made up 57%, dry units 19%, and mid-channel pool units 13%.

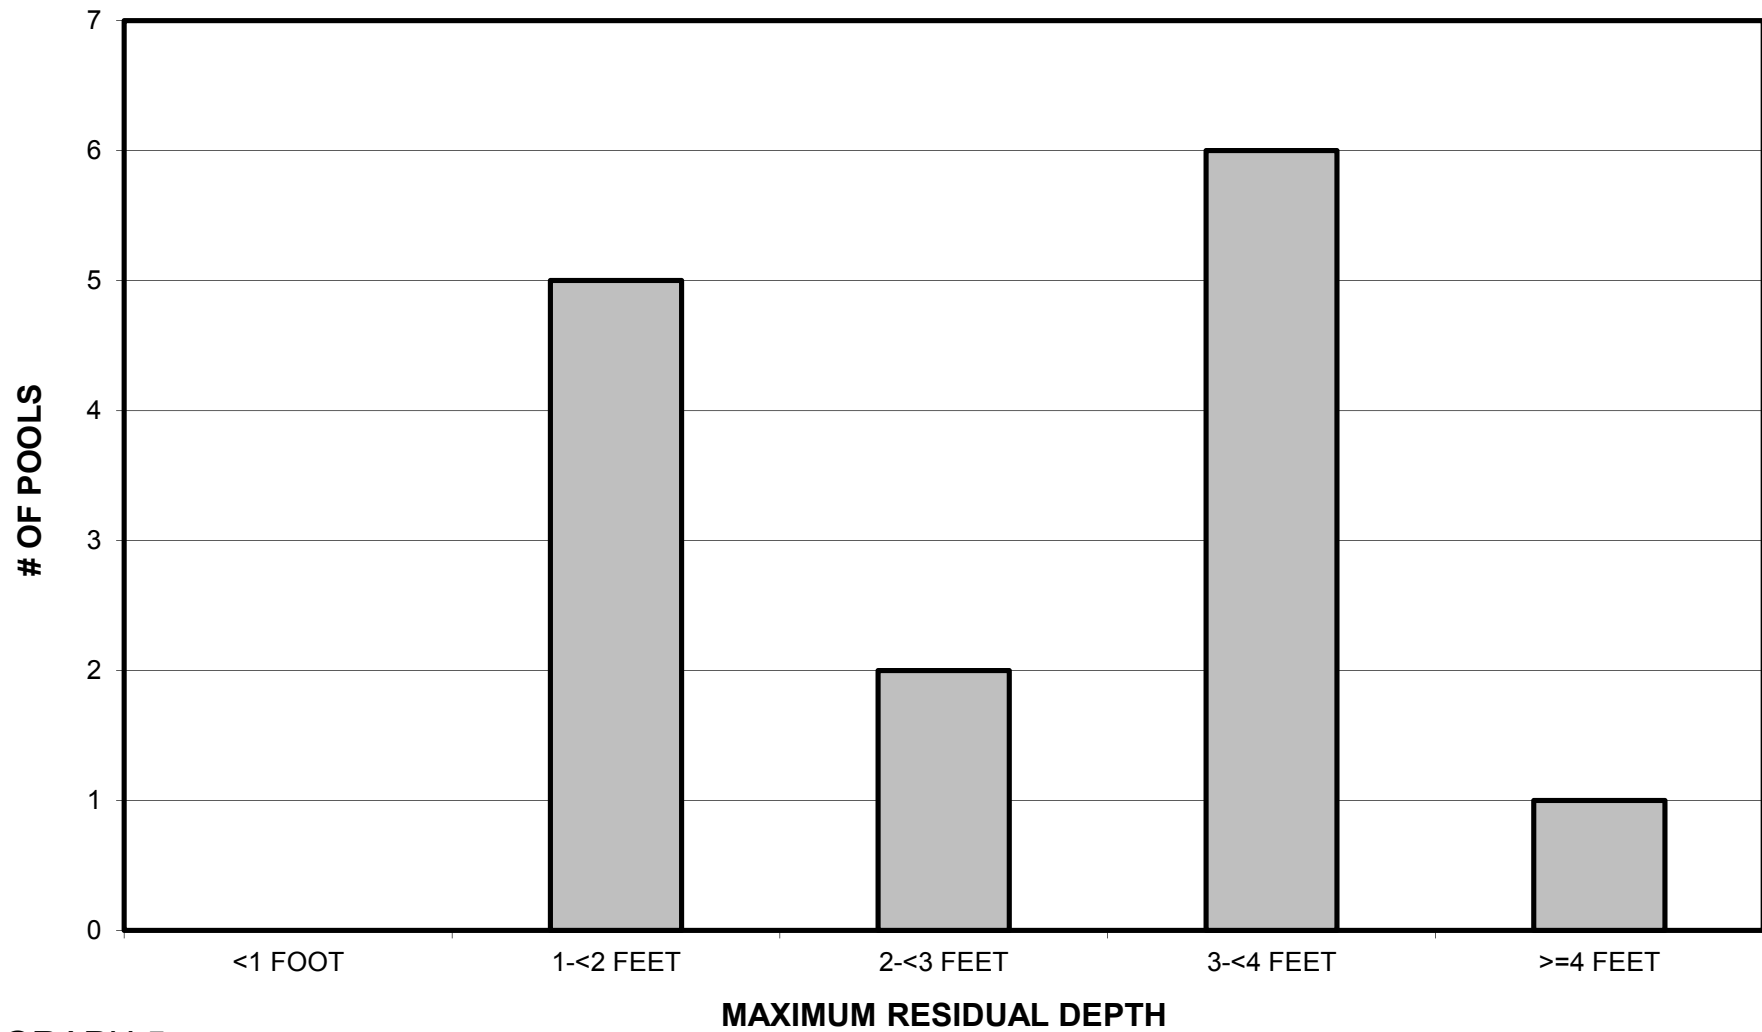
GRAPH 5

Table 4 is a summary of maximum residual pool depths by pool habitat types. Pool quality for salmonids increases with depth. Nine of the 14 pools (64%) had a residual depth of two feet or greater (Graph 5).

Flatwater habitat types comprised 12% of the total length of this survey and pools 13%. Nine of the 14 (64%) pools had a maximum residual depth greater than two feet. In general, pool enhancement projects are considered when primary pools comprise less than 40% of the length of total stream habitat. In first and second order streams, a primary pool is defined to have a maximum residual depth of at least two feet, occupy at least half the width of the low flow channel, and be as long as the low flow channel width.

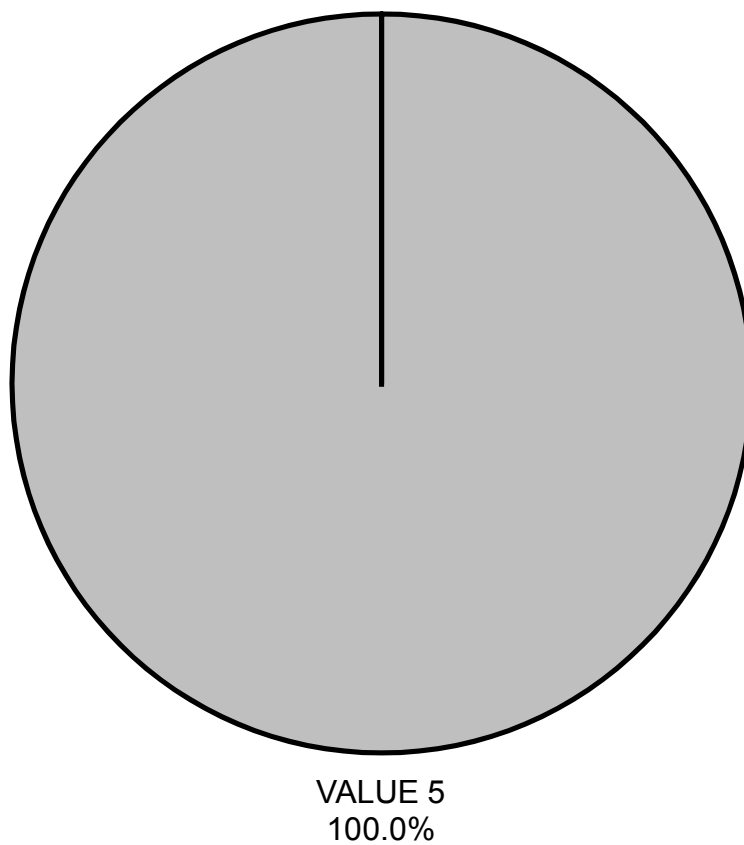
GRAPH 6

The depth of cobble embeddedness was estimated at pool tail-outs. Of the pool tail-outs measured, all 14 had a value of 5 (100%) (Graph 6). A value of 5 was assigned to tail-outs deemed unsuitable for spawning due to inappropriate substrate such as bedrock, log sills, boulders, or other considerations.

All 14 of the pool tail-outs had a rating of 5, which is considered unsuitable for spawning. Sediment sources in Laguna Creek should be mapped and rated according to their potential sediment yields, and control measures should be taken.

- 3) Active and potential sediment sources related to the road system need to be identified, mapped, and treated according to their potential for sediment yield to the stream and its tributaries.

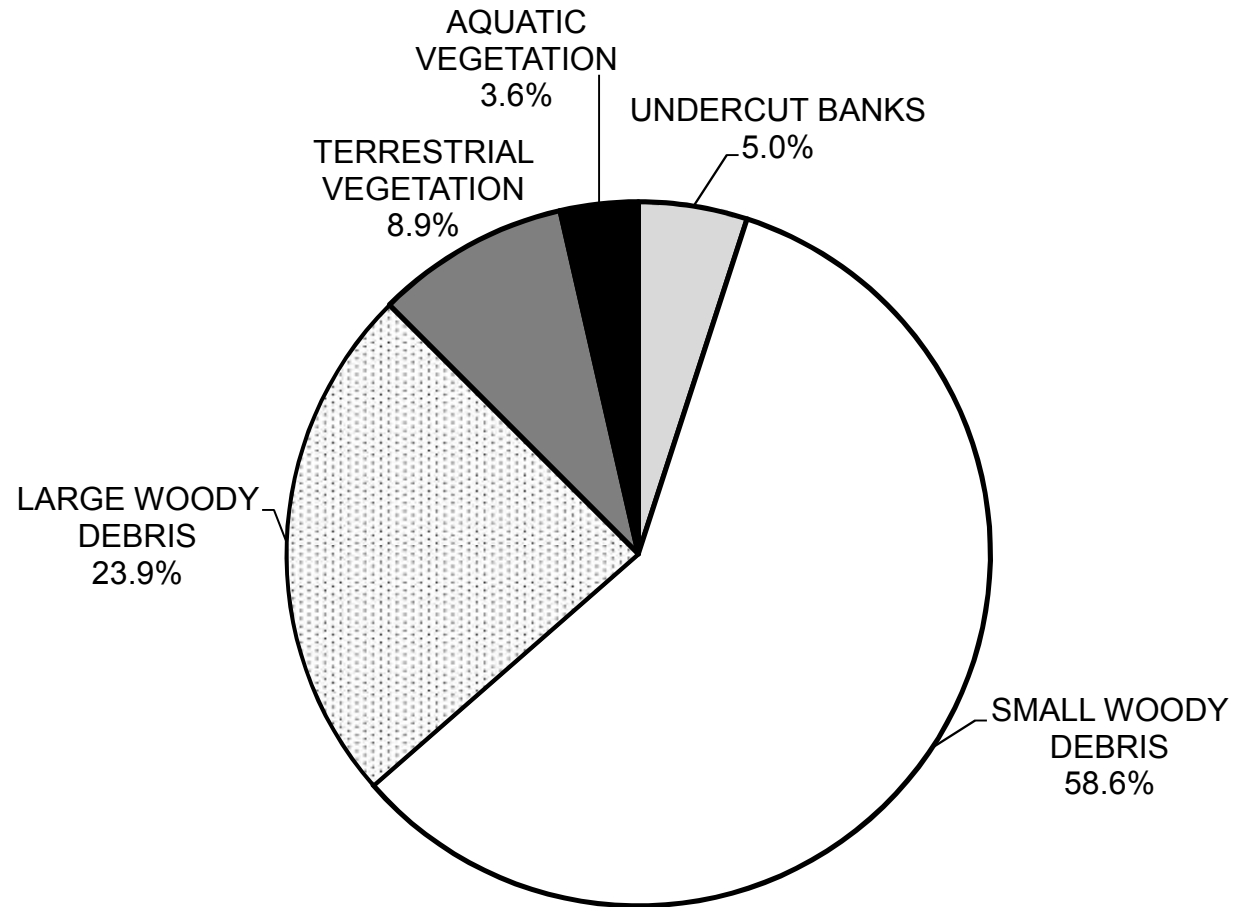
GRAPH 7

Table 5 summarizes mean percent cover by habitat type. Small woody debris is the dominant cover type in Laguna Creek. Graph 7 describes the pool cover in Laguna Creek. Small woody debris is the dominant pool cover type followed by large woody debris.

The mean shelter rating for pools is 31. The shelter rating in the flatwater habitats is 20. A pool shelter rating of approximately 100 is desirable. The amount of cover that now exists is being provided primarily by small woody debris in Laguna Creek. Small woody debris is the dominant cover type in pools followed by large woody debris. Log and root wad cover structures in the pool and flatwater habitats would enhance both summer and winter salmonid habitat. Log cover structures provide rearing fry with protection from predation, rest from water velocity, and also divide territorial units to reduce density related competition.

- 1) Increase woody cover in the pools and flatwater habitat units. Most of the existing cover in the pools is from small woody debris. Adding high quality complexity with woody cover in the pools is desirable.

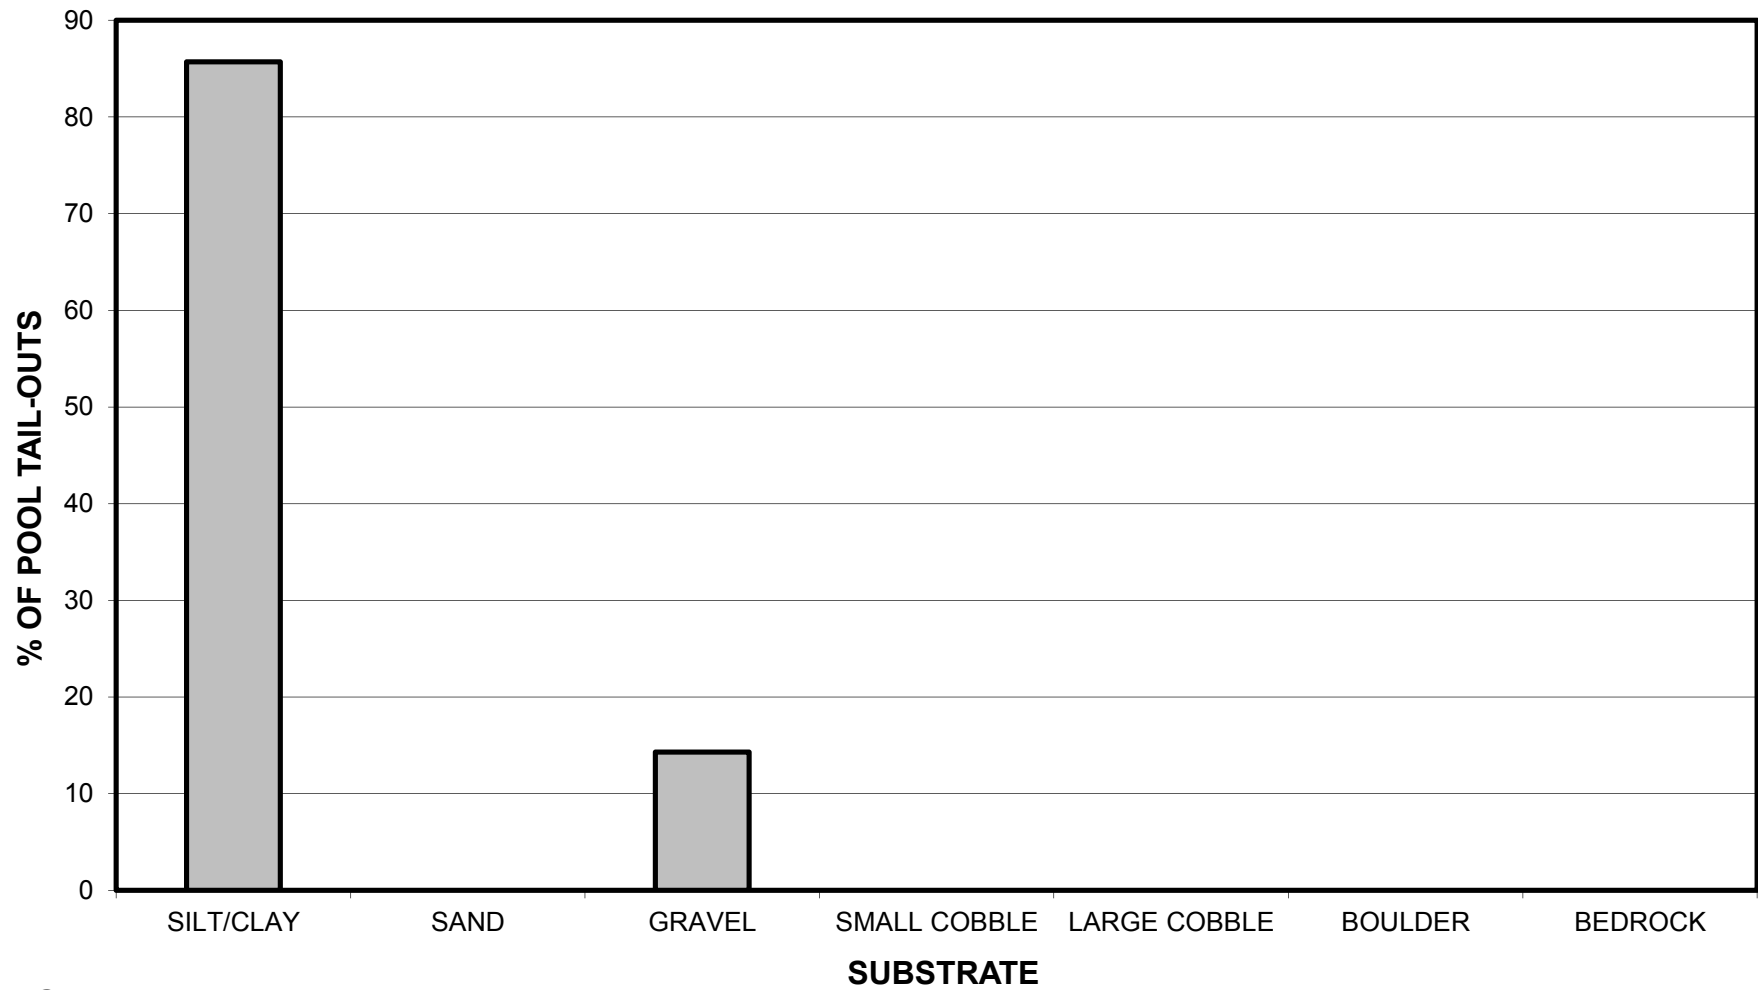
GRAPH 8

Table 6 summarizes the dominant substrate by habitat type. Graph 8 depicts the dominant substrate observed in pool tail-outs. Silt/clay was the dominant substrate observed in 86% of the pool tail-outs. Gravel was the next most frequently observed dominant substrate type and occurred in 14% of the pool tail-outs.

Twelve of the 14 pool tail-outs had silt, sand, large cobble, boulders or bedrock as the dominant substrate. This is generally considered unsuitable for spawning salmonids.

- 2) Suitable size spawning substrate on Laguna Creek is limited to relatively few reaches. Projects should be designed at suitable sites to trap and sort spawning gravel.

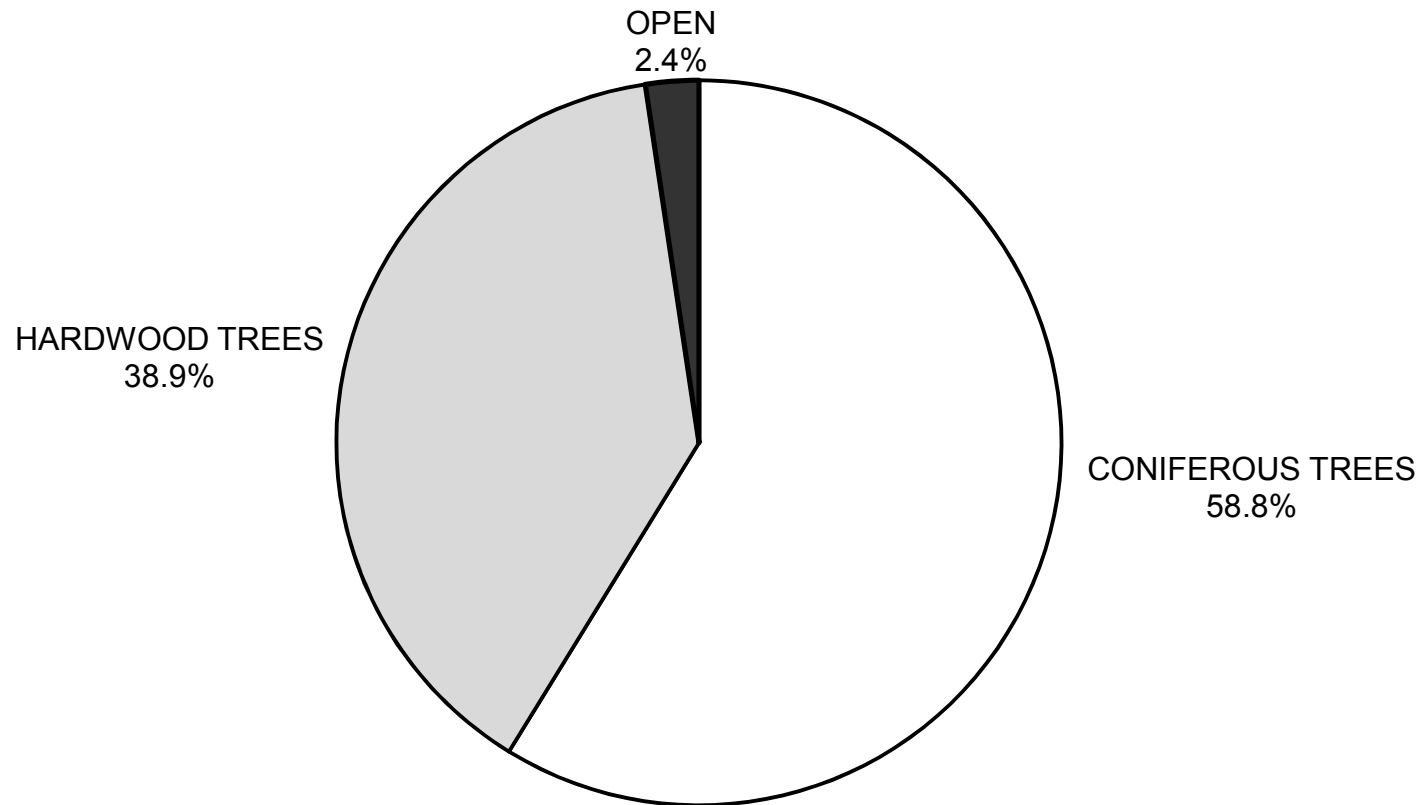
GRAPH 9

The mean percent canopy density for the surveyed length of Laguna Creek was 98%. Two percent of the canopy was open. Of the canopy present, the mean percentages of hardwood and coniferous trees were 40% and 60%, respectively. Graph 9 describes the mean percent canopy in Laguna Creek.

The mean percent canopy density for the stream was 98%. In general, revegetation projects are considered when canopy density is less than 80%. The percentage of right and left bank covered with vegetation was 97% and 98%, respectively.

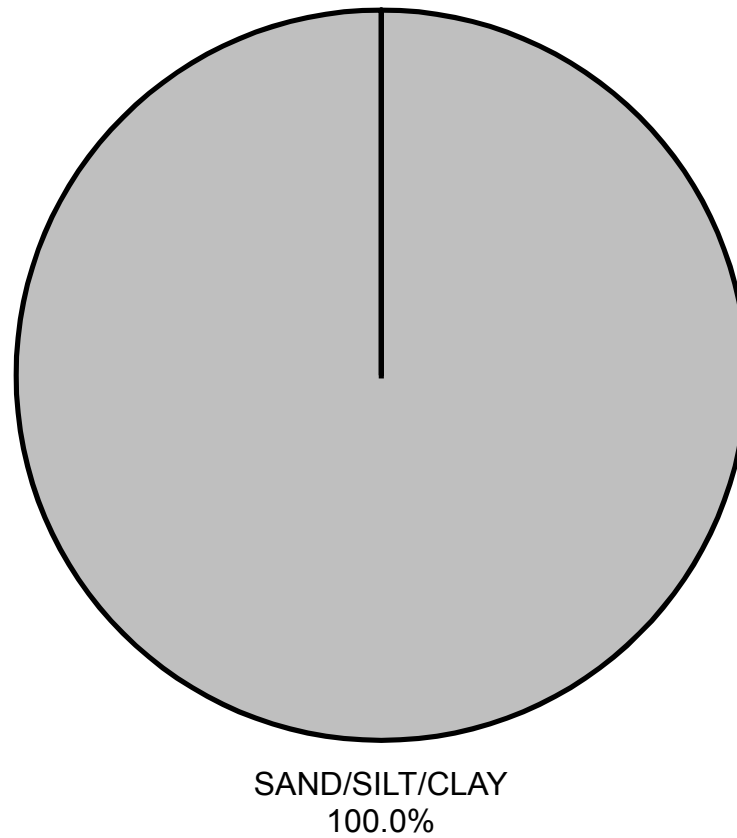
GRAPH 10

For the stream reach surveyed, the mean percent right bank vegetated was 97%. The mean percent left bank vegetated was 98%. The dominant elements composing the structure of the stream banks consisted of 100% sand/silt/clay (Graph 10). Brush was the dominant vegetation type observed in 47% of the units surveyed. Additionally, 28% of the units surveyed had coniferous trees as the dominant vegetation type, and 25% had hardwood trees as the dominant vegetation type (Graph 11).
