CALIFORNIA DEPARTMENT OF FISH AND WILDLIFE

STREAM INVENTORY REPORT

Bunker Gulch

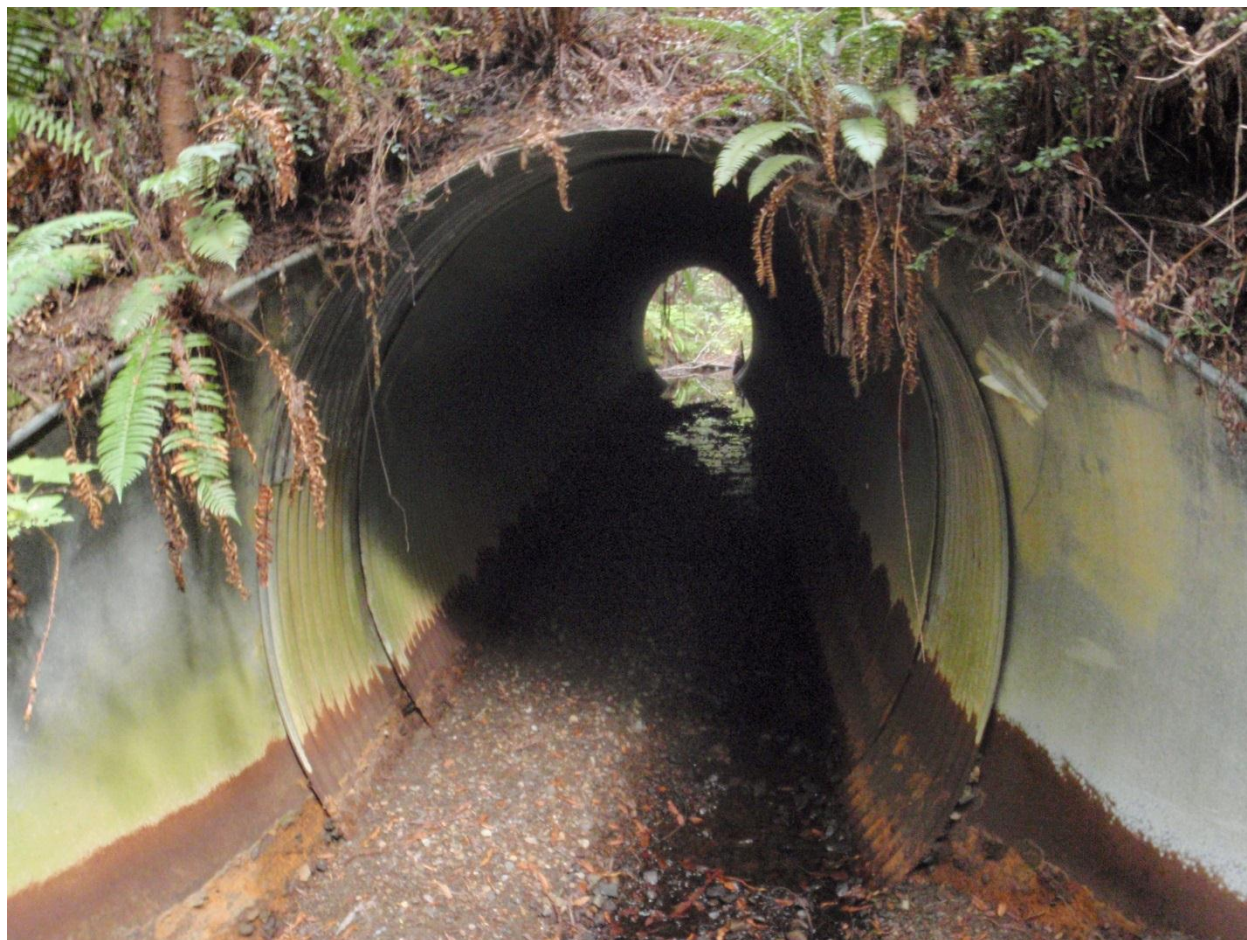
938	0026.00	Fish observed.
1884	0056.00	Culvert #1 is under Road 400, and is 6.7' high x 6.5' wide x 63' long. It is a corrugated metal pipe (CMP). The culvert's diameter is 6.5', its plunge height is 0', and it has a maximum depth of 0' within 5' of the outlet as it is dry. The slope is estimated 1%, and its condition is poor with rusted sides towards bottom. It is not a possible barrier to juvenile and adult salmonids.
2140	0064.00	Left bank small drainage culvert is 1' wide x 1' long.
2536	0073.00	Culvert #2 is under Road 400, and is 7' high x 7' wide x 6.0' long. It is made of CMP. The culvert's diameter is 7', its plunge height is 0', and it has a maximum depth of 0.4' within 5' of the outlet. The slope is estimated 1%, and its condition is poor. It is not a possible barrier to juvenile and adult salmonids. There is a tree growing out of the culvert

and the culvert is rusted and has a torn bottom that breaks with every step taken while walking through.

Photo 1: Habitat Unit #56, Culvert runs through Bunker Gulch and under road 400, it is not a barrier to salmonids.
Photo taken on 9/28/2016

- 2) The culverts located at 1,884' and 2,536' are in poor condition and should be treated to prevent failure. The culvert at 8,087' is an ongoing potential passage problem. A fish passage assessment should be conducted at all culverts sites. If the assessments find the culverts to be barriers to fish passage they should be replaced with structures that provide unimpeded fish passage or decommissioned. Good water temperature and flow regimes exist in the stream and it offers good conditions for rearing fish.

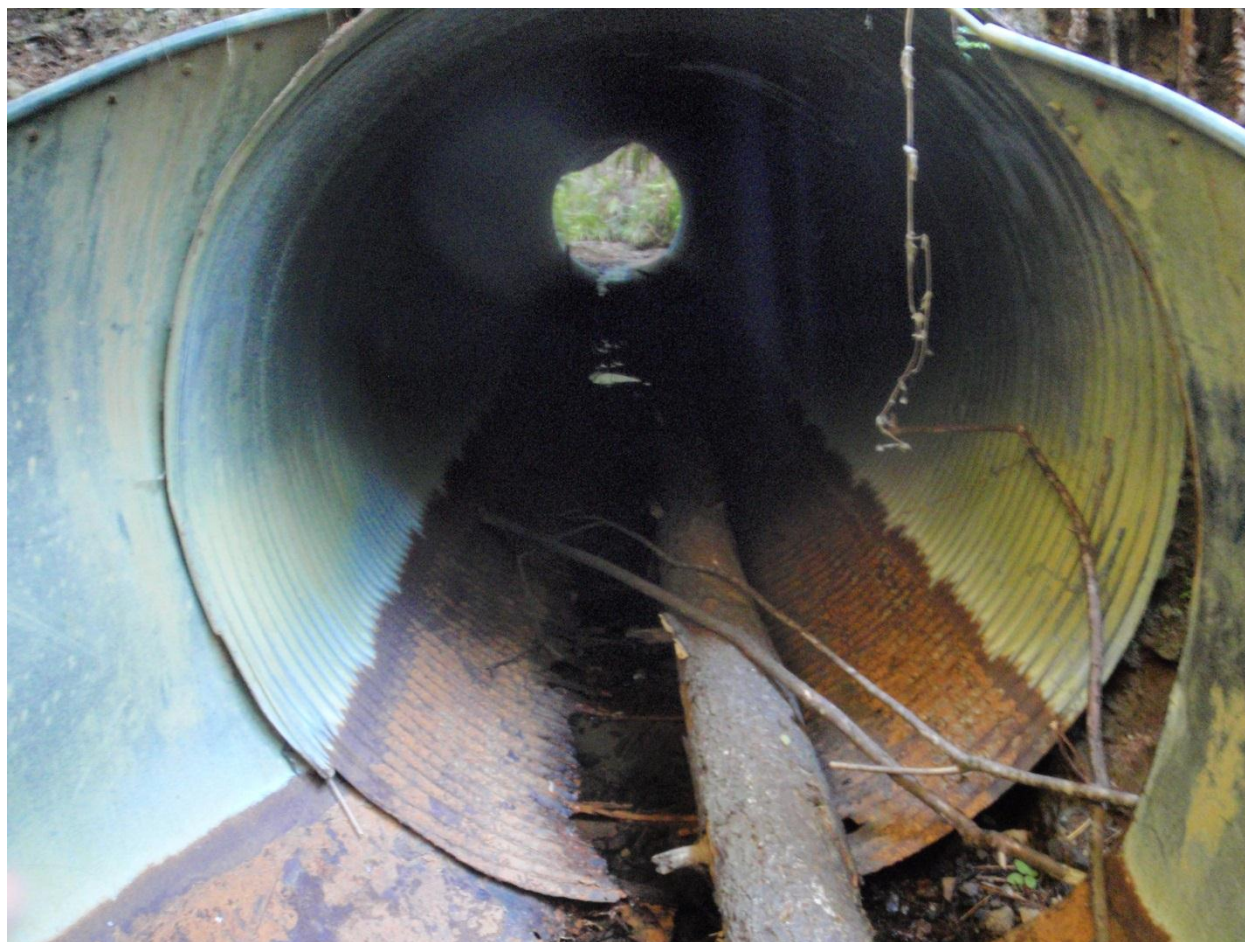
Photo 2: Habitat Unit #73, rusted culvert with a tree inside of it. Photo taken on 9/28/2016
