## CALIFORNIA DEPARTMENT OF FISH AND WILDLIFE

## STREAM INVENTORY REPORT

#### **Parlin Creek**

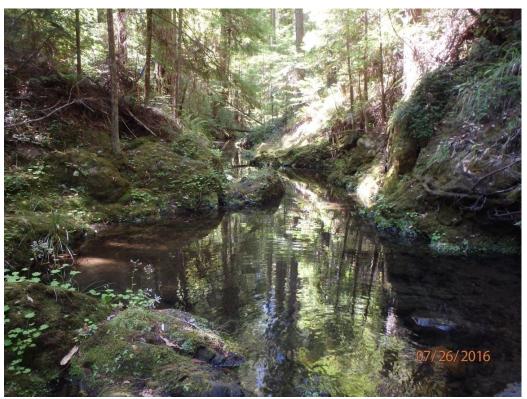
Photo 1: Bedrock dominated pool approximately 11,000' upstream of the start of survey (SOS). (Photo taken 7/26/16)

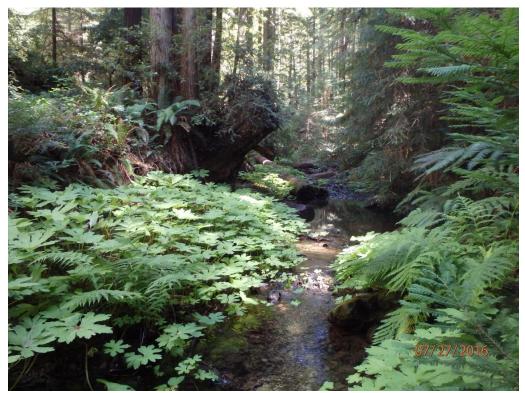
Photo 2: Scour pool at habitat unit #313. (Photo taken 7/27/16)

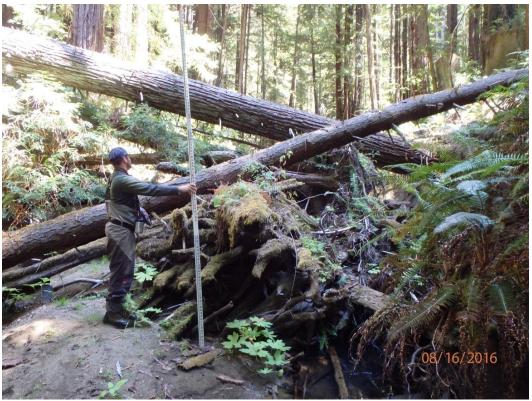
Photo 3: LDA at habitat unit #423. Ryan Bernstein pictured. (Photo taken 8/16/16)

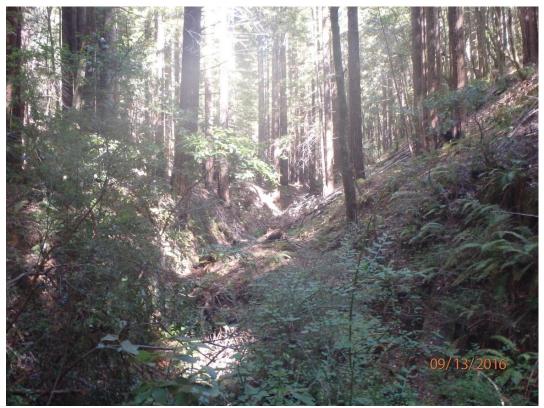
Photo 4: End of survey at habitat unit #642, 23,674' upstream of SOS due to dry channel for the last 987 ft of survey. (Photo taken 9/13/16)
