CALIFORNIA DEPARTMENT OF FISH AND WILDLIFE

STREAM INVENTORY REPORT

“Walton Gulch”

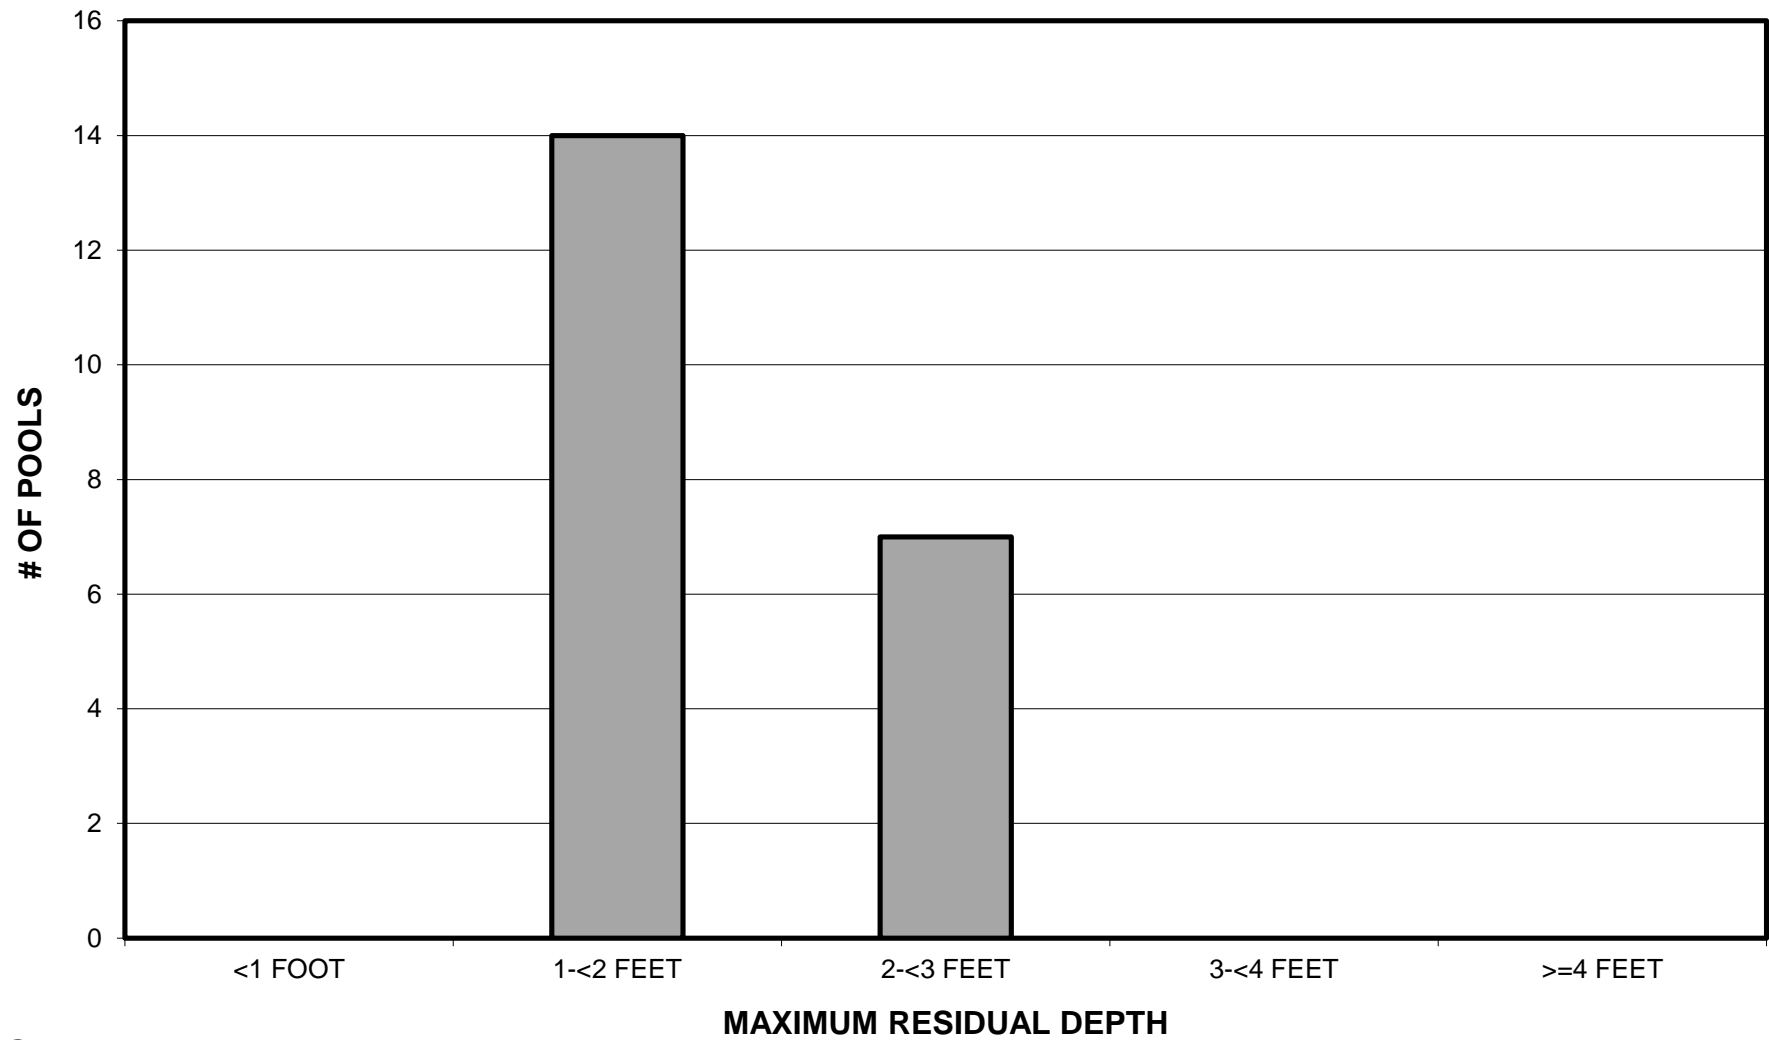
GRAPH 5

Table 4 is a summary of maximum residual pool depths by pool habitat types. Pool quality for salmonids increases with depth. Seven of the 21 pools (33%) had a residual depth of two feet or greater (Graph 5).

Flatwater habitat types comprised 56% of the total length of this survey, riffles 10%, and pools 14%. Seven of the 21 (33%) pools had a maximum residual depth greater than two feet. In general, pool enhancement projects are considered when primary pools comprise less than 40% of the length of total stream habitat. In first and second order streams, a primary pool is defined to have a maximum residual depth of at least two feet, occupy at least half the width of the low flow channel, and be as long as the low flow-channel width. Installing structures that will increase or deepen pool habitat is recommended.

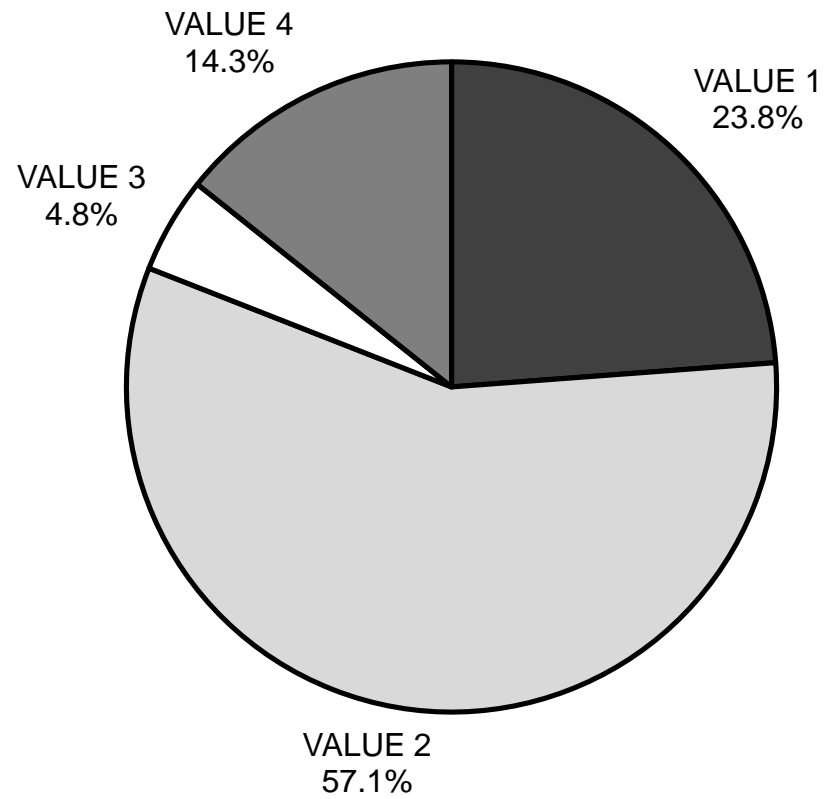
GRAPH 6

The depth of cobble embeddedness was estimated at pool tail-outs. Of the 21 pool tail-outs measured, 5 had a value of 1 (23.8%); 12 had a value of 2 (57.1%); 1 had a value of 3 (4.8%); 3 had a value of 4 (14.3%) (Graph 6). On this scale, a value of 1 indicates the best spawning conditions and a value of 4 the worst. Additionally, a value of 5 was assigned to tail-outs deemed unsuitable for spawning due to inappropriate substrate such as bedrock, log sills, boulders, or other considerations.

Seventeen of the 21 pool tail-outs measured had embeddedness ratings of 1 or 2. Four of the pool tail-outs had embeddedness ratings of 3 or 4. None of the pool tail-outs had a rating of 5, which is considered unsuitable for spawning. Cobble embeddedness measured to be 25% or less, a rating of 1, is considered to indicate good quality spawning substrate for salmon and steelhead.

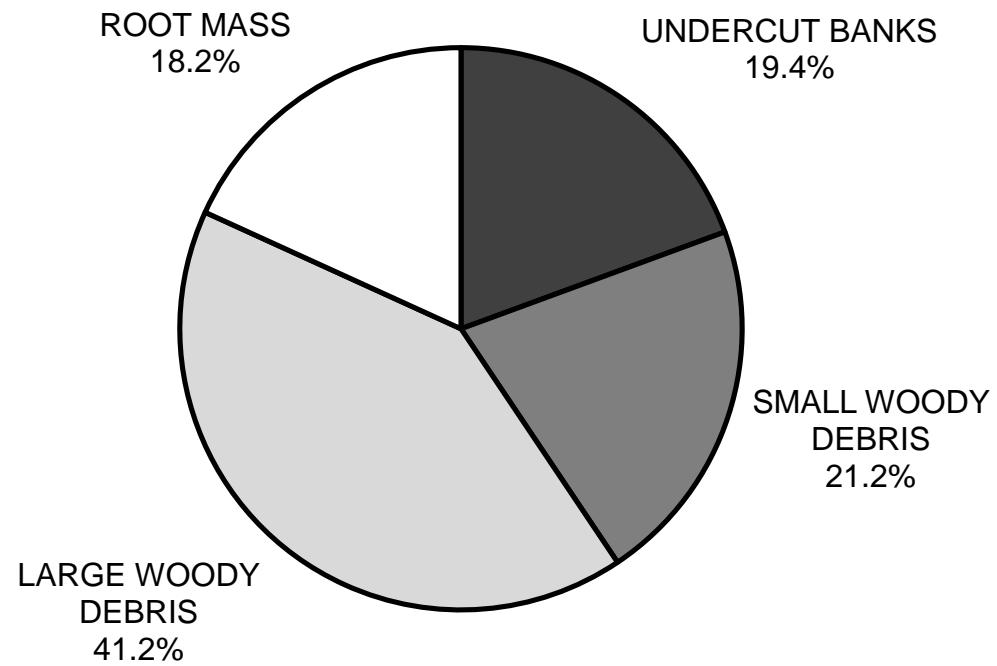
GRAPH 7

Table 5 summarizes mean percent cover by habitat type. Large woody debris is the dominant cover type in Walton Gulch. Graph 7 describes the pool cover in Walton Gulch. Large woody debris is the dominant pool cover type followed by small woody debris.

The mean shelter rating for pools is 28. The shelter rating in the flatwater habitats is 8. A pool shelter rating of approximately 100 is desirable. The amount of cover that now exists is being provided primarily by large woody debris in Walton Gulch. Large woody debris is the dominant cover type in pools followed by small woody debris. Log and root wad cover structures in the pool and flatwater habitats would enhance both summer and winter salmonid habitat. Log cover structures provide rearing fry with protection from predation, rest from water velocity, and also divide territorial units to reduce density related competition.

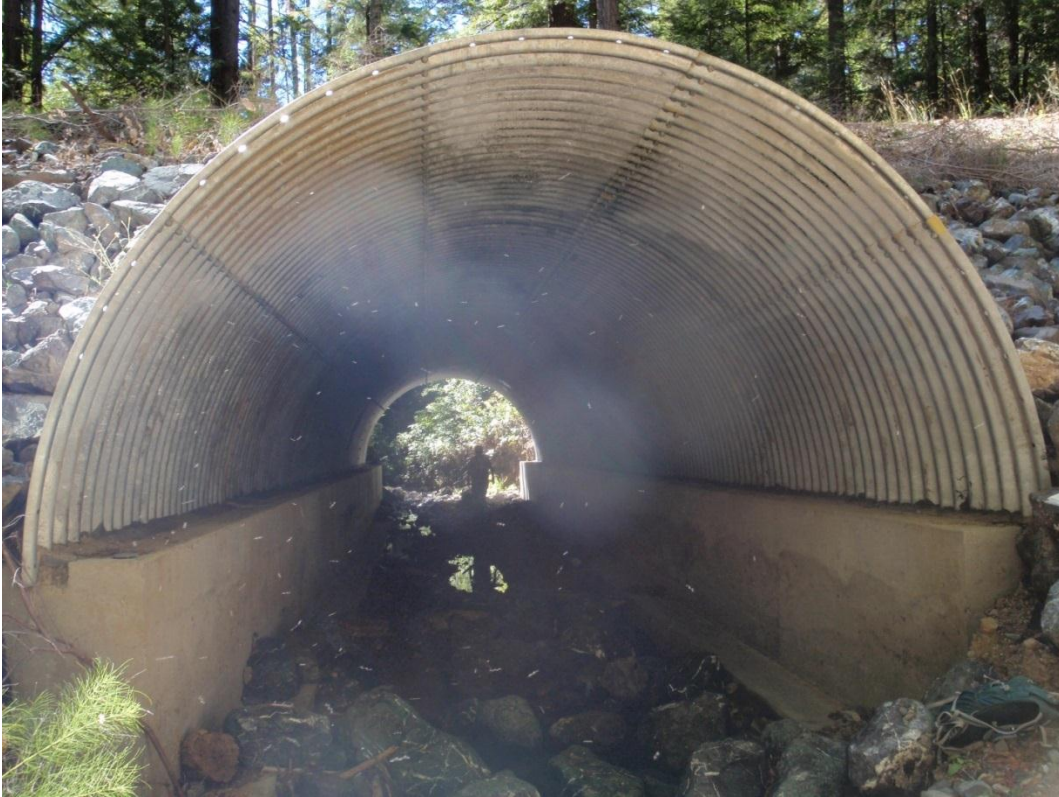
Photo 1: Habitat unit #3, looking downstream through arch culvert on Walton Gulch, under JDSF Forest Road 400. Photo Taken by Brain Starks, 9/26/17.

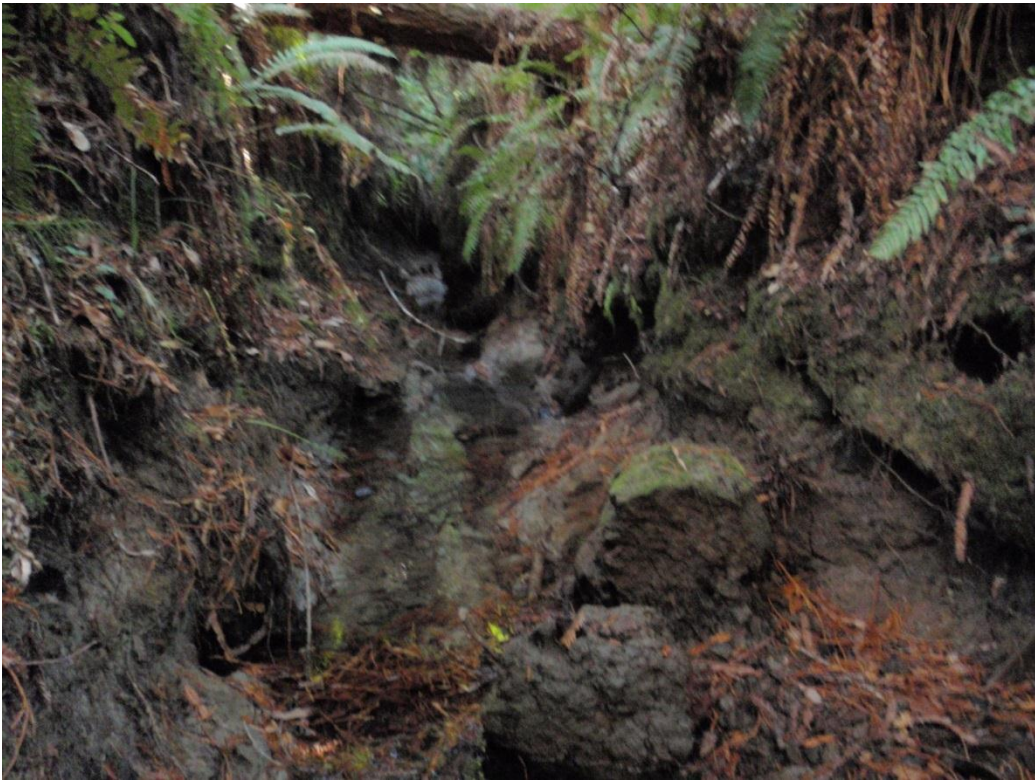
Photo 2: Stream channel on Walton Gulch. Stream channel is deeply entrenched, which is representative of mid to upper portion of survey reach.

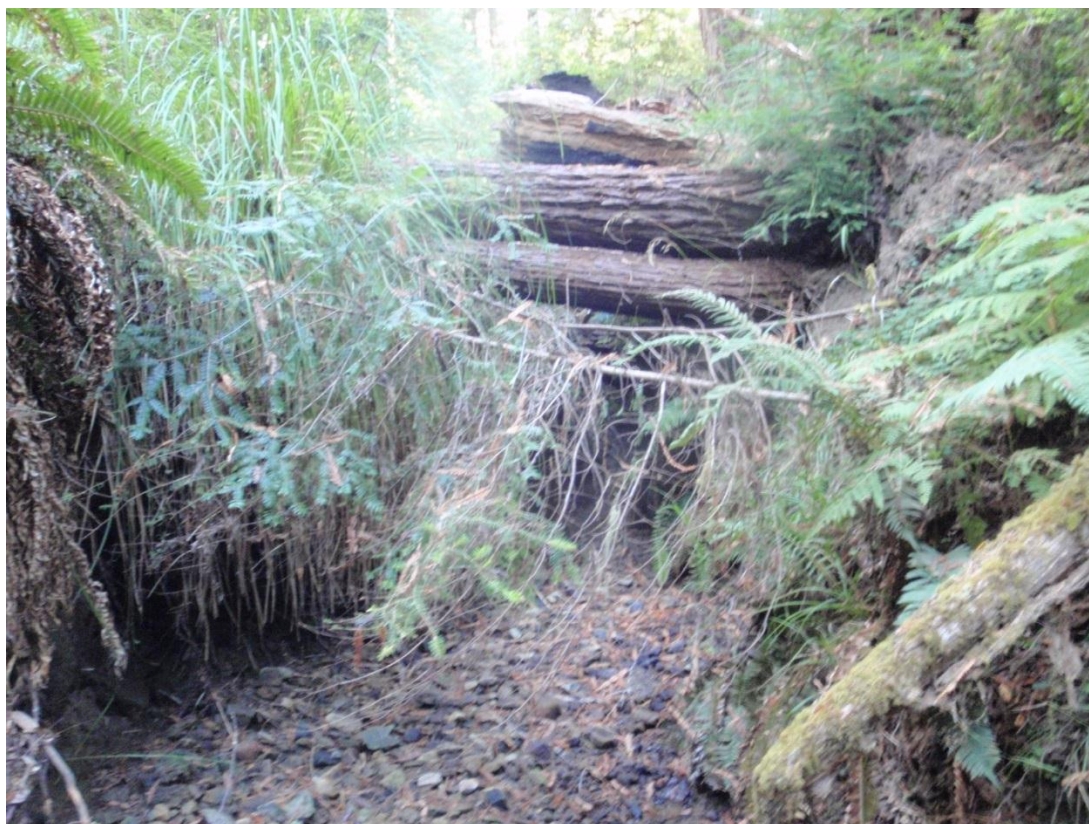
Photo 3: Stream channel (dry) on Walton Gulch, habitat unit # 14.

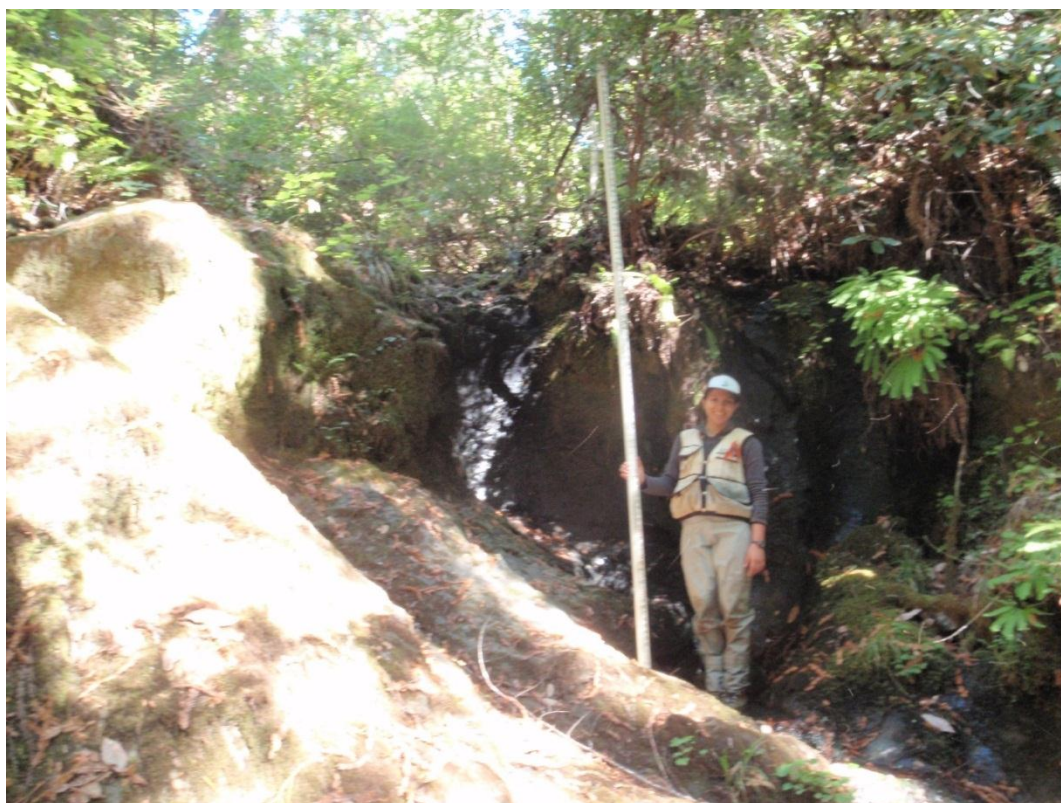
Photo 4: End of survey, 8 foot cascade over dry bedrock, habitat unit # 99 (Photo taken 9/27/16).
