CALIFORNIA DEPARTMENT OF FISH AND WILDLIFE

STREAM INVENTORY REPORT

Howe Creek

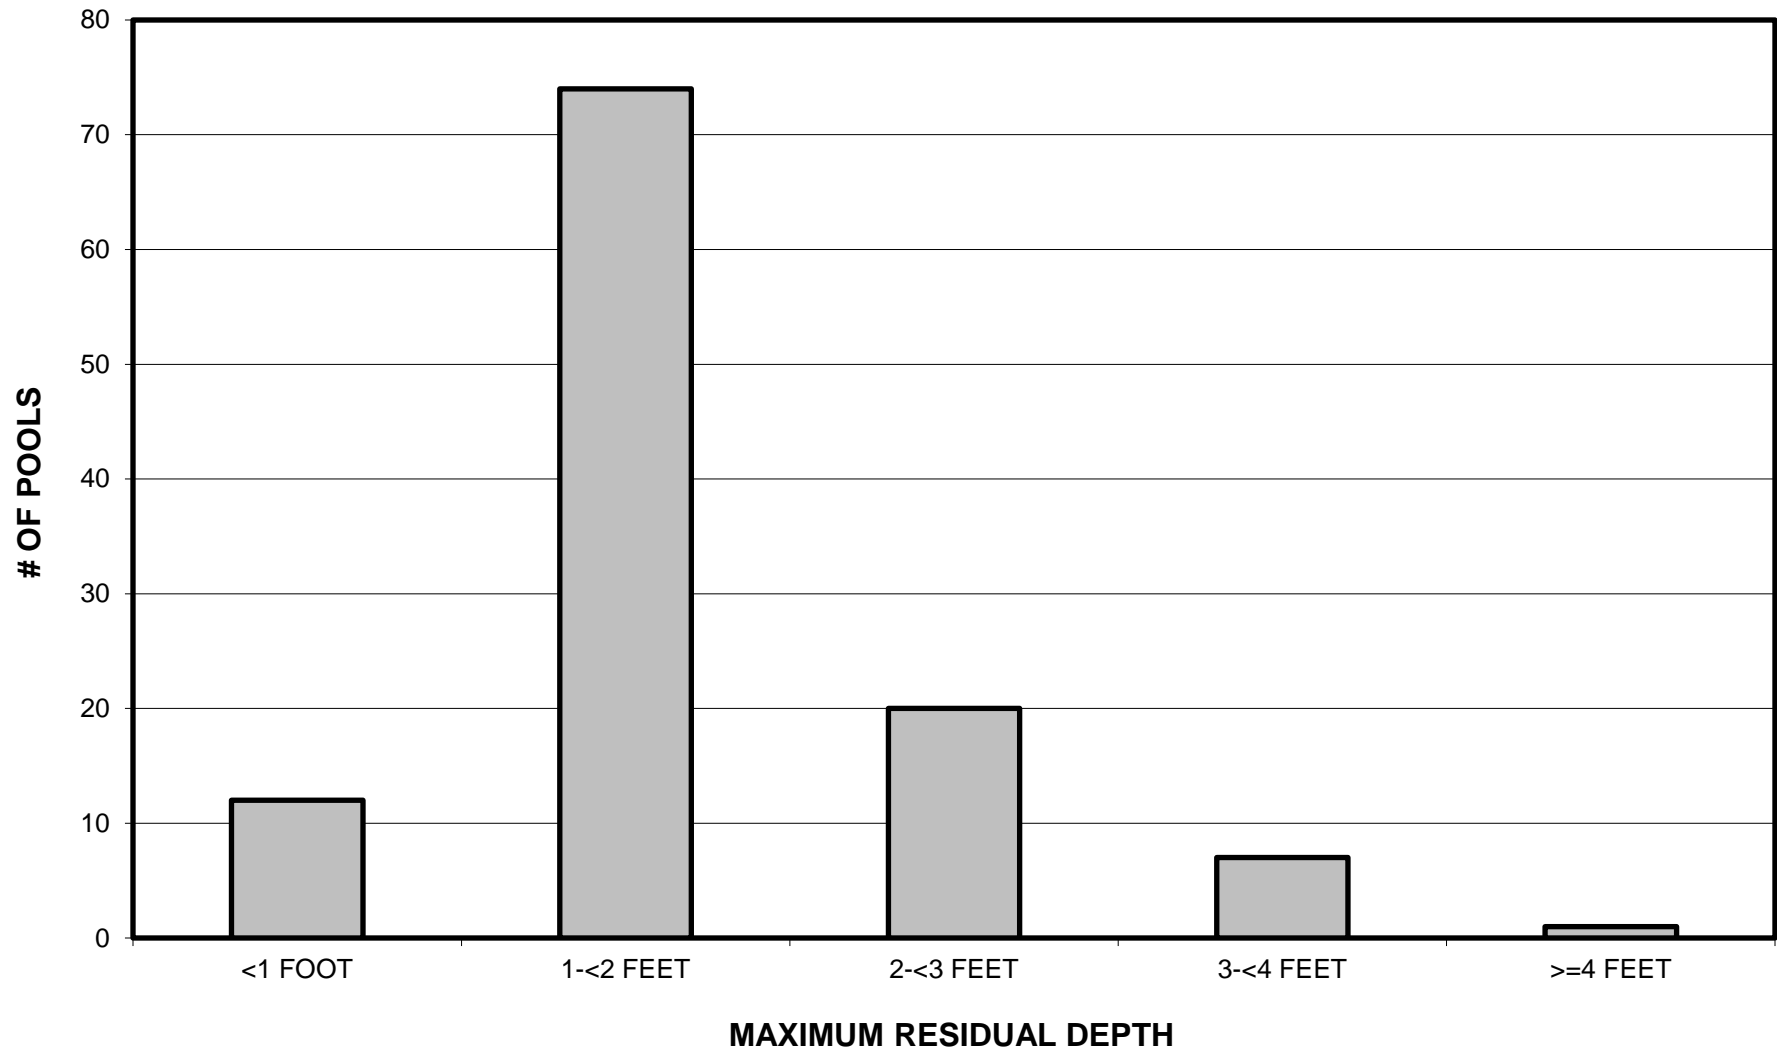
GRAPH 5

Table 4 is a summary of maximum residual pool depths by pool habitat types. Pool quality for salmonids increases with depth. Twenty-eight of the 114 pools (25%) had a residual depth of

two feet or greater (Graph 5). Of the 114 pools, 7% had a residual depth of three feet or greater (Graph 5).

Flatwater habitat types comprised 35% of the total length of this survey, riffles 48%, and pools 17%. Twenty-eight of the 114 (25%) pools had a maximum residual depth greater than 2 feet. In general, pool enhancement projects are considered when primary pools comprise less than 40% of the length of total stream habitat. In first and second order streams, a primary pool is defined to have a maximum residual depth of at least two feet, occupy at least half the width of the low flow channel, and be as long as the low flow channel width. Installing structures that will increase or deepen pool habitat is recommended.

- 6) Where feasible, design and engineer pool enhancement structures to increase the number of pools. This must be done where the banks are stable or in conjunction with stream bank armor to prevent erosion.

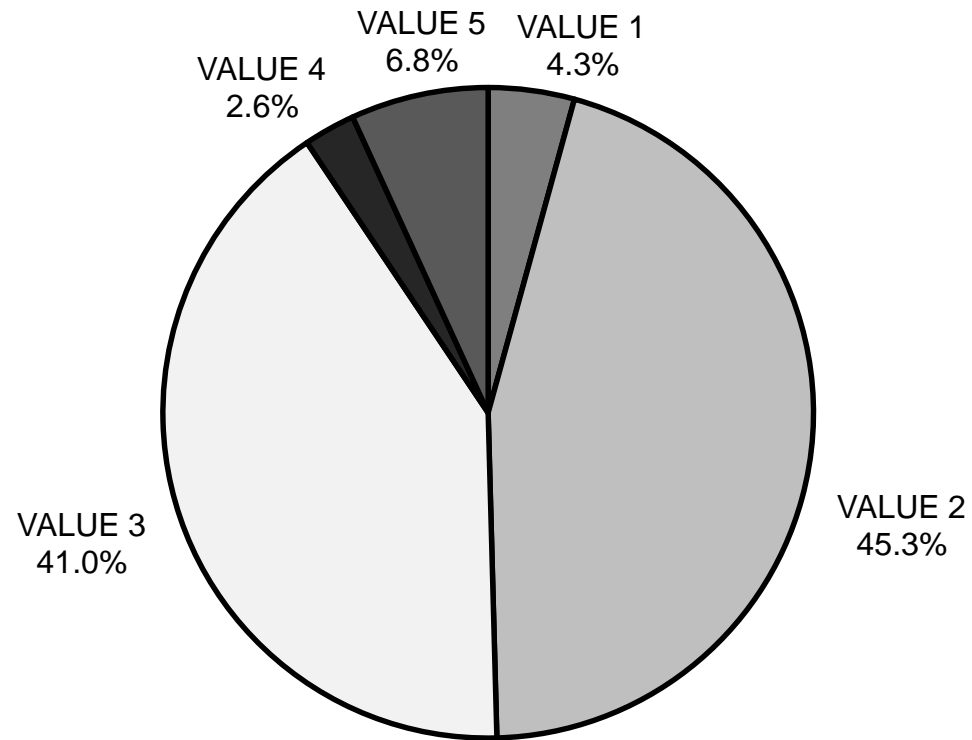
GRAPH 6

The depth of cobble embeddedness was estimated at pool tail-outs. Of the 117 pool tail-outs measured, 5 had a value of 1 (4.3%), 53 had a value of 2 (45.3%), 48 had a value of 3 (41%), 3 had a value of 4 (2.6%), and 8 had a value of 5 (6.8%) (Graph 6). On this scale, a value of 1 indicates the highest quality of spawning substrate. Additionally, a value of 5 was assigned to tail-outs deemed unsuitable for spawning due to inappropriate substrate such as bedrock, log sills, boulders, or other considerations.

Fifty-eight of the 117 pool tail-outs measured had embeddedness ratings of 1 or 2. Fifty-one of the pool tail-outs had embeddedness ratings of 3 or 4. Eight of the pool tail-outs had a rating of 5, which is considered unsuitable for spawning. Cobble embeddedness measured to be 25% or less, a rating of 1, is considered to indicate good quality spawning substrate for salmon and steelhead. Sediment sources in Howe Creek should be mapped and rated according to their

potential sediment yields, and control measures should be taken.

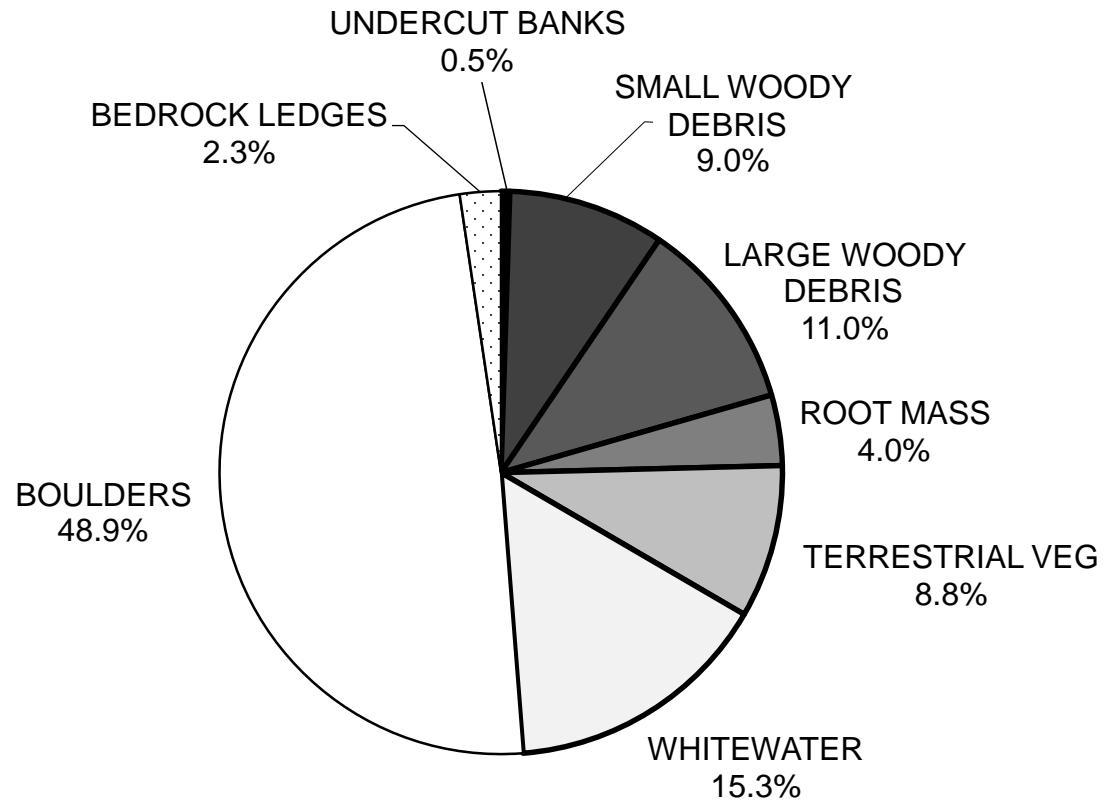
GRAPH 7

Table 5 summarizes mean percent cover by habitat type. Boulders are the dominant cover type in Howe Creek. Graph 7 describes the pool cover in Howe Creek. Boulders are the dominant pool cover type followed by whitewater.

The mean shelter rating for pools is 14. The shelter rating in the flatwater habitats is 2. A pool shelter rating of approximately 100 is desirable. The amount of cover that now exists is being provided primarily by boulders in Howe Creek. Boulders are the dominant cover type in pools followed by whitewater. Log and rootwad cover structures in the pool and flatwater habitats would enhance both summer and winter salmonid habitat. Log cover structure provides rearing fry with protection from predation, rest from water velocity, and also divides territorial units to reduce density related competition.

- 1) Increase woody cover in the pools and flatwater habitat units. Most of the existing cover in the pools is from boulders. Adding high quality complexity with woody cover in the pools is desirable.
- 2) Inventory and map sources of stream bank erosion and prioritize them according to present and potential sediment yield. Identified sites should then be treated to reduce the amount of fine sediments entering the stream.
- 3) Active and potential sediment sources related to the road system need to be identified, mapped, and treated according to their potential for sediment yield to the stream and its tributaries.
- 4) Suitable size spawning substrate on Howe Creek is limited to relatively few reaches. Projects should be designed at suitable sites to trap and sort spawning gravel.

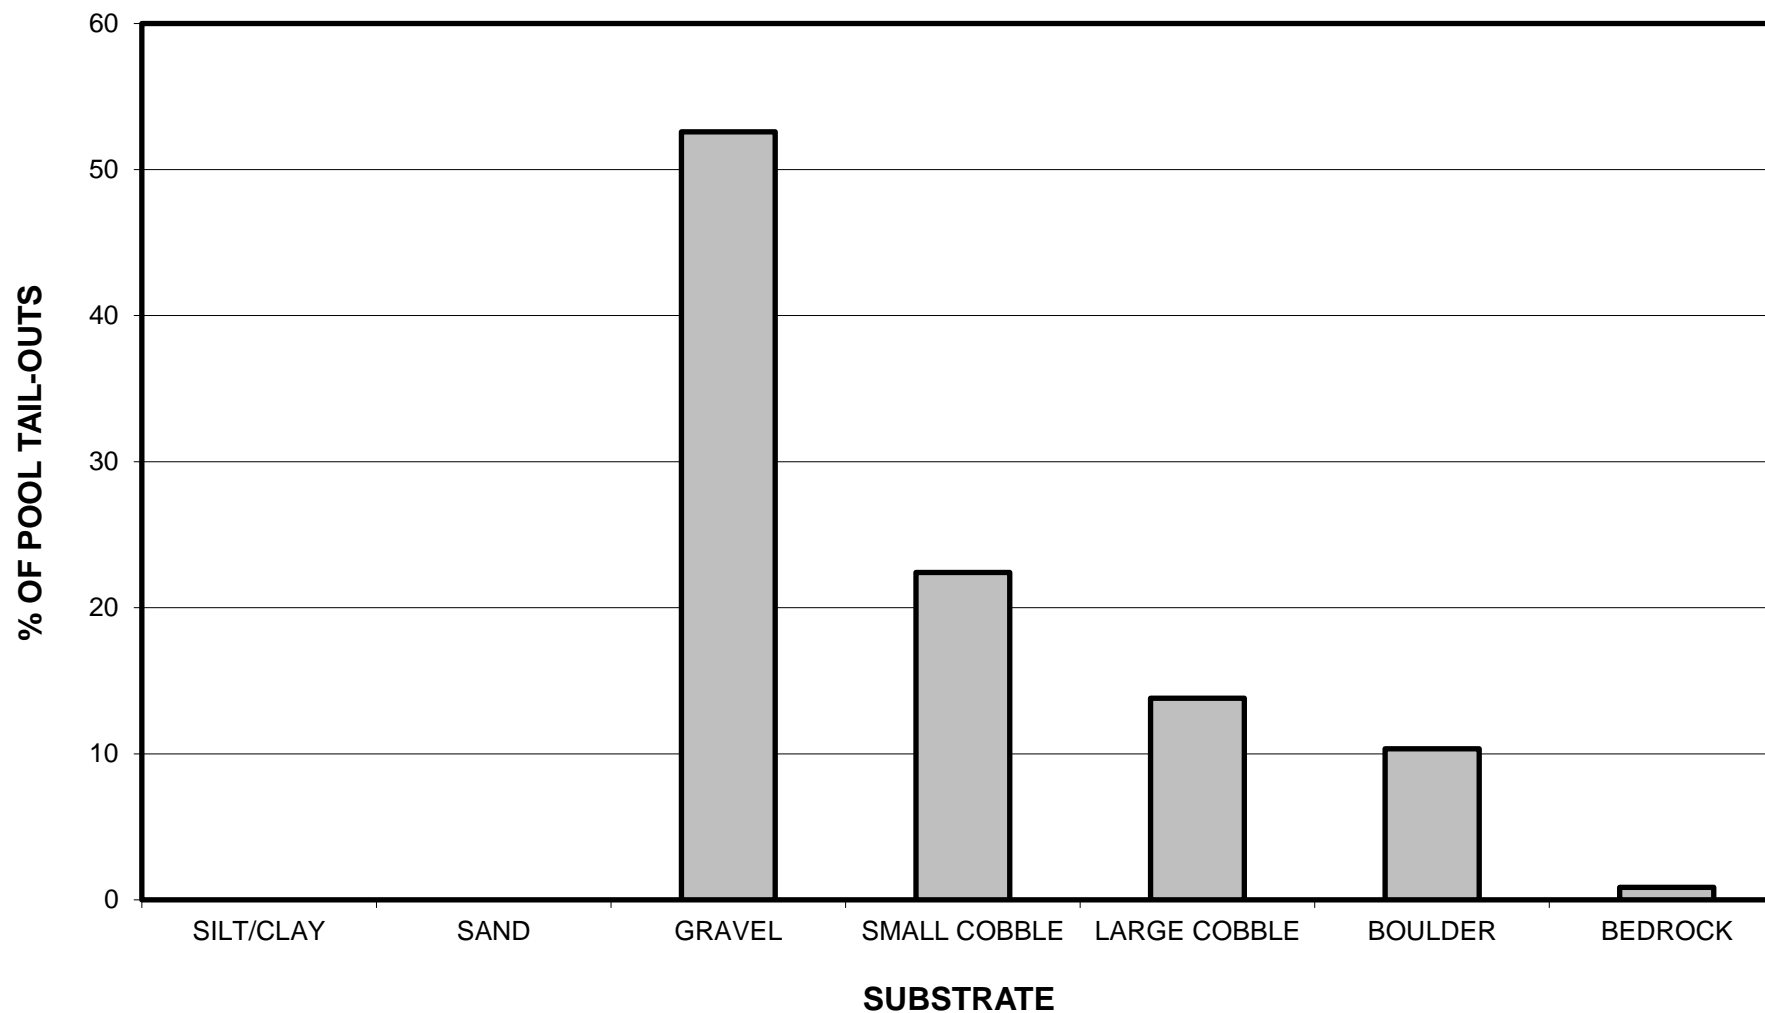
GRAPH 8

Table 6 summarizes the dominant substrate by habitat type. Graph 8 depicts the dominant substrate observed in pool tail-outs. Gravel was the most dominant substrate, observed in 53% of pool tail-outs. Small cobble was the next most frequently observed dominant substrate type, observed in 22% of pool tail-outs.

Eighty-seven of the 116 pool tail-outs measured had gravel or small cobble as the dominant substrate. This is generally considered good for spawning salmonids.

Thirty of the 116 pool tail-outs had silt, sand, large cobble, boulders or bedrock as the dominant substrate. This is generally considered unsuitable for spawning salmonids.

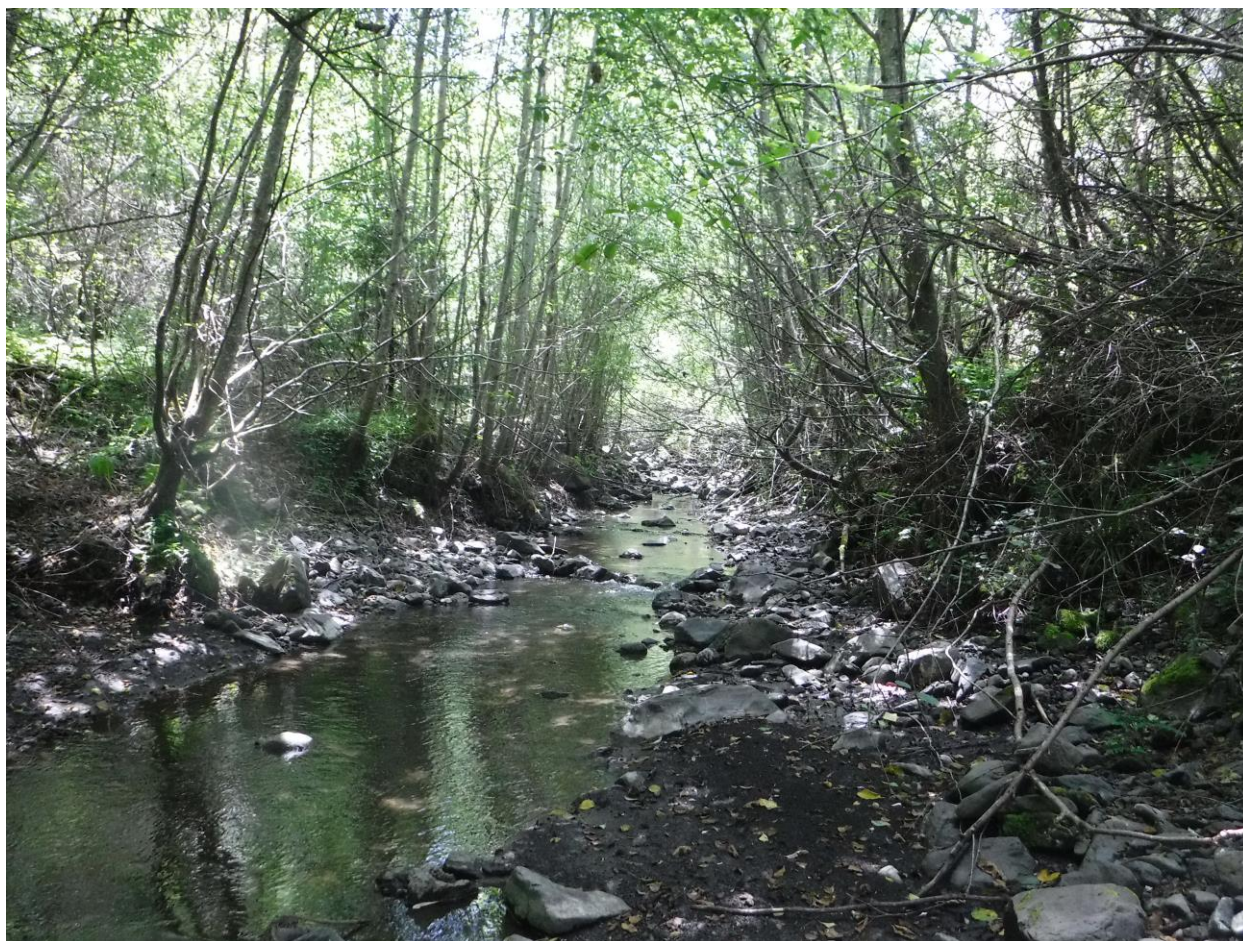
Photo 1: Run at habitat unit #271, 15,882' upstream of start of survey. (Photo taken 6/27/17)

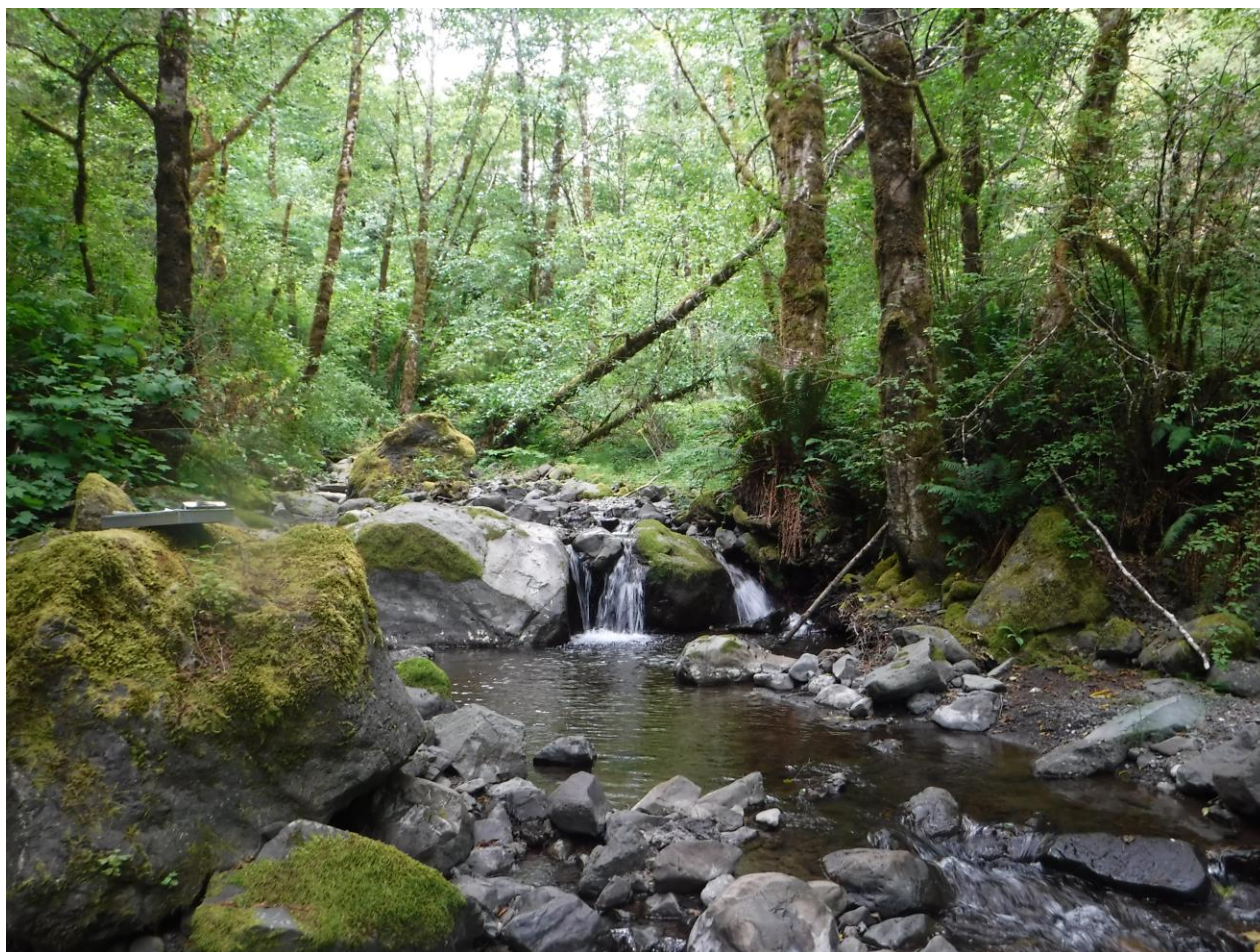
18273	0329.00	There is a landslide on the left bank, it measures 200' long x 80' high.
18431	0335.00	There is a 3.5' plunge over boulders into a pool that is 1.5' deep.
18521	0339.00	There is a 3' plunge over LWD into a pool that is 1.7' deep.
18624	0342.00	There is a 1' plunge over LWD into a 2.5' deep pool.
18959	0351.00	There is a 3.5' plunge over boulders with 1.5' steps into a 1.1' deep pool.
19281	0360.00	There is a 1.5' plunge over boulders into a pool.
19344	0363.00	There is a 5' plunge over LWD into a pool.
19396	0365.00	There is a landslide on the right bank that measures 20' long x 40' high.
19621	0370.00	There is a 1.5' plunge into a 1' deep pool.
19695	0374.00	Tributary #7 enters on the left bank. It contributes to approximately 10% of Howe Creek's flow. The water temperature of the tributary was 58° Fahrenheit, the water temperature downstream of the confluence was 58° Fahrenheit, and the water temperature upstream of the confluence was 58° Fahrenheit. The tributary is accessible to salmonids. It is very narrow and has lots of boulders. Fish were not observed in the tributary.

Photo 2: Mid-channel pool at habitat unit #335, 18, 627' upstream of start of survey.
(Photo taken 6/28/17)

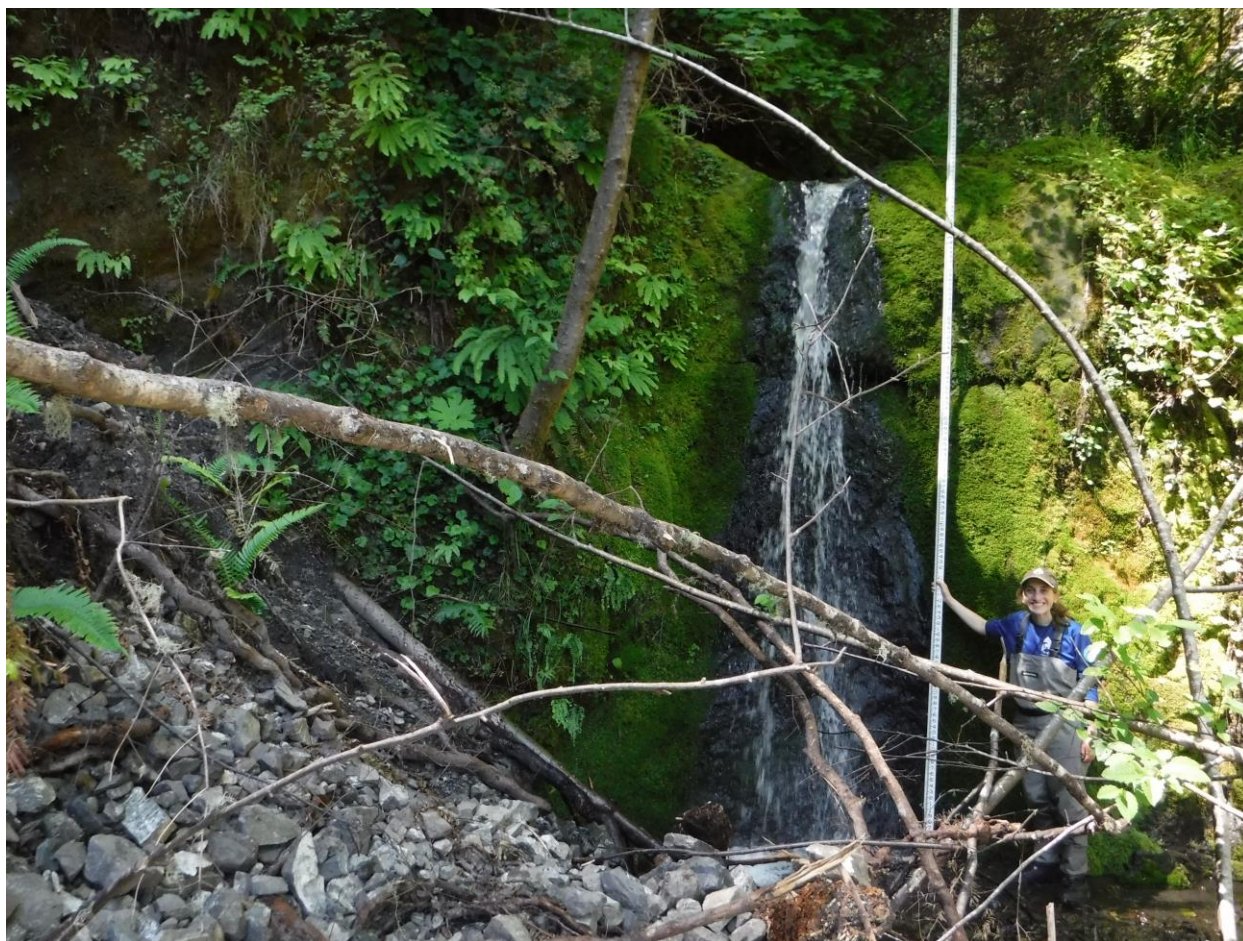
Photo 3: End of survey at habitat unit 438, 22,075' upstream of start of survey.
Pictured: Rachel Karlov. (Photo taken 06/29/17)
