## **CALIFORNIA DEPARTMENT OF FISH AND WILDLIFE**

### **STREAM INVENTORY REPORT**

#### **Price Creek**

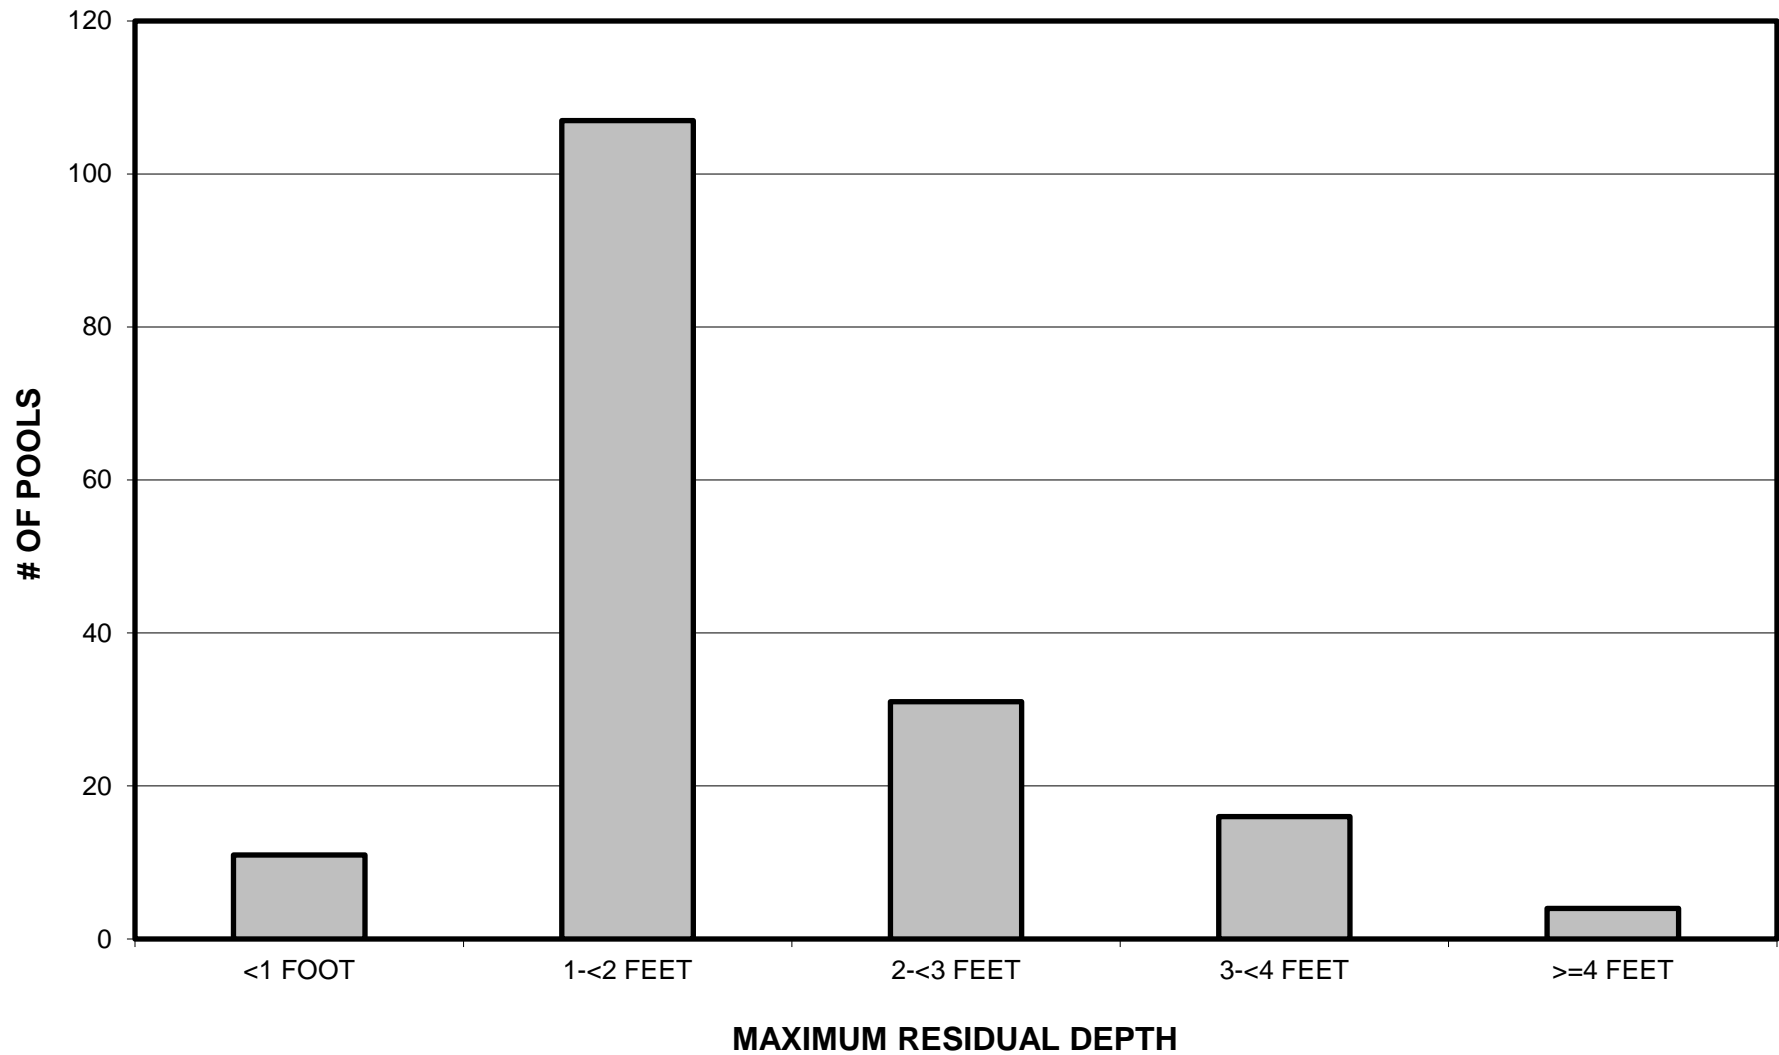
GRAPH 5

Table 4 is a summary of maximum residual pool depths by pool habitat types. Pool quality for salmonids increases with depth. Fifty-one of the 169 pools (30%) had a residual depth of two

feet or greater (Graph 5).

16%. Fifty-one of the 169 (30%) pools had a maximum residual depth greater than 2 feet. In general, pool enhancement projects are considered when primary pools comprise less than 40% of the length of total stream habitat. In first and second order streams, a primary pool is defined to have a maximum residual depth of at least two feet, occupy at least half the width of the low flow channel, and be as long as the low flow channel width. Installing structures that will increase or deepen pool habitat is recommended.

# PRICE CREEK 2017 MAXIMUM DEPTH IN POOLS

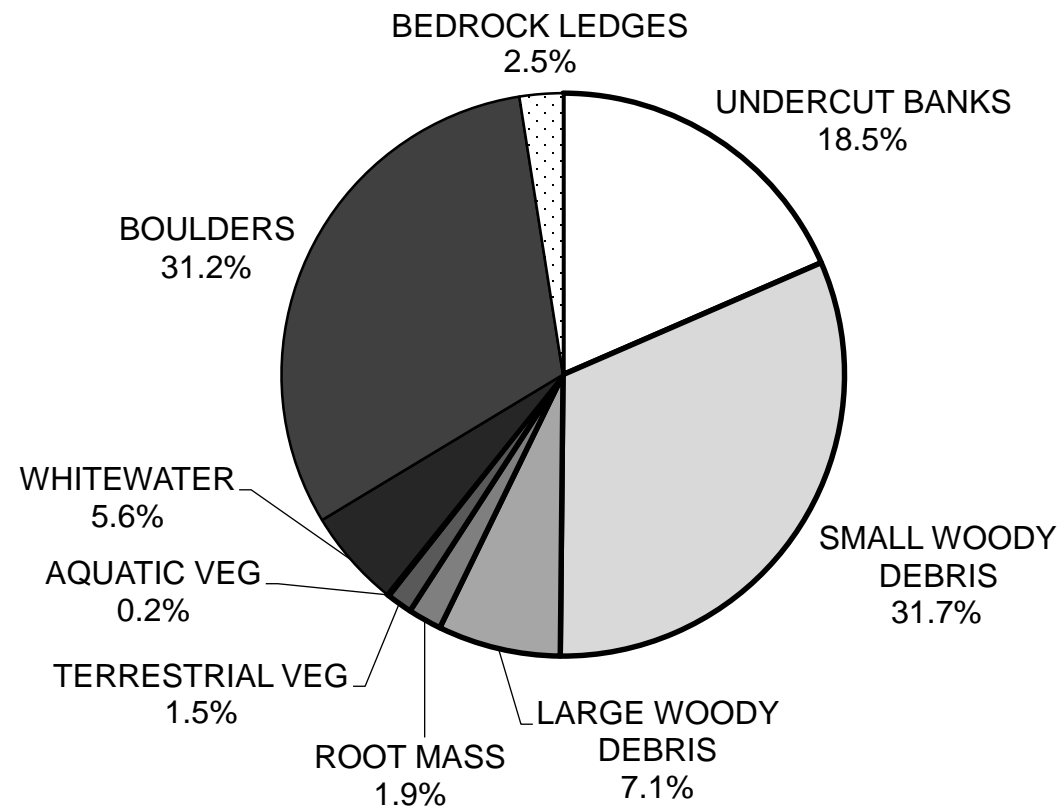
GRAPH 7

Table 5 summarizes mean percent cover by habitat type. Small woody debris is the dominant cover type in Price Creek. Graph 7 describes the pool cover in Price Creek. Small woody debris is the dominant pool cover type followed by boulders.

The mean shelter rating for pools is 13. The shelter rating in the flatwater habitats is 5. A pool shelter rating of approximately 100 is desirable. The amount of cover that now exists is being provided primarily by small woody debris in Price Creek. Small woody debris is the dominant cover type in pools followed by boulders. Log and rootwad cover structures in the pool and flatwater habitats would enhance both summer and winter salmonid habitat. Log cover structure provides rearing fry with protection from predation, rest from water velocity, and also divides territorial units to reduce density related competition.

# PRICE CREEK 2017 MEAN PERCENT COVER TYPES IN POOLS

- 1) Increase woody cover in the pools and flatwater habitat units. Most of the existing cover in the pools is from small woody debris. Adding high quality complexity with woody cover in the pools is desirable.
- 2) The limited water temperature data available suggest that maximum temperatures are

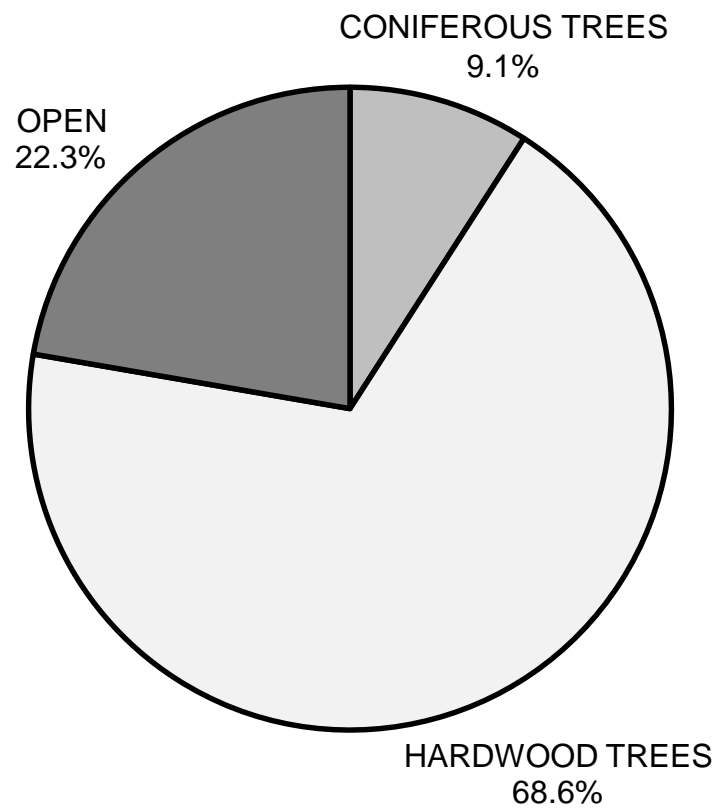
GRAPH 9

The mean percent canopy density for the surveyed length of Price Creek was 78%. Twenty-two percent of the canopy was open. Of the canopy present, the mean percentages of hardwood and coniferous trees were 88% and 12%, respectively. Graph 9 describes the mean percent canopy in Price Creek.

The mean percent canopy density for the stream was 78%. Reach 1 had a canopy density of 76%, Reach 2 had a canopy density of 78%, and Reach 3 had a canopy density of 80%. In general, revegetation projects are considered when canopy density is less than 80%.

# PRICE CREEK 2017 MEAN PERCENT CANOPY

- 3) Increase the canopy in Reaches 1 and 2 on Price Creek by planting appropriate native vegetation and preferably coniferous species like redwood and Douglas fir along the stream where shade canopy is not at acceptable levels. The reaches above this survey section should be inventoried and treated as well, since the water flowing here is affected from upstream. In many cases, planting will need to be coordinated to follow bank stabilization or upslope erosion control projects.

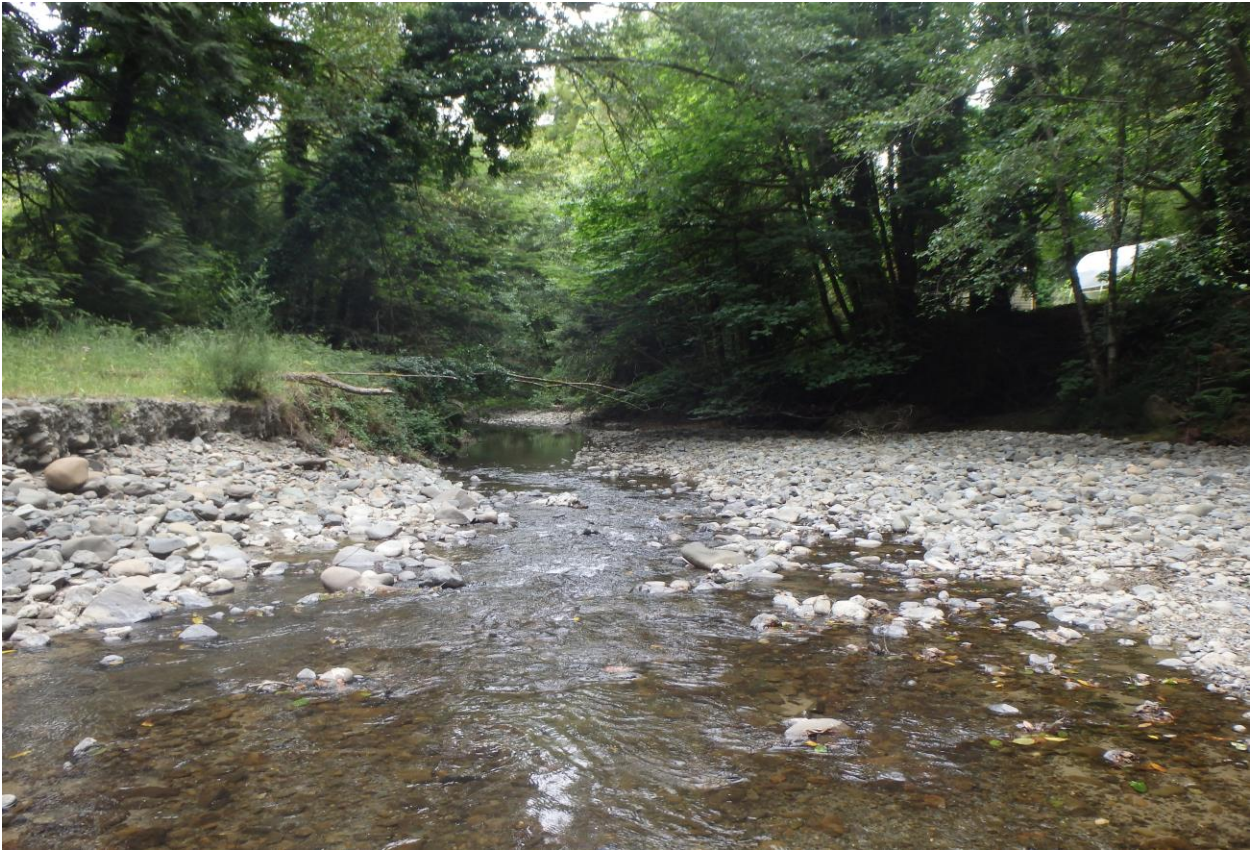
Photo 1: Run unit near the start of survey. (Photo taken 6/20/17)

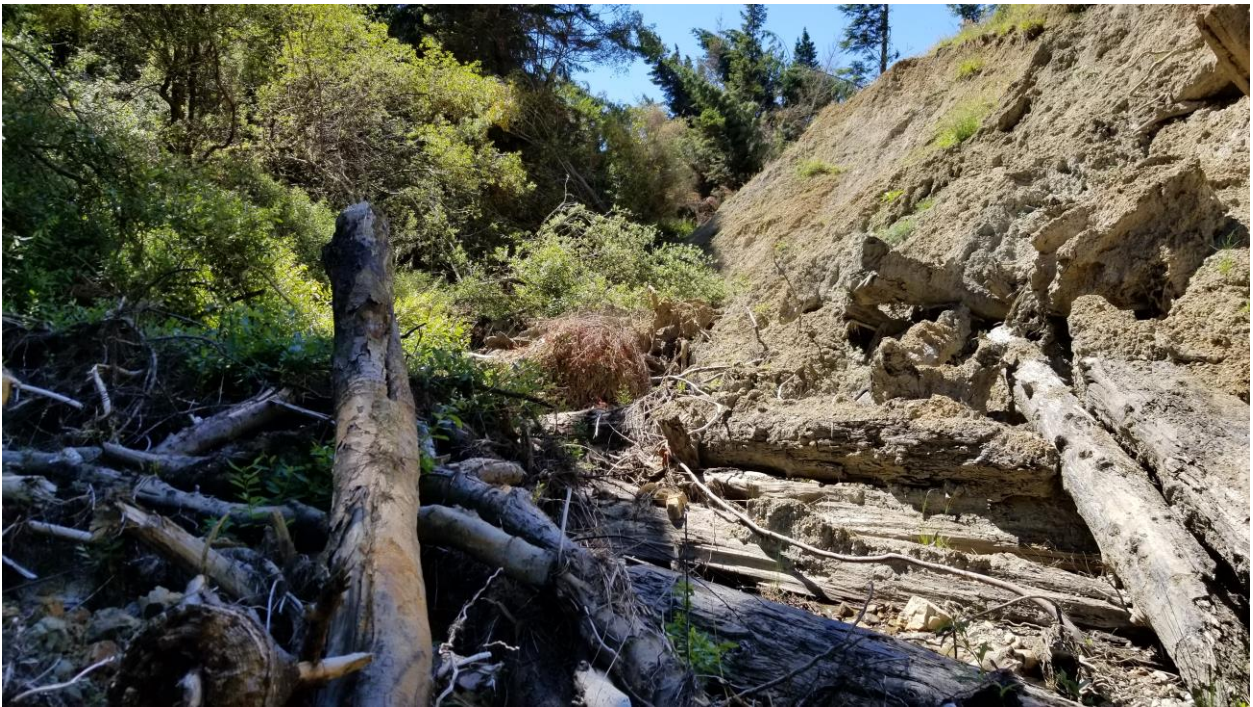
Photo 2: Landslide and large debris accumulation. (Photo taken 6/22/17)

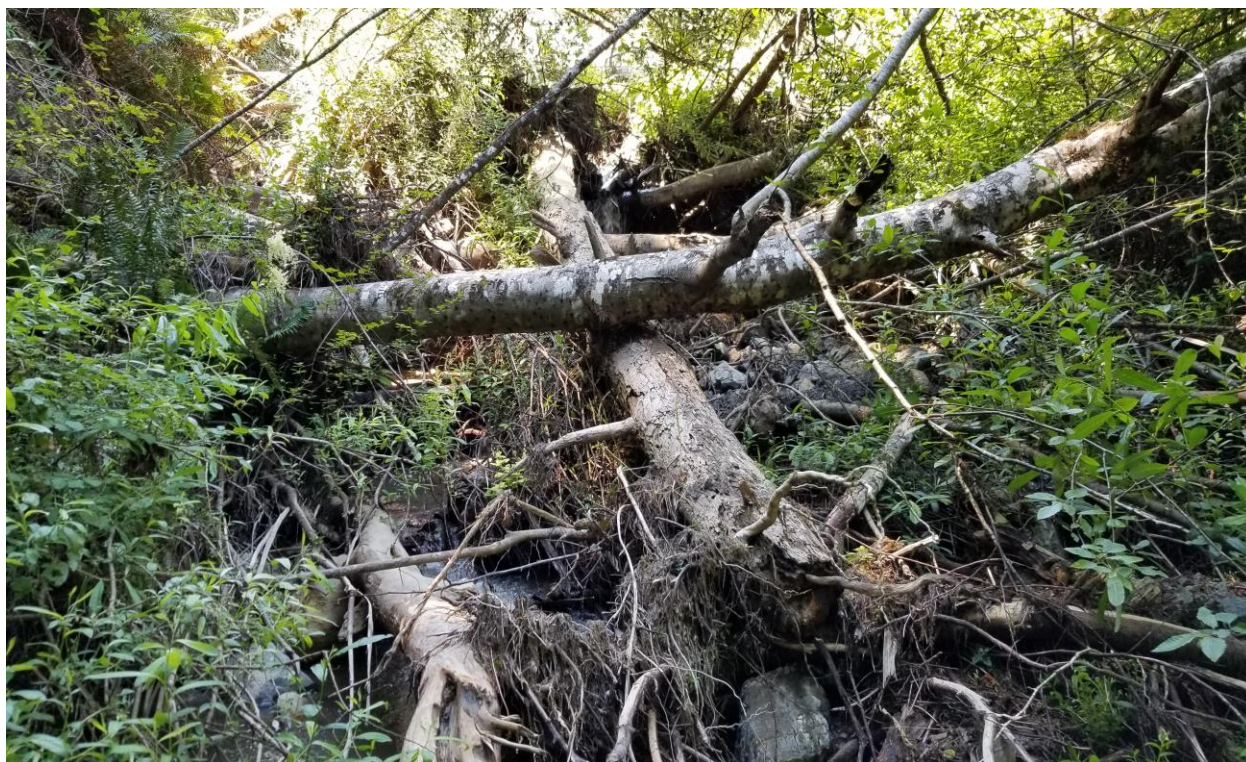
35247	0590.00	End of survey due to major landslide/LDA accumulation spanning width of channel. Total length was not measured due to restricted access from debris. It is at least 1,200' long and the width varies from 30' to 100'. There is a large volume of sediment collecting behind the debris. Landslide is still unstable with trees precariously balancing on slope.

Photo 3: End of survey due to major landslide and large debris accumulation, 35,230' upstream from start of survey. (Photo taken 7/7/17)
