## **CALIFORNIA DEPARTMENT OF FISH AND WILDLIFE**

### **STREAM INVENTORY REPORT**

#### **Grizzly Creek**

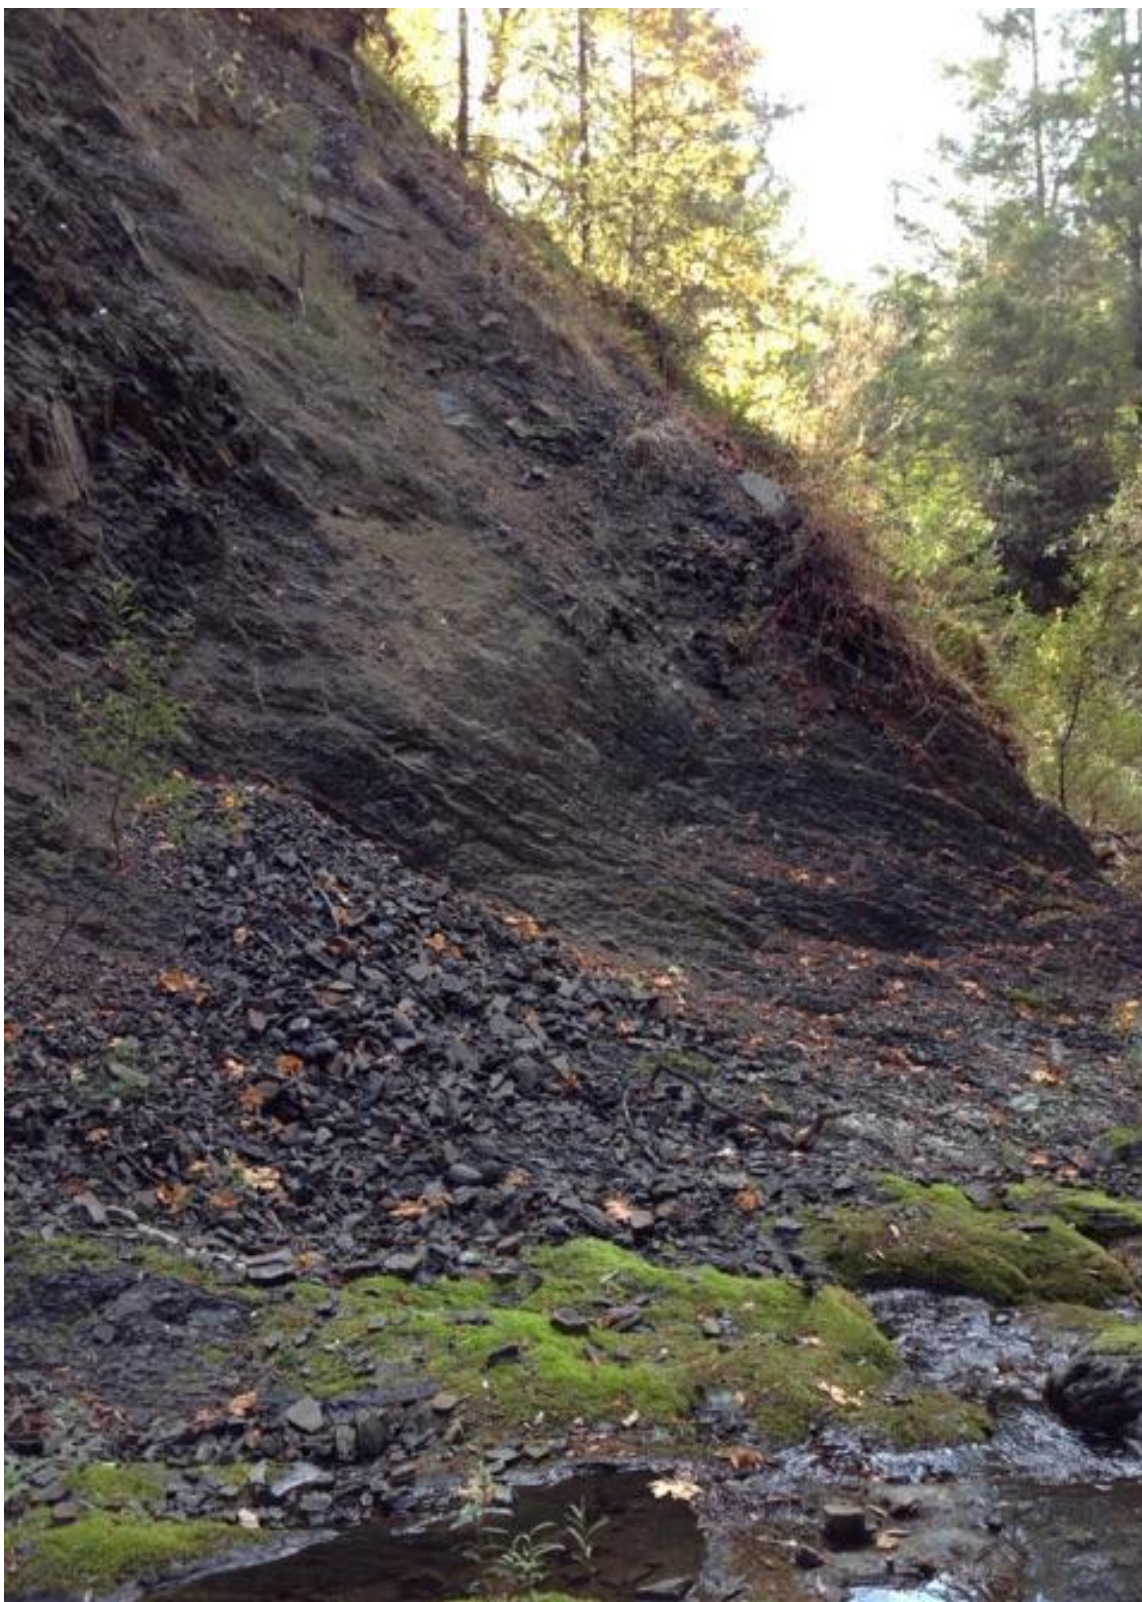
9610	0154.00	There is a landslide on the right bank, it measures 100' long x 35' high. It is depositing gravel, and is vegetated with brush.
10005	0161.00	Tributary #5 enters on the left bank. It contributes to approximately 10% of Grizzly Creek's flow. The water temperature of the tributary was 48° Fahrenheit, the water temperature downstream of the confluence was 48° Fahrenheit, and the water temperature upstream of the confluence was 48° Fahrenheit. The slope of the tributary is 1%. The tributary is accessible to salmonids due to gentle slope and open, clear channel. Fish were observed in the tributary.
10129	0164.00	Bridge #2 is the crossing for an unnamed road, and is 13.5' high x 20' wide x 58' long. It is a vehicle bridge (made of metal) and is not a barrier to salmonids.
10234	0165.00	There is a 2' boulder plunge into a 1.1' pool at the top of this unit. It is not a barrier to salmonids.

Photo 1: Landslide on the right bank measuring approximately 35' high X 100' long at habitat unit 154, 9,568' upstream of the start of survey. (Photo taken 10/17/17)

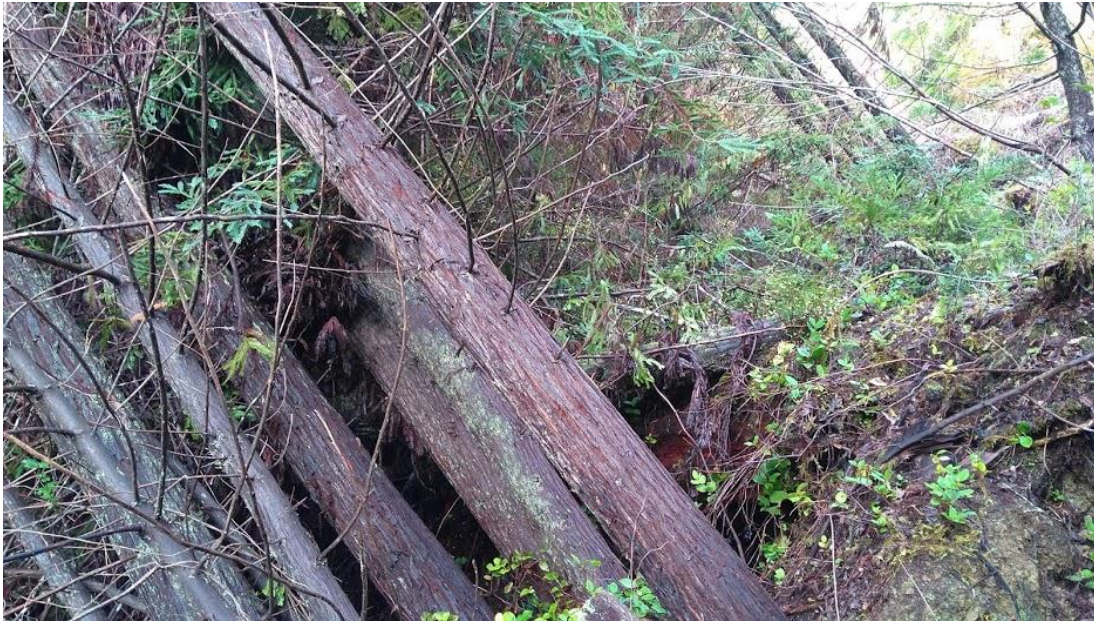
Photo 2: Channel constricted by fallen trees and a left bank landslide at habitat unit #212, 12,111' upstream of the start of survey. The fallen trees and landslide are possible barriers to anadromy. Photo taken from midway up the left bank landslide, facing downward towards the channel and upstream.  
(Photo taken: 12/5/17)

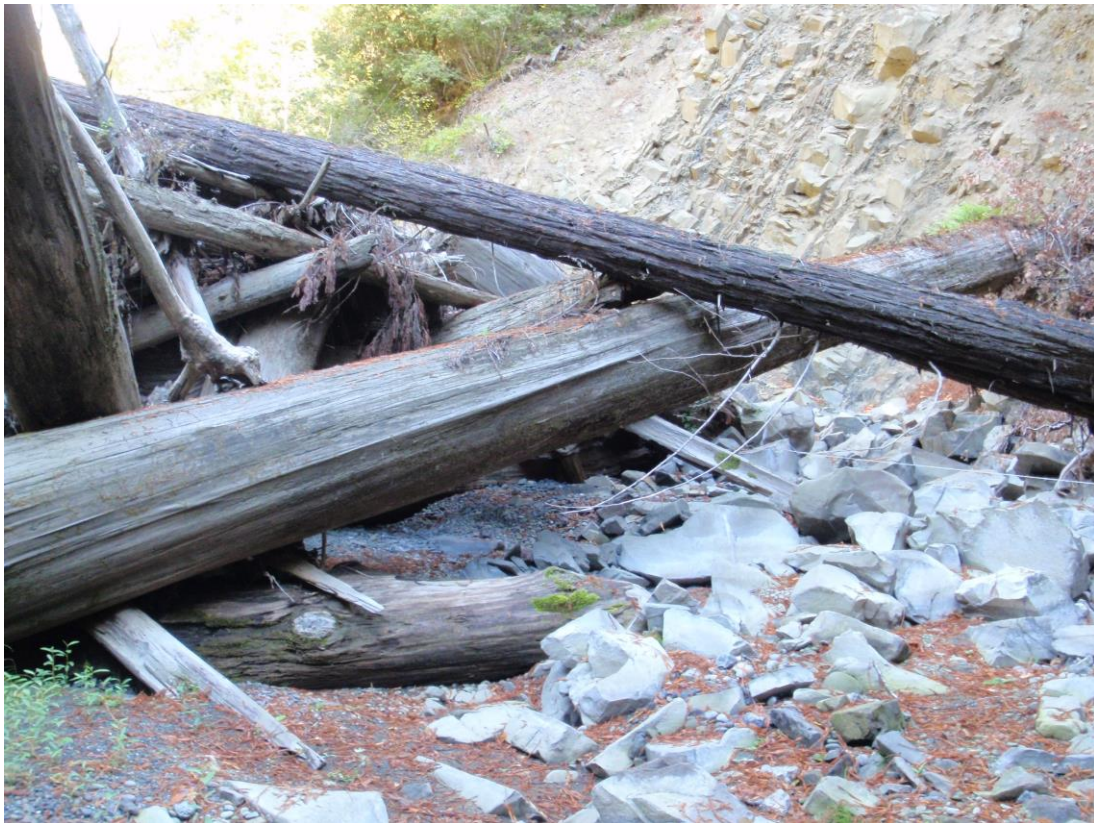
13104	0232.00	Rootwad on right bank.
13338	0237.00	There is a landslide on the left bank, it measures 100' long x 70' high. It is depositing gravel, and is not vegetated. LDA #2 is 10' high, 60' wide, 123' long and contains 33 pieces of LWD. Water does not flow through the LDA and there are no visible gaps in it. Sediment is being retained in the approximate dimensions of 50' wide, 50' long and 2' deep. The sediment ranges in size from silt to small cobble. The LDA is a possible barrier to salmonids because of its length. Fish were observed above the LDA.
13703	0239.00	Rootwad on right bank.
14482	0249.00	Tributary #6 enters on the right bank. It contributes to approximately less than 1% of Grizzly Creek's flow. The water temperature of the tributary was 49° Fahrenheit, the water temperature downstream of the confluence was 50° Fahrenheit, and the water temperature upstream of the confluence was 52° Fahrenheit. The slope of the tributary is around 35%. The tributary is not accessible to salmonids due to very steep slope and entrenched channel with boulder substrate. Fish were not observed in the tributary.

Photo 3: LDA #2 and left bank landslide at habitat unit #237, 13,237' upstream of the start of survey. Photo taken facing upstream. (Photo taken: 10/24/17)

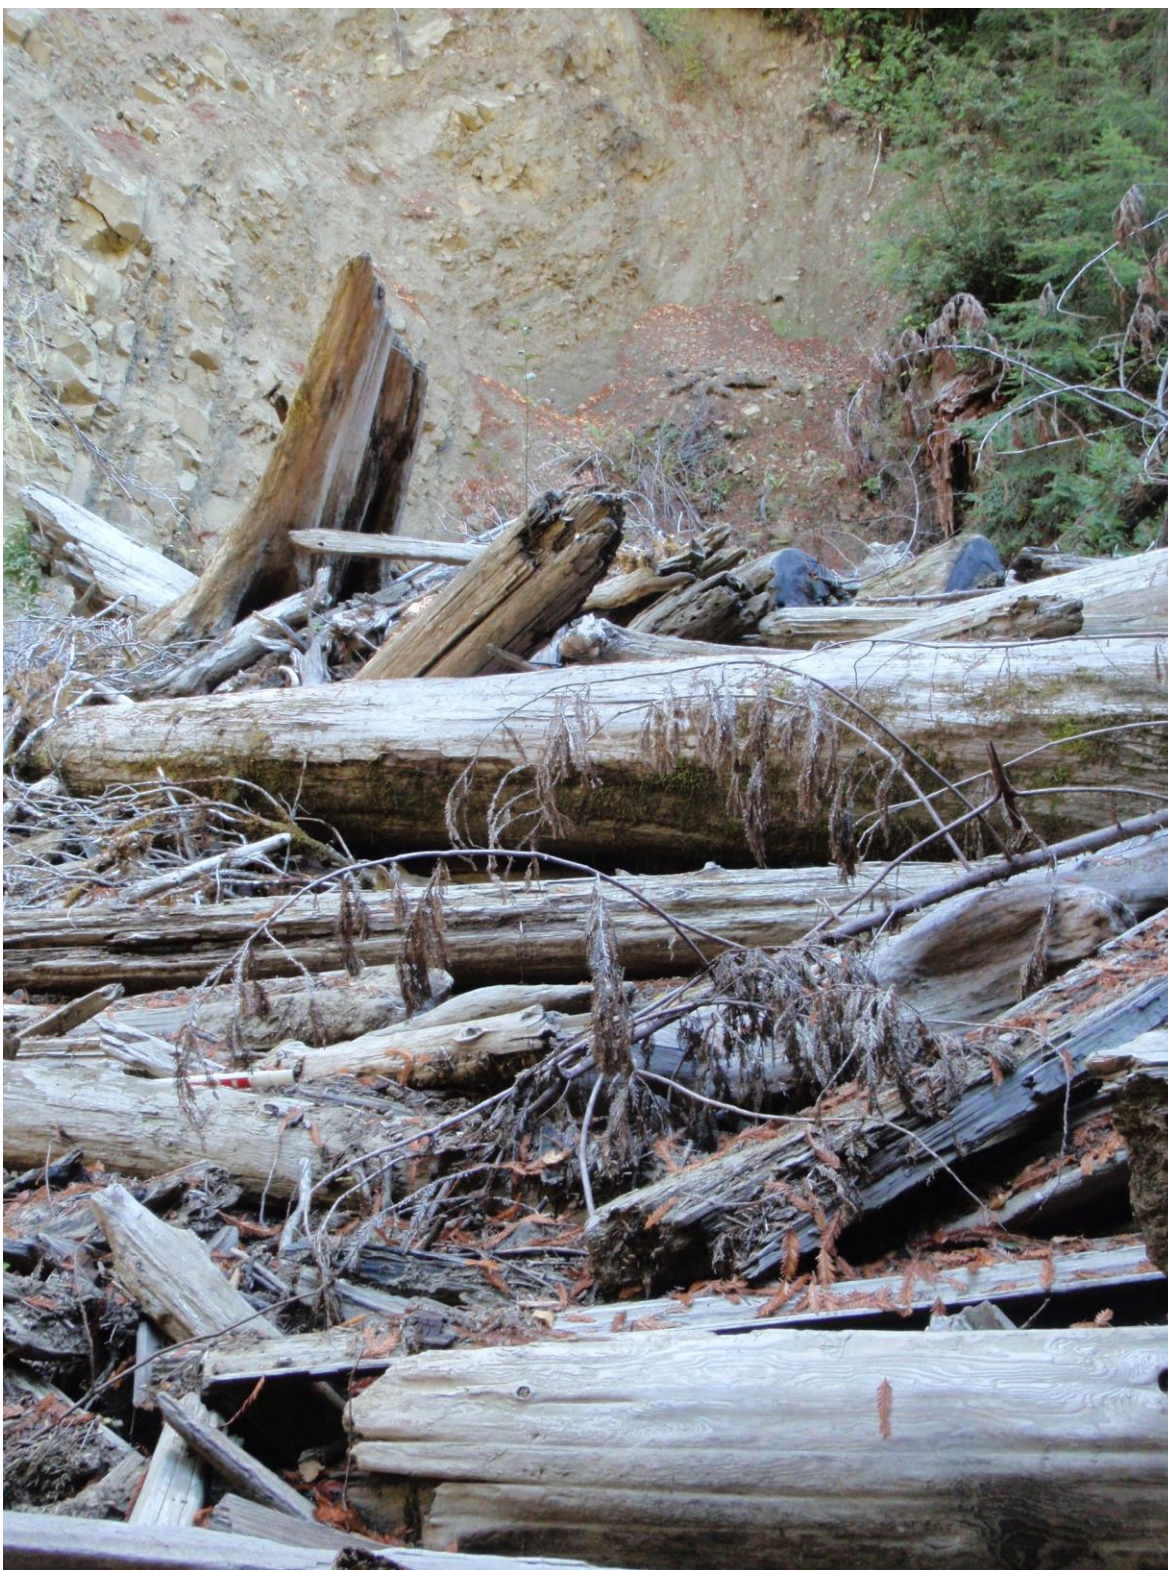
Photo 4: LDA #2 and left bank landslide at habitat unit #237, 13,237' upstream of the start of survey.  
Photo taken facing downstream. (Photo taken: 10/24/17)

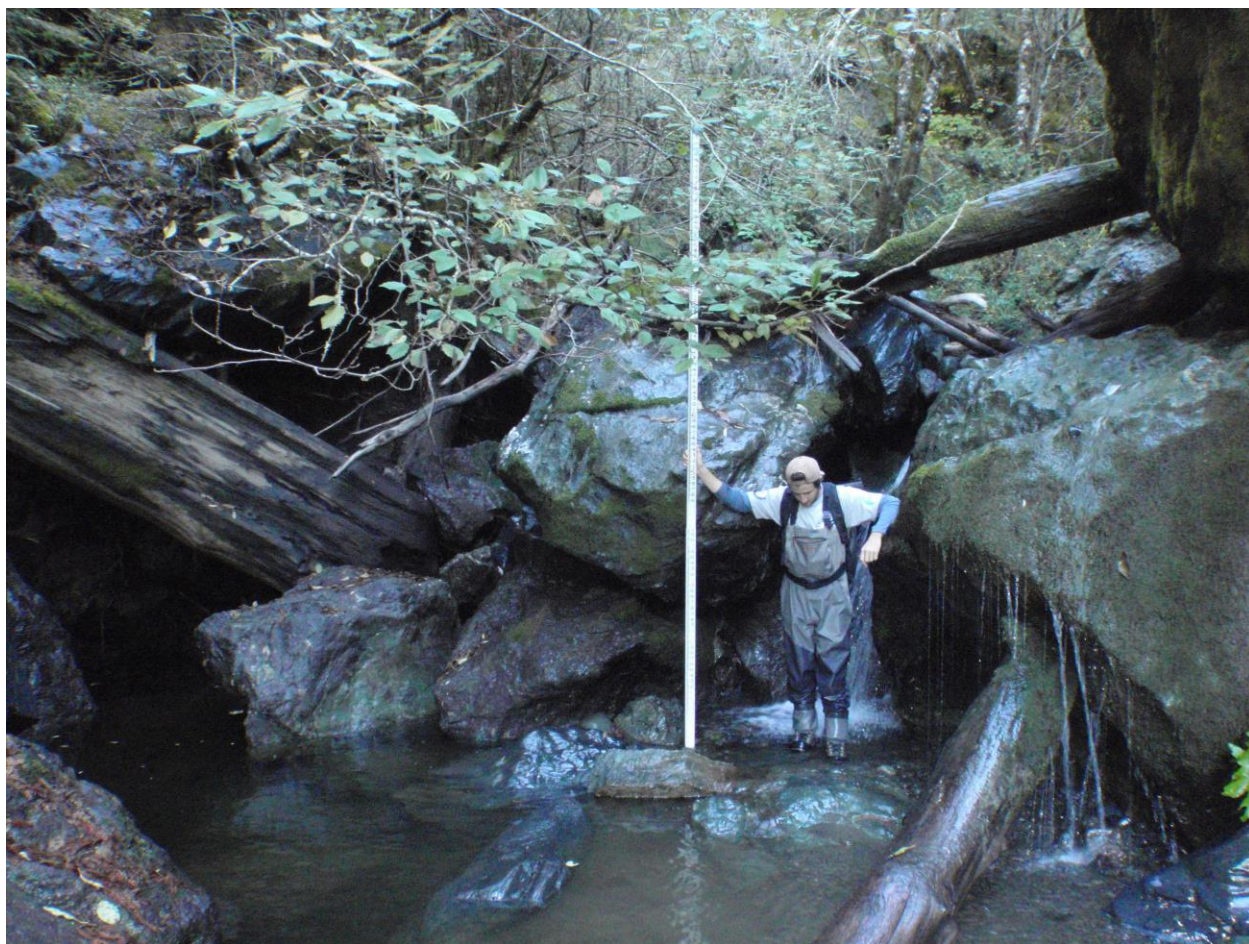
16630	0300.00	There is a 7.5' boulder plunge into a 0.6' pool at the top of this unit. It is not a barrier to salmonids.
16850	0303.00	End of survey due to 18' waterfall plunge into shallow pool (<0.5') at top of unit. Plunge falls onto large boulders and large cobbles. Steep cascade for over 100' before waterfall. It is a barrier to salmonids.

Photo 5: 7.5' plunge over boulders with no pool below at habitat unit 300, 16,675' upstream of the start of survey. Pictured: Teddy Masters. (Photo taken 10/24/17)

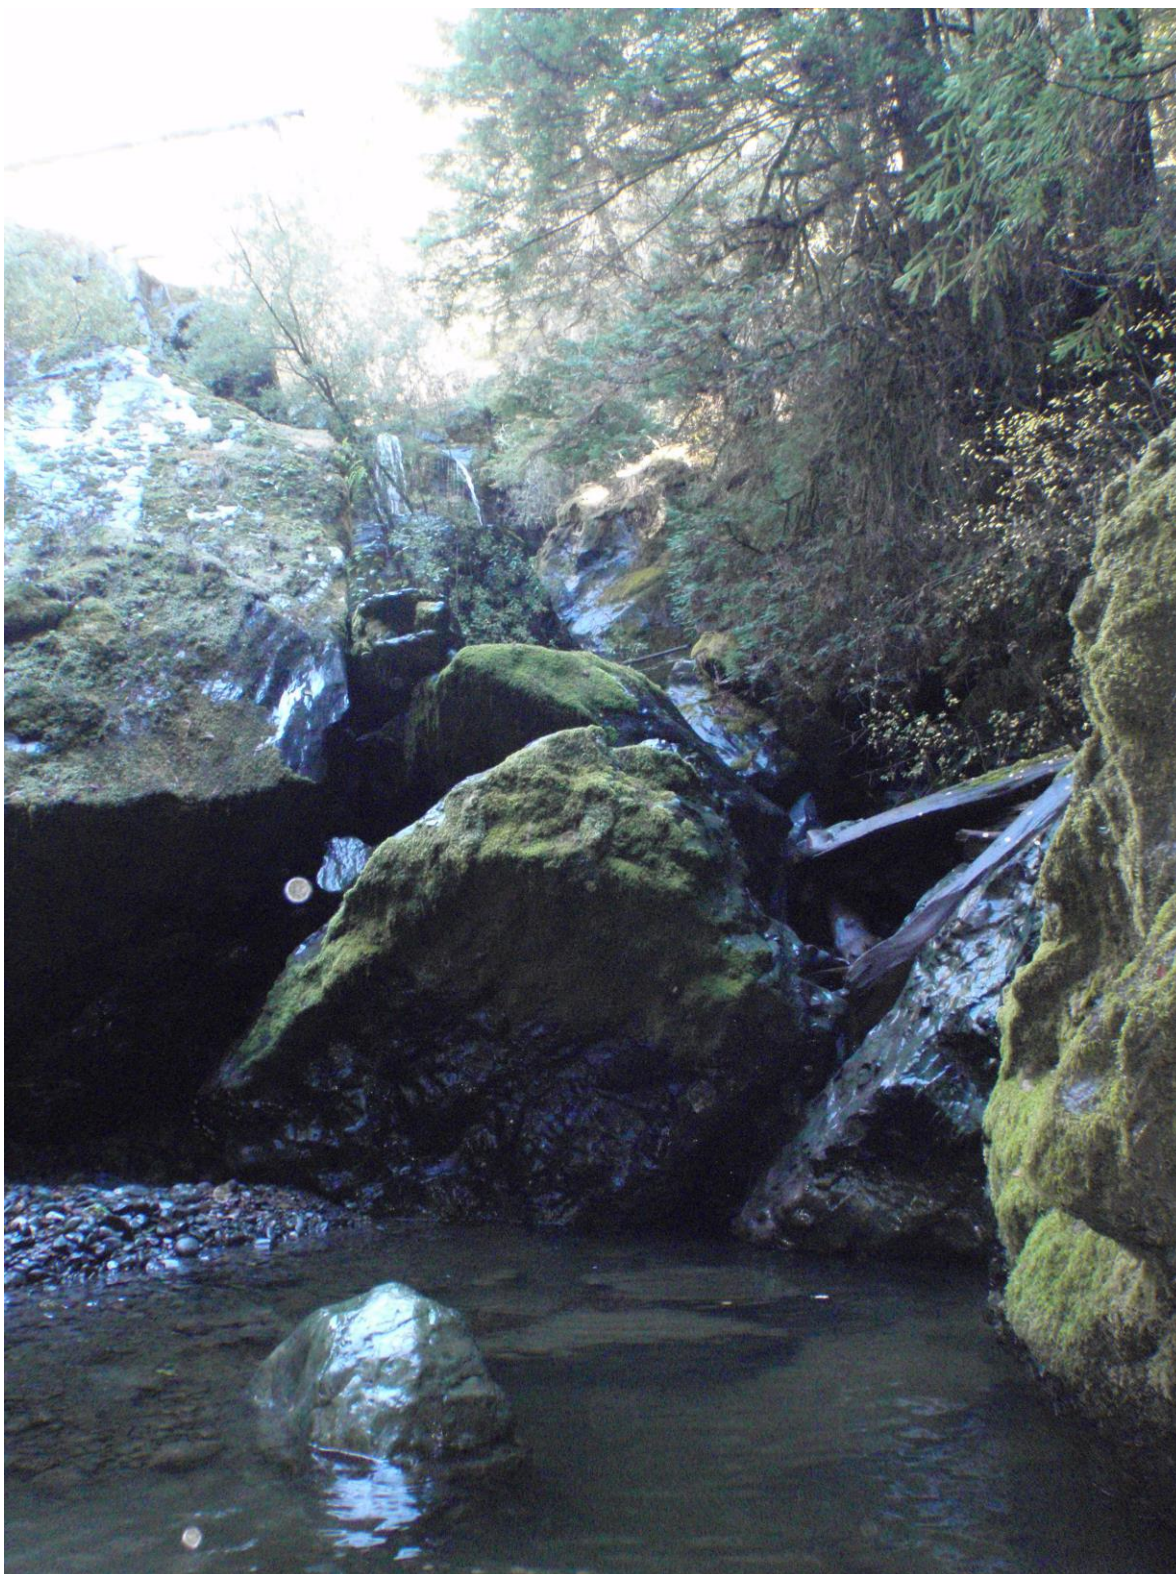
Photo 6: The last pool with steelhead observed at habitat unit 302, 16,793' upstream of the start of survey.  
(Photo taken 10/24/17)

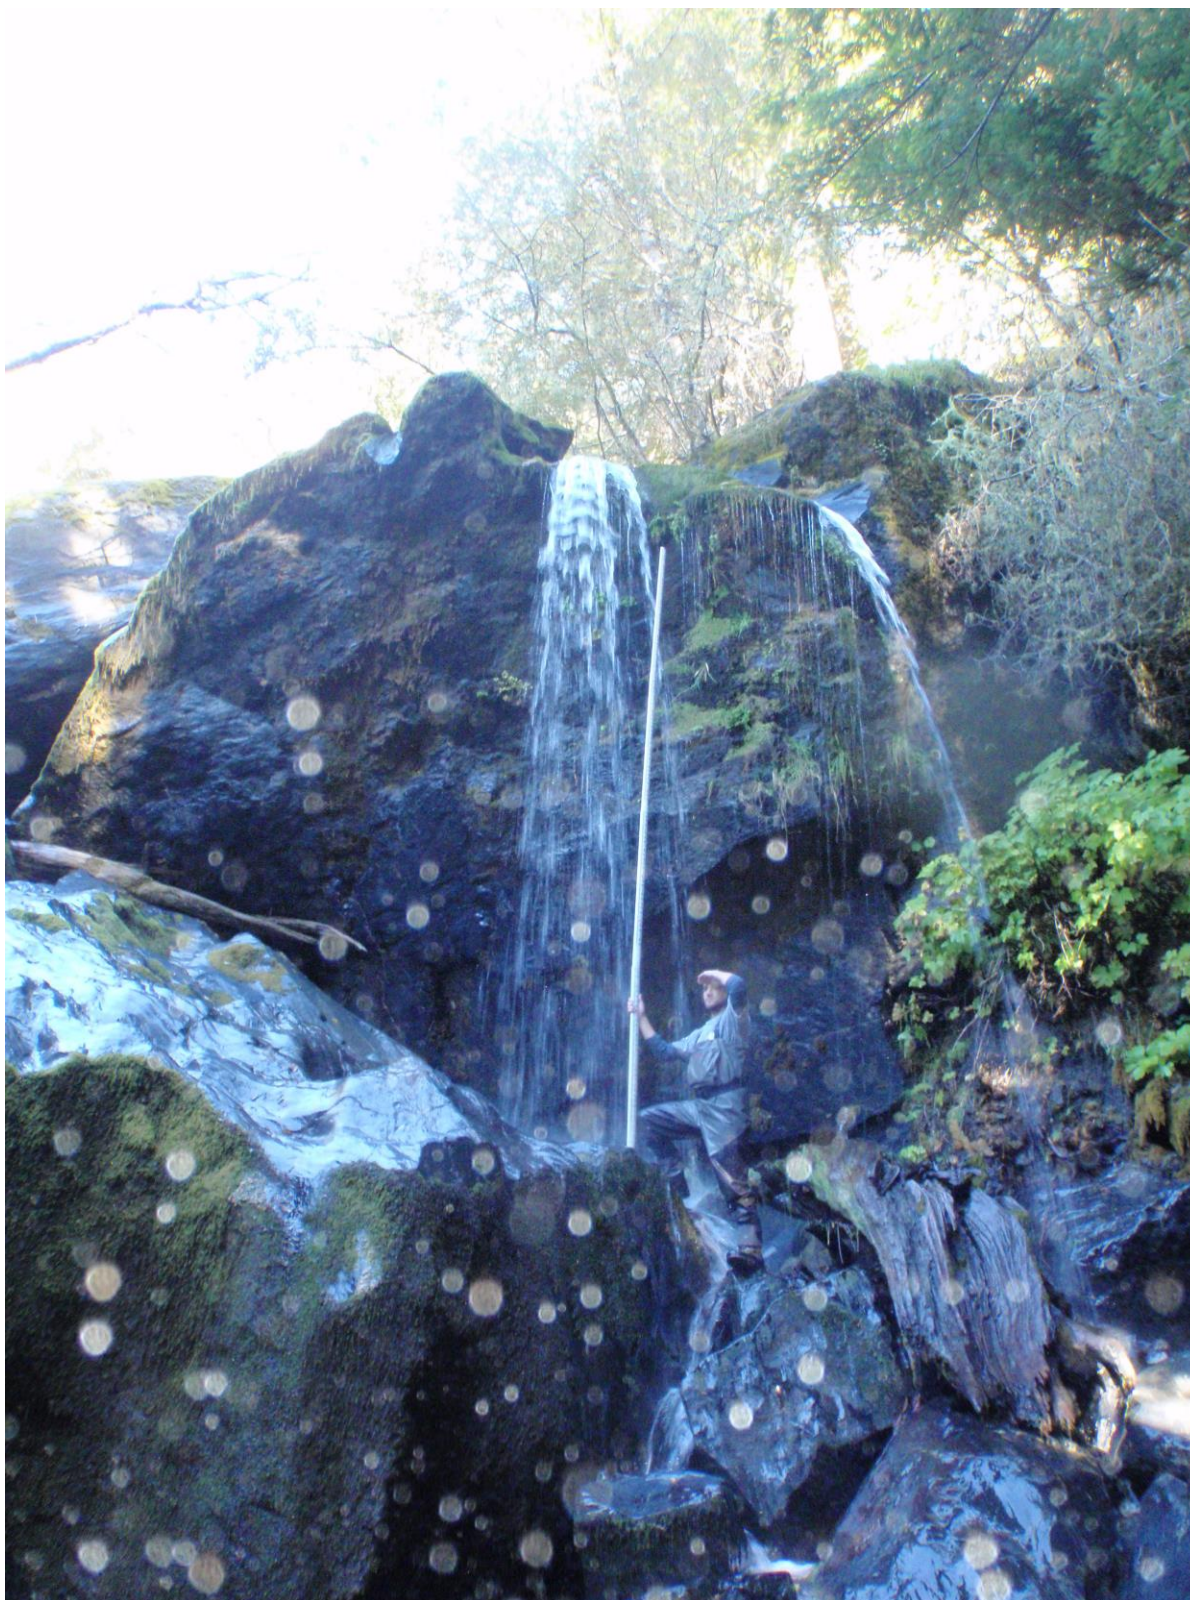
Photo 7: End of survey at habitat unit 303, 16,895' upstream of the start of survey. 18' waterfall over boulders with no pool beneath it. Pictured: Teddy Masters. (Photo taken 10/24/17)
